DAMAGE SURVEY AND OBSERVED DATA ANALYSIS OF LONG RC BUILDING WITH IRREGULAR PILE SUPPORTING STRATUM AFTER THE 2011 TOHOKU EARTHQUAKE

Kazuya MITSUJI¹, Susumu OHNO² and Masato MOTOSAKA³

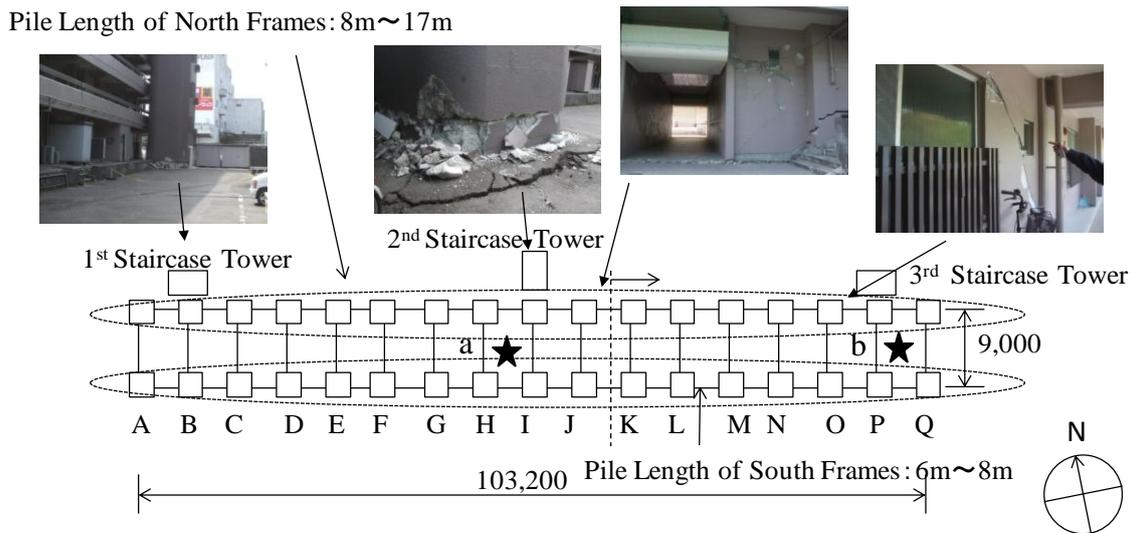
The authors conducted damage survey of building A after the 2011 Tohoku earthquake. Outline of the damage of building A is shown in Figure 4. The building A has three staircase towers. One of the most specific characteristics of the damage is the leaning staircase tower due to damage at the foot of the tower. All of the three towers indicated the leaning to the north. Bending failure at the foot of the tower was observed in the first and second towers. Severe damage at the pile head may have been occurred in the third tower, because minor and intermediate cracks were observed, but any significant failure couldn't be found at the foot of the third tower. On the other hand, superstructure didn't show any significant structural damage, but large shear cracks on non-structural walls of a lot of housing units and large bending cracks at the centre of girder at the east edge of the building were observed.

Figure 4. Damage distribution of building A after 2011 Tohoku earthquake

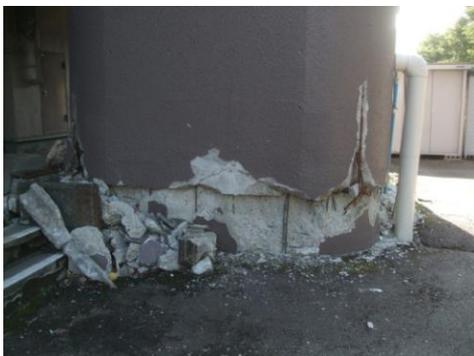
Specific severe damages of building A caused by the strong shaking of the 2011 Tohoku earthquake are shown in Photo 2 to 5. Photo 2 is damage at the foot of the 1st staircase tower. Three staircase towers have rectangular plan and the 1st and 3rd tower have those strong axes in NS direction, while the 2nd tower has its strong axis in EW direction as shown in Figure 4. Bending failure at the foot of tower shown as Photo 2 was observed in all the towers. One of the characteristics of building A is difference of the height of the first floor. The height of the first floor on the west from frame "J" is 3360mm, and that on the east from frame "K" is 3950mm. Difference of the height may have caused shear cracks on the wall of the first floor around frame "J" and "K" as shown in Photo 3.

Photo 2. Damage at the foot of staircase tower

- 1) Severe bending failures at the foot of staircase tower adjacent to superstructure are quite distinctive. Shear cracks on the non-structure walls and bending crack on the girder around the frames where the first floor heights change in longitudinal direction.

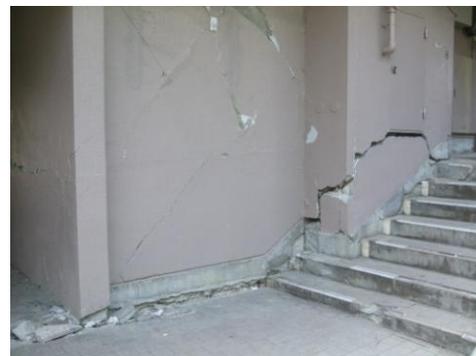
Photo 3. Damage caused by the different height of the first storey

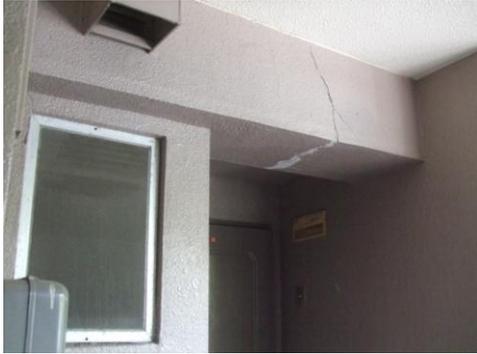
Bending crack on the girder of the second floor was observed at around frame “O” as shown in Photo 4. Damage is severer at the east side of the building than west, and the corridor of the east side at the second floor was temporarily reinforced by steel plate as shown in Photo 5.

Photo 4. Crack of the girder of the second floor

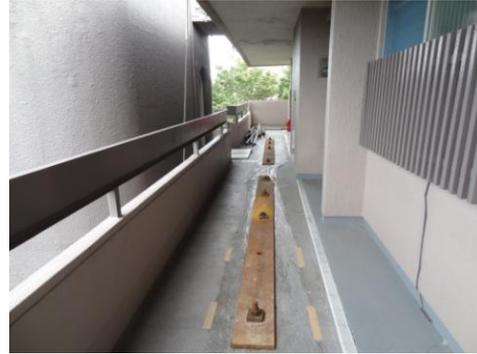
Photo 5. Temporary reinforcement of the east edge of corridor of the second floor
