SEISMIC SAFETY AND STABILITY OF EXISTING STRUCTURE OF ST. MARY PERIBLEPTOS CHURCH IN OHRID

Veronika SHENDOVA¹, Zivko BOZINOVSKI², Roberta APOSTOLSKA³,
Aleksandar ZLATESKI⁴, Goran JEKIKJ⁵

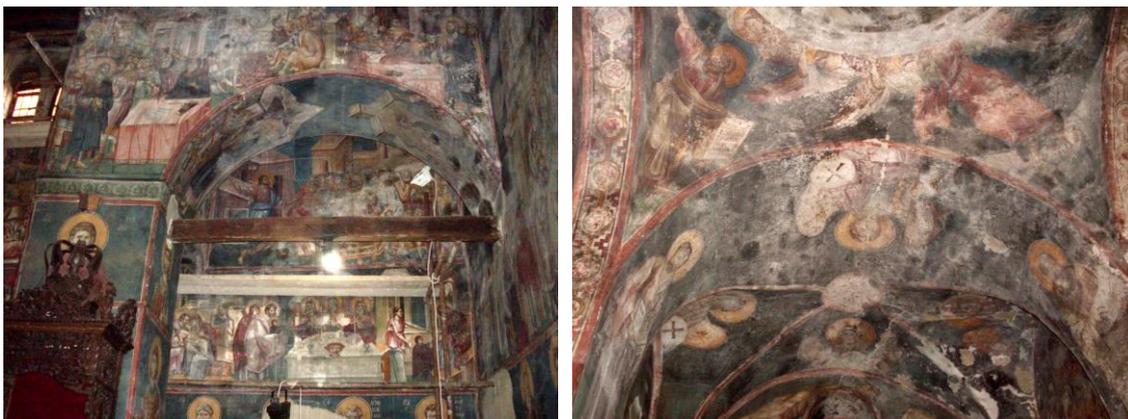
Conservation works on preservation of the architecture and the structure of the monument were carried out in the course of the 1950-ties and in the midst of the 1980-ties of the last century. During the last interventions, the cracks at characteristic places in the vaulted parts due to loss of function of the timber ties, were repaired (Fig. 3).

Figure 3. Existing cracks in the church repaired in 1986

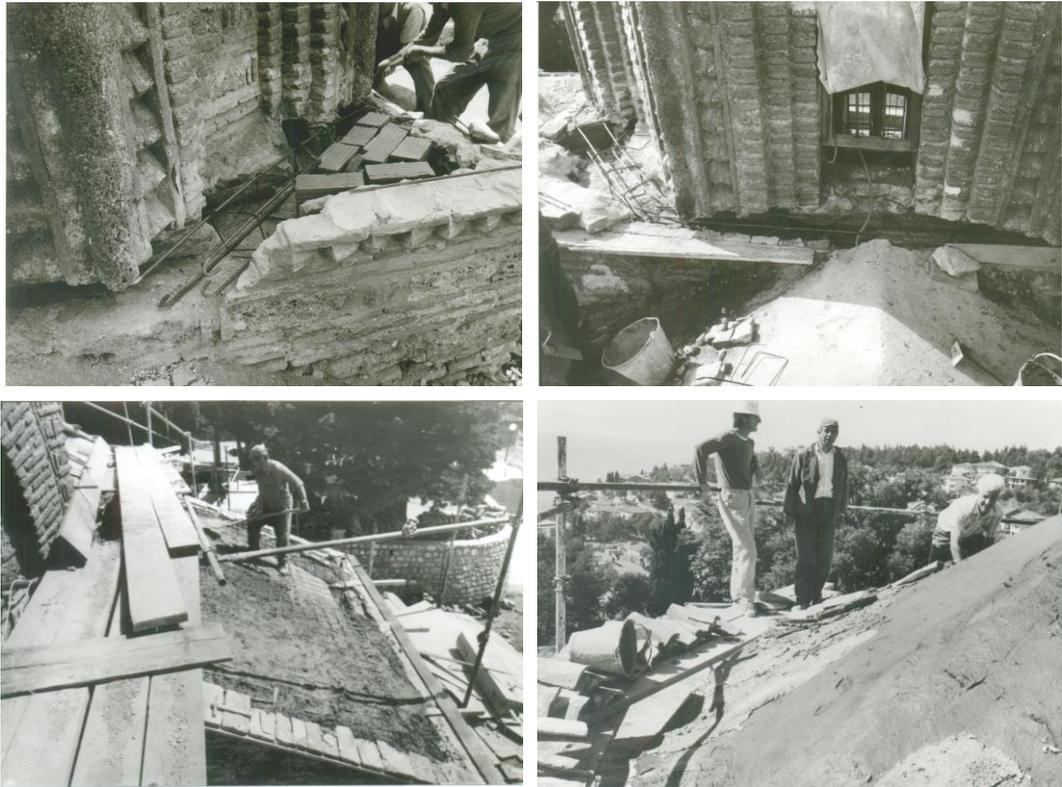
Then, steel ties were inserted in the central area below the dome and anchored in the wall mass of the bearing walls. The reinforced concrete slabs placed over the vaults, the diaconicon, the prothesis, the reinforced concrete rings in the base of the tambour (Fig. 4, 5) as well as the cement layer and tar paper over the dome were constructed in 1986 in compliance with the then existing level of technical knowledge and represent massive structural interventions.

This type of work is certainly “incorrect” both in terms of “historical respect” for the building and its original construction techniques and in terms of the actual capacity to prevent leaks and protect the decorations inside the church. This was confirmed by the massive leaks which affect both the vault of the north chapel and the far eastern end of the north wall of the naos, which is due to original construction errors but also to the use of unsuitable materials and the lack of adequate maintenance. Consequently, one of the main task within the project was to consider the possibility of removing of all the reinforced concrete and cement layers.

From structural aspect, it can be concluded that the existing bearing structure is in stable conditions with minimal structural damage to the roof vaulted parts dating back prior to the restoration in 1986. These have not been enlarged since then. The steel ties of the main vaults were appropriately incorporated in 1986 and are still functioning. In accordance with the present knowledge, reinforced concrete should not be applied in strengthening and protecting monuments of this type. However, although the reinforced concrete elements are constructed as free standing and separated from the existing walls by an air space, (Fig. 5), due to presence of reinforcement, these cannot be removed

without the use of equipment that will cause vibrations and will most probably damage the existing masonry.

Figure 4. Incorporation of reinforced concrete elements (tambour, vault, dome) (1986)

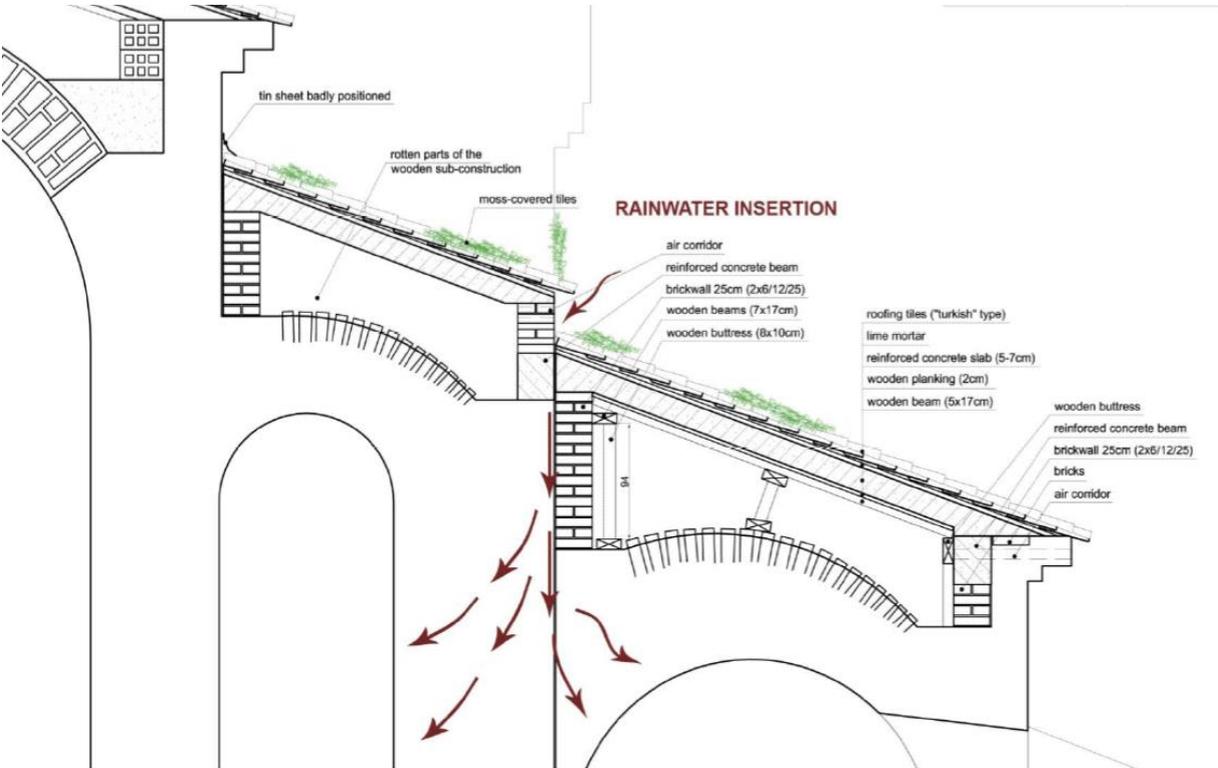
Figure 5. Construction details of the roofing over prothesis and northern chapel

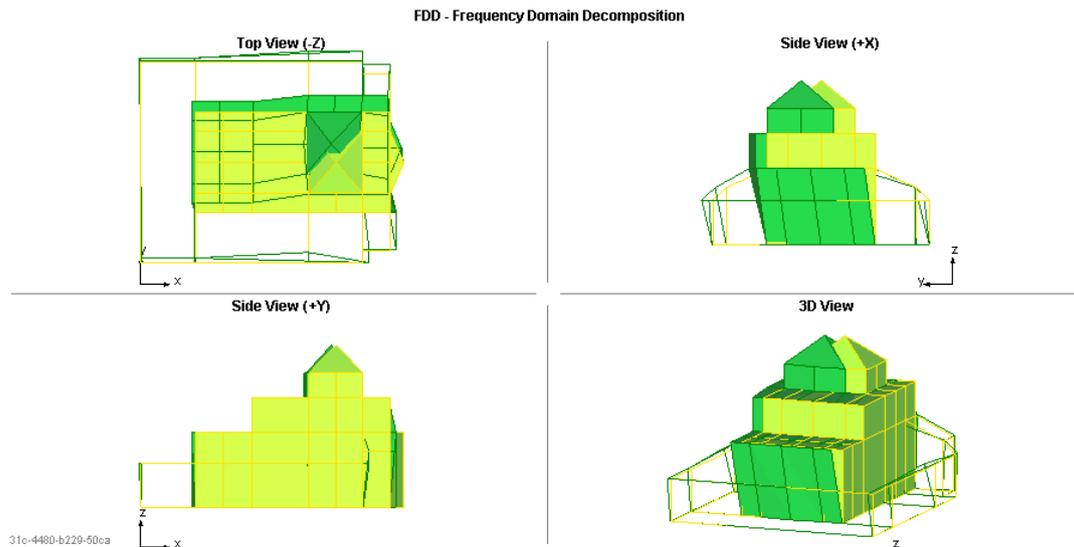
The resonant frequency in lateral (transversal) direction for the church is 5.08Hz, in longitudinal direction is 6.45Hz and for torsion it is $f=7.6\text{Hz}$ as well $f=10.9\text{Hz}$, while the frequency $f=8.8\text{Hz}$ belongs to lateral vibration of the longitudinal walls of the portico. The church itself has clear and well expressed natural frequencies and corresponding mode shapes of vibration. The church complex (the church, the paraklisses and the portico) works mostly together, (Fig. 7). as a result of the existing wooden beams connecting the walls of the church and of the portico, but also independently at the higher frequencies because of existing separation joints. The values obtained for damping ranging within 1.3-3.8% are relatively lower than the usual ones for this type of structures which speaks for itself about the compactness of the original masonry.

Figure 7. Mode shape of vibration at a frequency of 5.08Hz

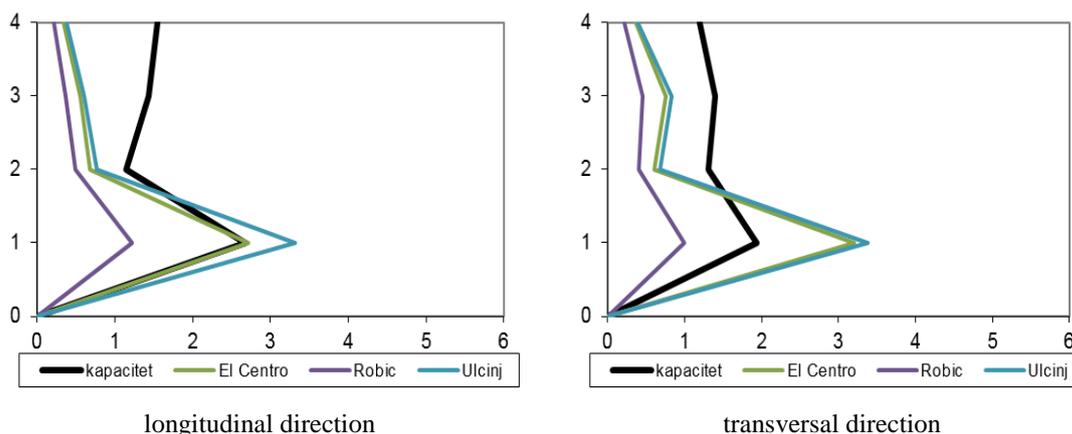
The insufficient deformability of the first level of the church structure can be overcome only by large interventions as is addition of new ductile structural elements for strengthening. However, considering that the authenticity of the church is a priority and an imperative, it has been assessed that the intervention in this sense is not allowable, particularly that, after detailed investigations and analyses, it has been shown that the church structure is stable and safe under gravity serviceability loads for the design level of seismic effects.

Figure 10. Required ductility for input $a_{max}=0,31g$ in respect to ductility capacity of the church
