DAMAGE SUFFERED BY INDUSTRIAL BUILDINGS DURING THE 2012 EMILIA (ITALY) EARTHQUAKES

ABSTRACT

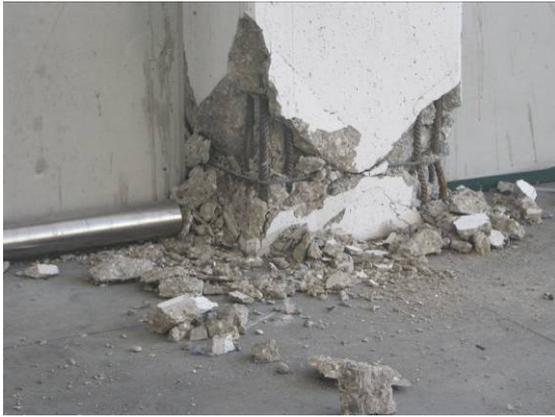
(a)

The activation of a plastic hinge at the base of a column (e.g., Figure 2a) has been observed in more than 40% of the buildings investigated. As a matter of fact, despite the reduced ductility due to axial force, the formation of plastic hinges at the base represents the main source of energy dissipation of these buildings due to the absence of bilateral connection between columns and beams. Rebar buckling has been observed in a few examples (Figure 2b); in these cases the rotation of the columns has been substantial.

- Foundations should be connected to one another and the collaboration of the building flooring, frequently rather thick, should be taken advantage of. These details will grant synchronous motion and an effective rotation restraint at the base.
- The base of the column should have appropriate stirrup spacing, in order to avoid the buckling of longitudinal bars, and adequate longitudinal reinforcement. Intervention on existing structures with reinforced concrete, steel or fiber reinforced polymers can supply sufficient confinement and

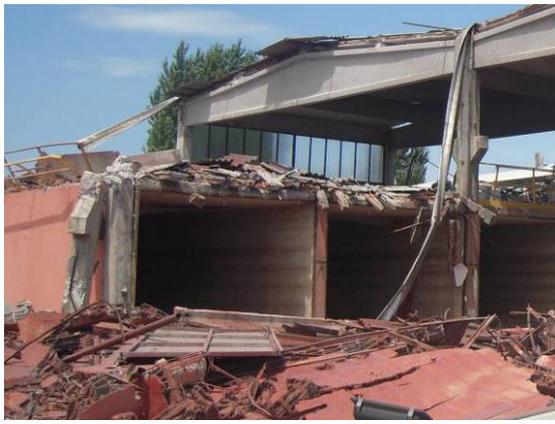
(c)

Short-column failure has been fairly frequent due to infills (Figure 2c). In other cases it has been originated by adjacent new constructions without an adequate seismic joint or by contiguous halls of different height (Figure 2d). Another short-column source is the presence of sawtooth roofs with inclined beams: the marked change in stiffness at the base of the tooth induced the severe damage shown in Figure 2e.

- improve ductility. According to the type of intervention, an increase of stiffness and/or strength can also be obtained (Gruppo di Lavoro, 2012).
- Short-column failure should be averted by: appropriate design of the infills, adequate joint between adjacent halls or buildings, avoiding inclined-beam sawtooth roofs, specific design of the column.

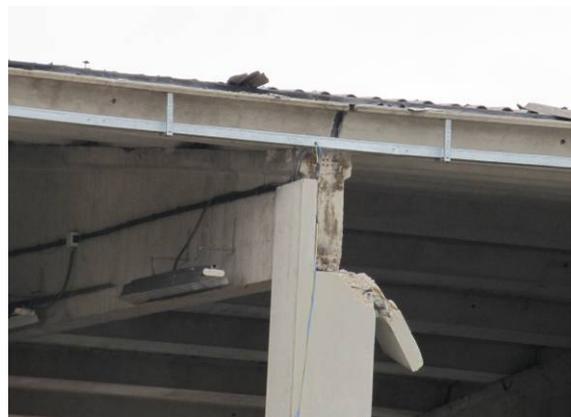
(f)

The top of the columns has been frequently impaired. Two types of damage have been reported: spalling of the concrete directly supporting the beam and failure of the cantilever lateral restraints of the pocket supports (Figure 2f). The first type of damage, which can be related to the very thick fire-protection cover concrete, and to the lack of a rubber interface between the concrete elements, is seldom critical, unless coupled with beam sliding. On the contrary, the second damage mode is frequently associated with beam unseating. The connection between the two lateral restraints and the beam head may reduce the bending moment at the base of the pocket support walls and hamper the unseating of the beam.

The activation of a plastic hinge at the base, the short-column mechanism and the failure of the lateral restraints of the pocket supports are the only failures related to the reinforcement observed during the surveys. The 1987 code for precast structures and the 1986 code for earthquake-resistant structures (DM 1986) did not specify any regulations in terms of design for shear against short-column failure and minimum amount of longitudinal reinforcement. On the contrary, such provisions are present in the current code. Contrarily, the 1987 code prescribed a verification of the pocket support against bending moment, which is not present in the current building code. Clearly, the design of the lateral restraints of the pocket did not avoid the failures represented in Figure 2f.

Figure 2 Damage to columns: a) plastic hinge at the base, b) buckling of longitudinal rebars, c) short column failure due to infills, d) short column failure due to different height of adjacent halls, e) short column failure at sawtooth roof base, f) failure of the lateral restraint of a pocket beam support

- Beams and columns should be connected using mechanical devices to prevent lateral failure of pocket supports and the more dangerous unseating of the beam; as a matter of fact, the numerical analyses proved that it is not safe to rely on friction, as stated also in the Italian code.

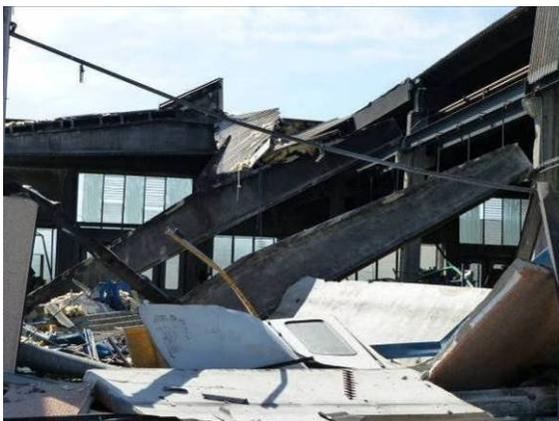
(a)

The most severe damage to beams has been their unseating (e.g., Figure 3a), which was observed in almost 30% of the buildings investigated. It is clear that the reliance on friction alone is not sufficient to prevent such damage, especially when a significant vertical component of ground motion can be expected, as investigated in the next section. Because of any lack of redundancy, a catastrophic collapse of the roof has usually followed the failure of one or more shed beams (Figure

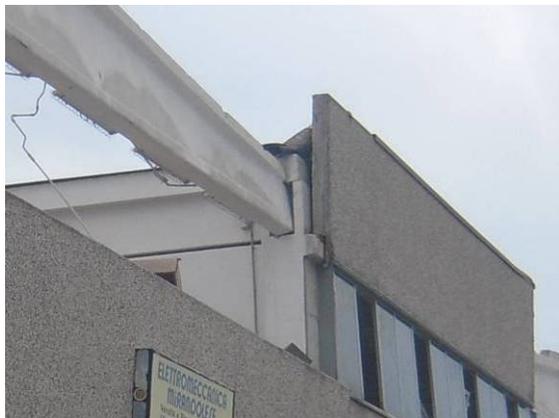
(c)

3b). A case of out-of-plane rotation of the shed beam is presented in Figure 3c. This type of damage is associated with (unconnected) roof panels, while older clay-block RC slabs avoided such rigid-body movements.

- The fastening between roof panel and beam will preclude the unseating of the top element and the rigid-body torsion of the beam; moreover, it will stabilise the columns in the direction normal to the beam.

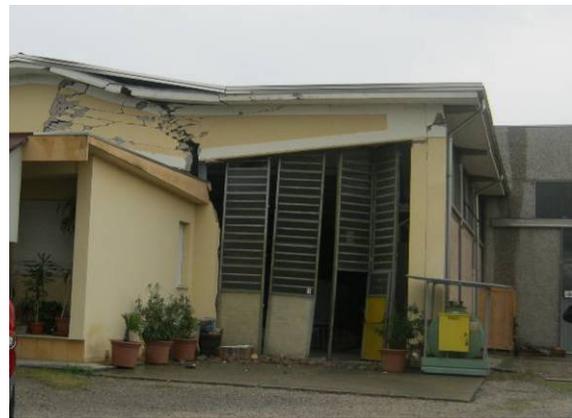
(d)

An uncommon damage is shown in Figure 3d. The building has internal shed beams, which suffered limited displacement at beam-column joint, due to column rotation. However, on 20th May the façade suffered a very severe crack of the tympanum, whose beam is completely unreinforced. Due to its high vulnerability, the building front collapsed on 29th May, although most of the surrounding structures survived the new event without additional damage. Therefore, particular care should be taken for the assessment of older buildings, checking for adequate reinforcement in cast-in-place beams, lintels and cantilevers.

Figure 3 Damage to beams and roof elements: a) unseating of shed beams, b) collapse of the roof, c) out-of-plane rotation of a shed beam, d) failure of the façade tympanum due to the lack of reinforcement in the concrete beam

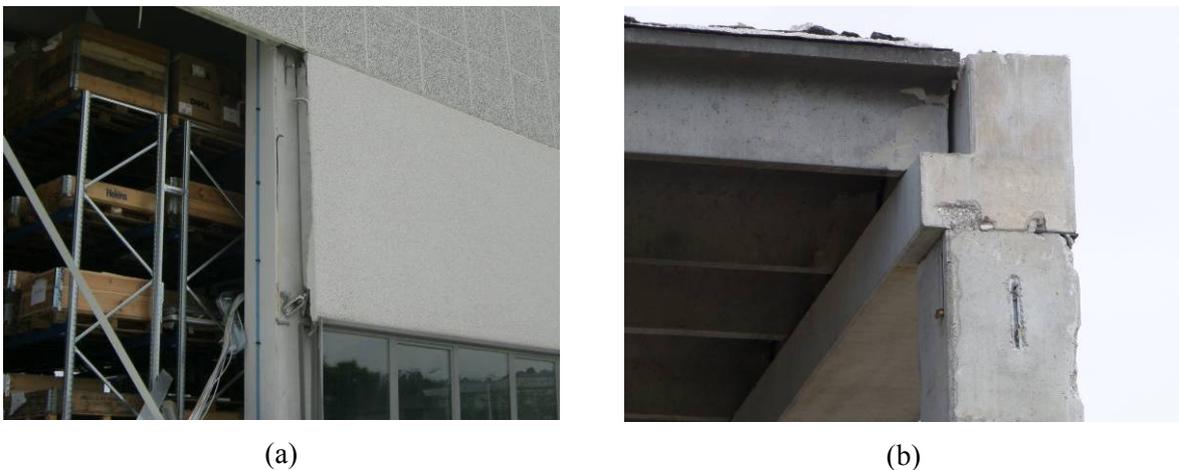
The high vulnerability of cladding panels is evident in the case shown in Figure 4a. The light connections proved inadequate to restrain the heavy elements. Concrete pullout has been registered in several buildings, as proved by the steel connectors attached to columns or beams. In some other cases it is the channel section embedded in the column that failed, whose brim deformed so much as to allow the connector head to be extracted. On the contrary, the steel connection of Figure 4b, between external panel and channel bar embedded in the column, failed in tension.

Figure 4 Failure of cladding panels: a) failure due to the light connections, b) tensile failure of the steel fasteners (both left and front sides)

Reduction of the vulnerability of cladding elements is one of the most urgent tasks for improving the seismic performance of precast RC buildings. This can be done through the design of the fastenings for appropriate earthquake-related forces. The 1986 seismic code prescribed generically to guarantee external cladding panels against separation from the structure (DM 1986). The performance in this and L'Aquila earthquakes indicates that no effective measures were taken. The current Italian code provides rules to calculate the acceleration to be applied on any cladding panel (DM 2008), but does not specify its distribution among the fastenings. A procedure for estimating the design force in the fastenings is suggested by Liberatore et al. (2013b). It is based on the statics related to the out-of-plane mechanism and assumes that the rotation takes place around the bottom support and that a symmetric top-bottom arrangement of the fastenings is provided.

- Particular care should be devoted to the connection between the main structure and cladding panels, in order to control their dynamic interaction with the resisting frames and to avoid their dangerous out-of-plane failure (Liberatore et al., 2013b).

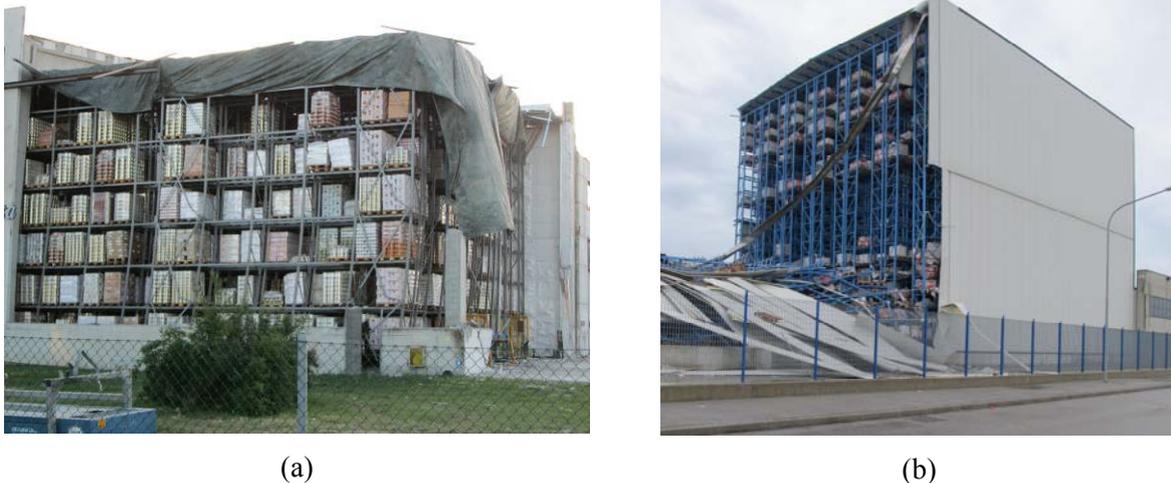
Different situations are present according to whether the steel stands are independent from the structure or not, in the latter case steel stands may be connected to the structure or be part of the main structure itself. The steel stands in Figure 5a are not connected to the precast RC structure. They have

longitudinal braces every four bays. Although the braces are eccentric, since not in the same plane as columns and beams, and although most of the braces buckled, the stands did not suffer a total collapse and were also able to support the roof elements, once the front shed beam failed. This proves that these secondary structures may have a safety reserve with regard to gravity loads.

Probably, the most catastrophic failure surveyed among factories is that of the building in Figure 5b, induced by the May 20th event. In this case the stands are also the structure of the building. The steel trusses are connected to each other only at roof level, where a truss beam linked the stands in the transverse direction; from what is visible in the surviving portion of the structure, the longitudinal braces are inserted in a single bay; at least seven bays without longitudinal braces have been counted. This can be explained by the fact that longitudinal braces reduce the storage capacity of these stands. As a matter of fact the stands are usually 1.0 m deep, while pallets are 1.2 m deep, and goods stored on pallets may even exceed this size. Therefore, longitudinal braces, even if confined to the back face of a stand, are considered a waste of valuable storage space. In this building the longitudinal stiffness and strength are very small. The high flexibility of the structure and the presence of considerable masses are likely to be the causes of collapse. The second-order P- Δ effect due to the horizontal deformations, increased by the heavy masses, triggered the loss of stability and led to the consequent total failure of a significant part of the building.

Figure 5 Damage to steel stands: a) damaged steel stands not connected to the main structure, b) collapsed building, in which the steel stands were part of the structure

- The vulnerability of steel stands, which seems related to inadequate longitudinal bracing, should be prevented by means of design for earthquake-induced loads. European Codes for both static (CEN 2005, 2009) and earthquake loads (CEN 2004) provide rules and recommendations. Moreover, in-depth recommendations about inspection and possible retrofitting of internal stands are specified in Consiglio Superiore Lavori Pubblici (2012).
