SEISMIC ASSESSMENT AND STRENGTHENING OF AN EXISTING MULTI-STOREY MASONRY BUILDING IN SARAJEVO, BOSNIA AND HERZEGOVINA

Naida ADEMOVIĆ¹ and Mustafa HRASNICA²

ABSTRACT

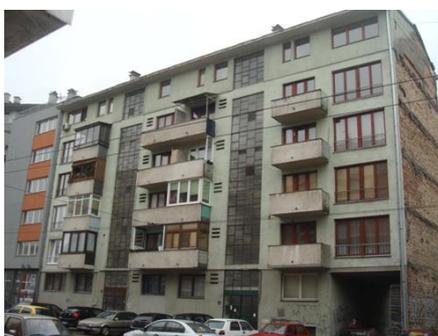
Figure 2. (a) Analyzed building, built in 1957 (b) Methodology by ICOMOS

In the plan, the structure is of dimensions 38.0m by 13.0m with 7 levels. It has been built in 1957 and it did not undergo any structural changes. Structural walls are mainly in the transverse direction (Y direction, see also Fig. 3). A significant percentage of openings in the amount of 46% of the wall area is in the longitudinal walls (Ademović, 2012). Accordingly, the lateral resistance in X direction is significantly inferior to the lateral resistance in the transverse (Y) direction. Only two inner walls in X direction are without openings. The external structural walls are made of standard brick elements 25x12x6.5cm and non-structural façade made of hollow bricks 0.125m thick, while the inner structural walls are 0.25m thick solid brick walls, all connected with cement-hydraulic mortar (Fig.3). The slabs are made out of semi-prefabricated concrete slabs "Herbst" with concrete hollow elements, details can be found in (Ademović, 2011). Basement walls are made out of reinforced concrete. Inner walls of the basement in Y direction are 0.38m thick, while the outer walls in X direction are 0.30m thick, and two inner walls are 0.25m thick, as shown in Fig.4. No damages were observed on the structure.

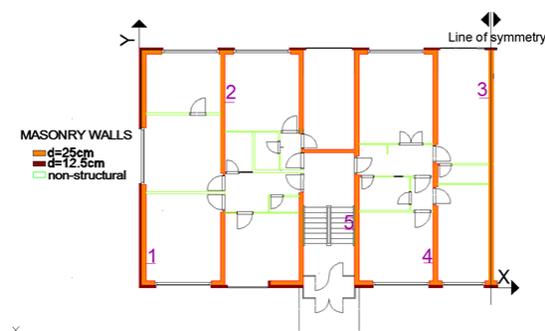
Brick units and concrete cylinders were taken out from representative locations in the structure as illustrated in Fig.3 and Fig.4. Samples of brick during testing of compressive strength are shown in Fig.5(a), while Fig.5(b) shows brick samples after testing procedure. Testing was done at the Institute for Materials and Structures of the Faculty of Civil Engineering in Sarajevo (IMK, 2010).

Figure 3. Masonry walls and sample location

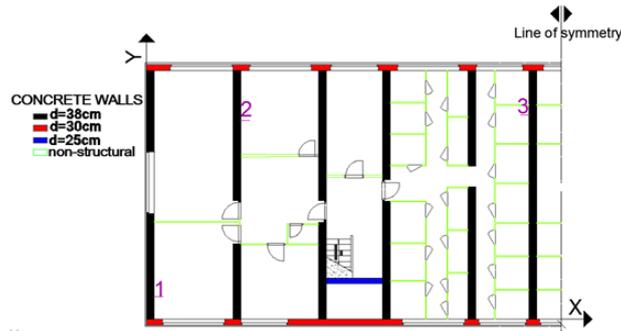
Compressive strength of bricks was determined according to the Bosnian standards. It was determined that the compressive strength of bricks corresponds to the class M150 (new M15) and fulfills the requirement for structural walls. Experimentally it was determined that the basement walls are made out of reinforced concrete, corresponding to grade C20/25, and a reinforcement $\varnothing=14\text{mm}$, type of steel GA240/360 ($f_y=240\text{ MPa}$).

Figure 4. Basement walls and sample location

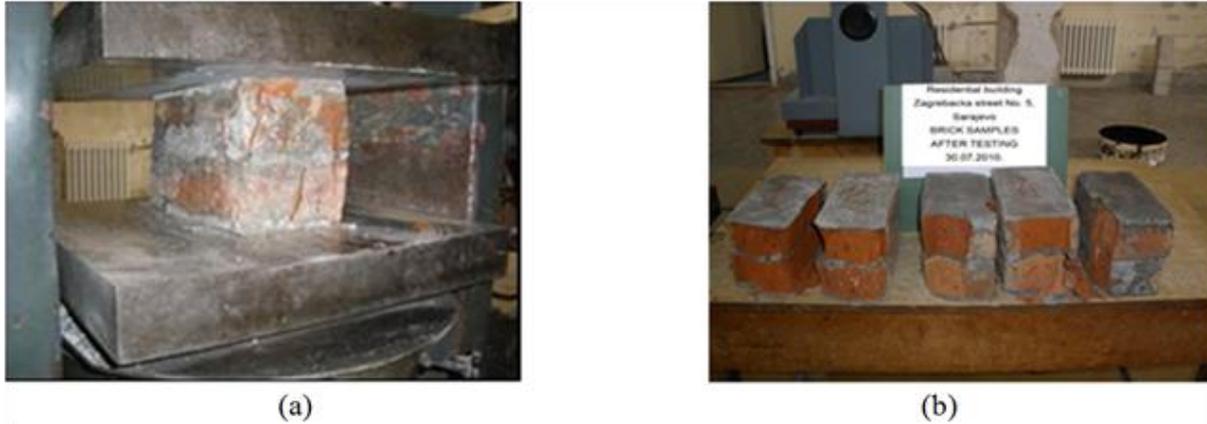
Figure 5. (a) Samples during testing (b) Samples after testing

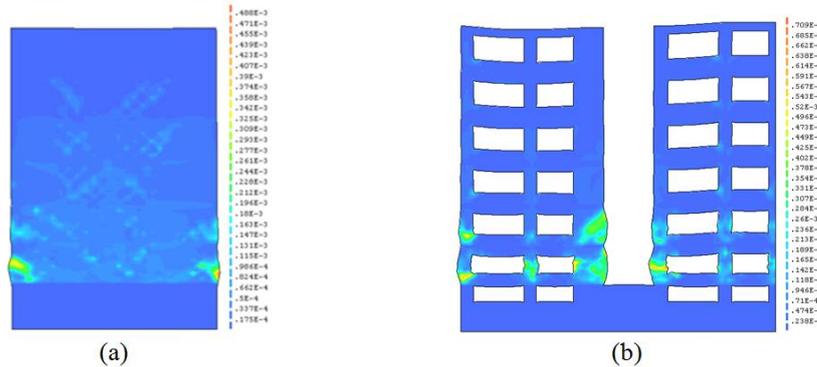
On the basis of the results obtained from the THA it can be seen that the structure has a typical shear behavior. The walls parallel to the load experience diagonal cracks caused by shear, and due to the cyclic loading, an evident diagonal "X" type cracks are formed, as illustrated in Fig.11(a). At the location of the openings the concentration of the damage is evident due to the concentration of the

stresses as seen in Fig.11(b). As it can be noticed in Fig.11(b) at the end of the earthquake action major damage, besides the structural walls (Y direction), that are governing the behavior of the structure, are seen at the façade walls and mainly at the lower levels.

Figure 11. (a) Damage pattern W-Y6; (b) Damage pattern W-X1

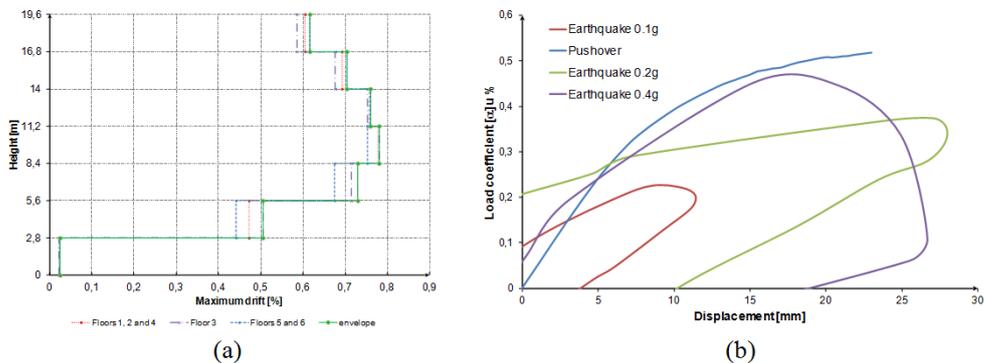
The major concentration of the damage is located between the basement and the ground floor, which can be connected with the discontinuity and large difference in the stiffness. Large damage is observed in the lower floors where the largest inter-story drift was observed, as shown in Fig.12(a), imposing severe deformation and ductility demand at these walls.

Fig.12(b) shows a part of the hysteresis curves for these three different cases of ground acceleration (0.43g, 0.2g and 0.1g) as well as the capacity curve obtained from the Pushover Analysis for Y direction. As it can be seen the structure has a relatively small displacement during the earthquake with the PGA of 0.1g. It is evident that significant damage and energy dissipation occurred during the ground movement corresponding to the acceleration of 0.2g, while the structure collapsed during the real Petrovac earthquake record. It should be pointed out that during the earthquake action of 0.2g values of the inter-story drift are unacceptable, so the structure is not safe (Ademović, 2012).

For 0.1g earthquake acceleration the maximum displacement in the value of 11.38mm as seen in Fig.12(a) and Fig.12(b) is observed at the last floor. The biggest rise in the inter-storey drift is observed at the ground level, at the height of 2.8m, being equivalent to 0.51%, as shown in Fig.12(a). The cause of damage in walls is a high value of the drift. The rise in the drift values is a sign of deep changes in stiffness. The envelope shows the largest storey drift is 0.78% located at the second floor (8.4m), which is consistent to the damage patten shown before. Smaller damage is observed at the upper floors where the inter-storey drift is smaller, so a good correspondence is observed.

Figure 12. (a) Inter-story drift for 0.1g; (b) Part of the hysteresis curves and pushover

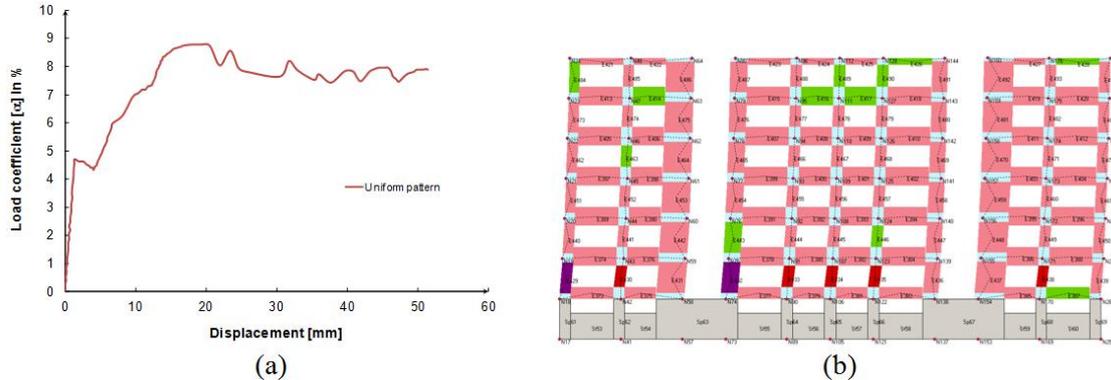
As the structure has a rather inferior resistance in X direction, the first crack appeared already at 4.5% of the force, whereas the maximum coefficient $\alpha = \frac{\sum F_{\text{horizontal}}}{\sum F_{\text{vertical}}}$ reached only 9%, as shown in Fig.14(a) (Ademović and Oliviera, 2012). Failure of the façade walls is due to bending and compression failure at the ground level, as illustrated in Fig.14(b) and explained in Fig.15.

Figure 14. (a) Capacity curve for "± X" direction; (b) Failure pattern

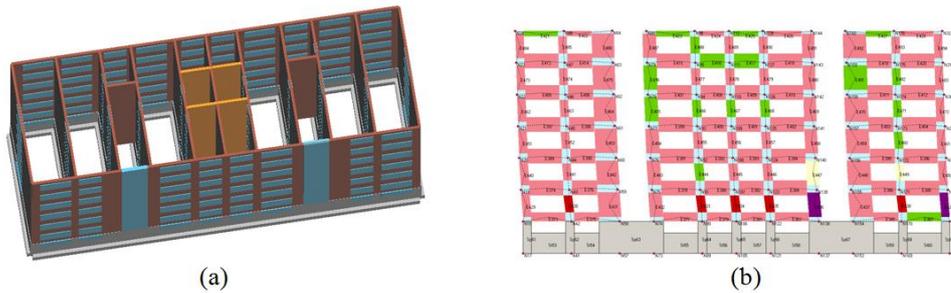
Figure 16. (a) New structural walls; (b) Local crushing

It has been decided to build four additional walls in X direction, the location of these walls has been chosen such that a uniform distribution is obtained in plane and in height, in order to avoid unwanted torsion effects. The four new structural walls are built at the location of separation walls, as shown in Fig.16(a), as this would be the most convenient location for their construction. However, the problem of local failure at the ground floor along the façade walls still remained, as seen in Fig.16(b).

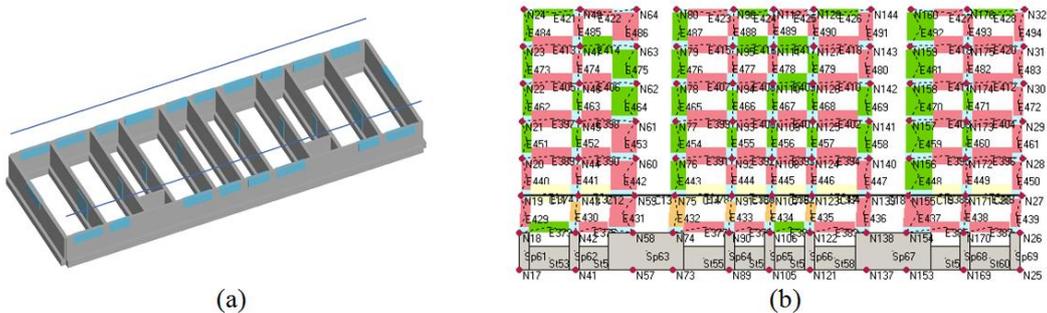
Figure 17. (a) Location of ties; (b) Partial reduction of local crushing

In order to overcome these problem ties were built at the level of the ground floor. Ties, mainly consisting of a stainless steel bolt SS 316 50mm in diameter as already implemented in the restoration works by Deshpande and Savant (2001) and as stated by Tomažević (1999) that the diameter of the bars should not be less than 20mm, in order to improve the energy dissipation capacity, were included at the level of the ground floor, as illustrated in Fig.17(a). Ties together with the inclusion of the new walls have a direct implication on the type and degree of damage on the ground floor as can be seen on Fig.17(b). The failure mode moved from compression failure to shear failure and a larger amount of the elements remained undamaged. However, the problem still remained. In order to overcome this it was proposed to include FRP mesh at the ground floor level as illustrated in Fig.18(a).

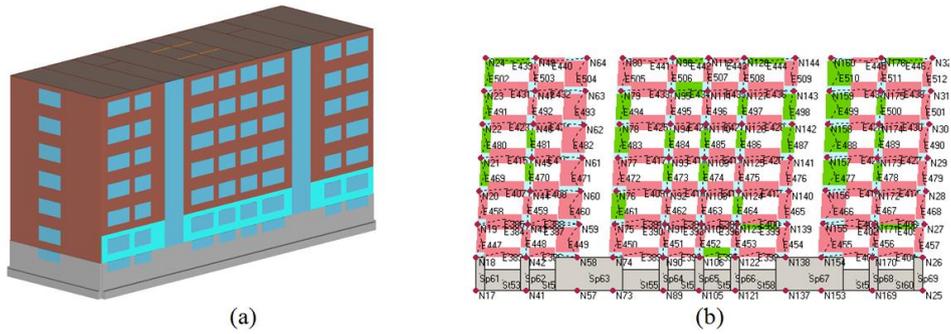
Figure 18. (a) FRP mesh at the ground floor; (b) Elimination of local crushing

Strengthening the structure with the FRP locally on the ground floor level solved the problem of shear failure and local crushing at the ground floor, and now only bending damage is observed as seen in Fig.18(b).
