SEISMIC SAFETY EVALUATION AND STRENGTHENING OF SCHOOL BUILDINGS AFTER 2011 VAN EARTHQUAKES

ABSTRACT

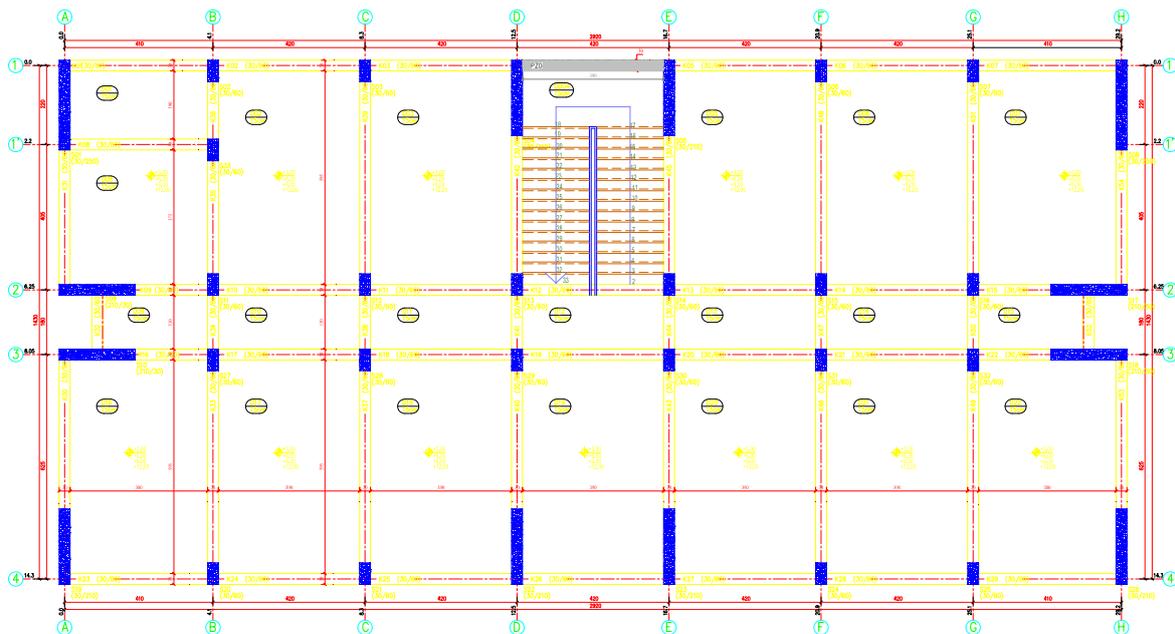
Figure 6. Strengthening of Merkez Cumhuriyet primary school in Van by adding shear wall

School buildings which do not satisfy one of the performance levels are strengthened usually by adding shear walls in two orthogonal directions. Jacketing of columns can be necessary, when the inadequacy in cross sectional area of the columns is determined. However, it is not preferred, because the jacketing of columns increases duration and cost of construction. On the other hand their detailing is difficult to do. A large portion of the seismic load is resisted by the existing and added shear walls. Architectural considerations were affective for position of shear walls and number, length and thickness of shear walls are selected by considering level of deficiency of the structural system. However, the selection of the shear walls is checked by analyzing the structural system. When the two performance levels are satisfied, then the strengthening configuration found to be an acceptable solution. However, in order to find the most suitable solution, the following checks are carried out additionally. It is expected that in a suitable solution the existing structural system should resist a reasonable portion of the lateral loads. When it is not the case, it means that the strengthening shear walls are more than necessary, their number, length and thickness could be decreased. On the other hand, it is expected that the existing structural system should not be overstressed, i.e., a good portion of the lateral loads should be carried by the added shear walls. When it is not the case, it means that the strengthening walls are less than necessary, their number, length and thickness could be increased. In order to be on the safe side, the added shear wall is shown in a sketch and forwarded to Van, to check once more, whether they have suitable position and location in terms of architectural aspect. At the last step, the approval of the school principal is received. When all these checks are done, then the design is finalized and corresponding detailed drawings are completed (Figure 6, 7 and 8).

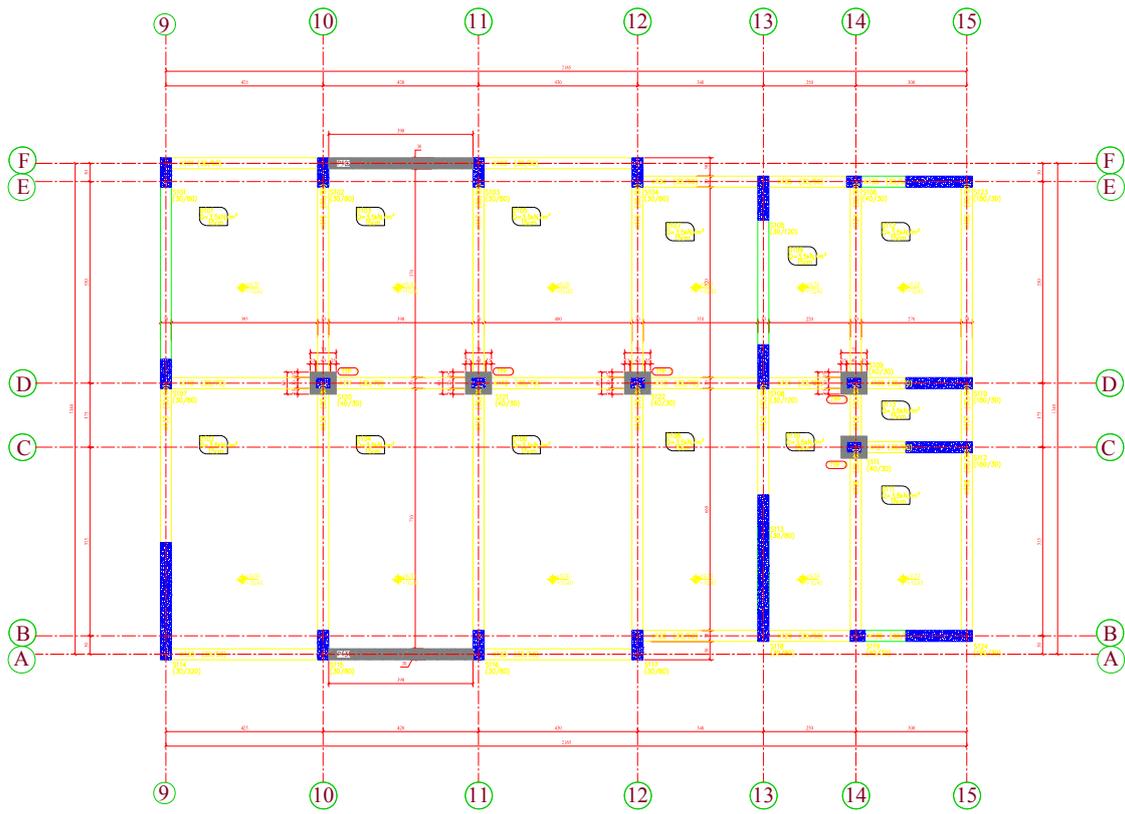
Figure 7. Strengthening of Kazim Karabekir gymnasium hostel B block in Van by adding shear walls and jacking of columns

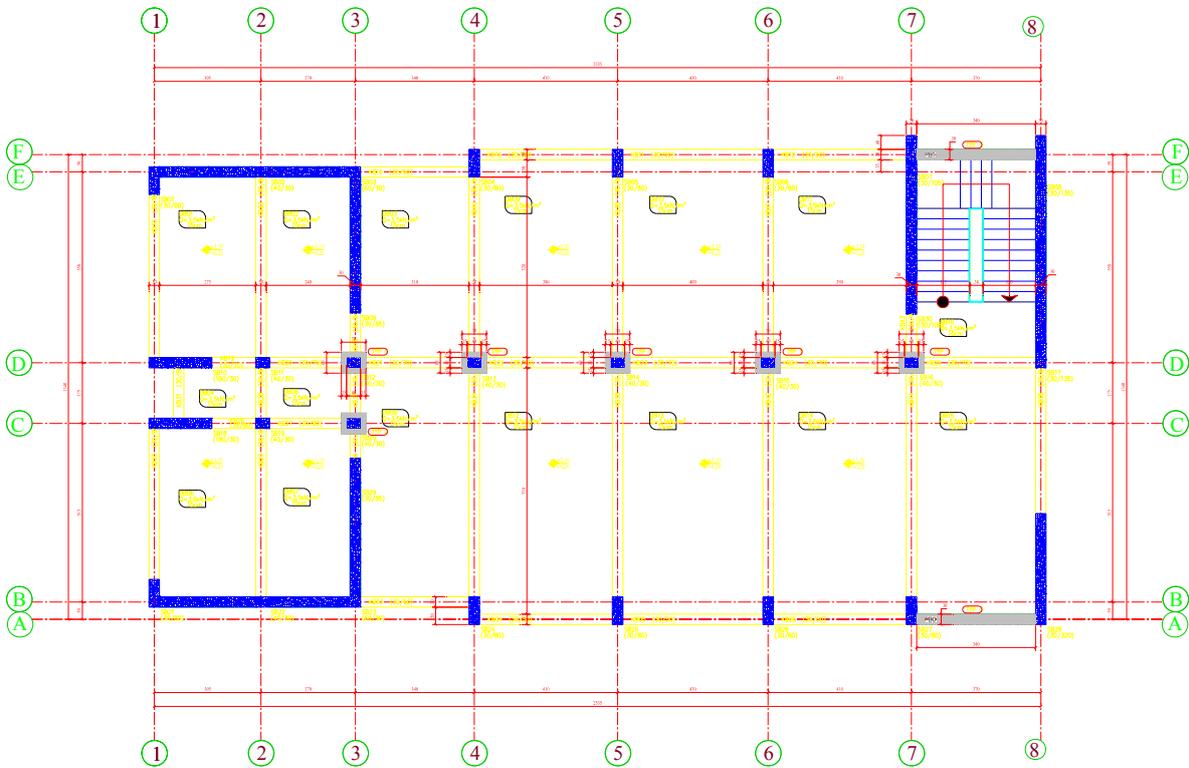
Figure 8. Strengthening of Kazim Karabekir gymnasium hostel A block in Van by adding shear walls and jacking of columns

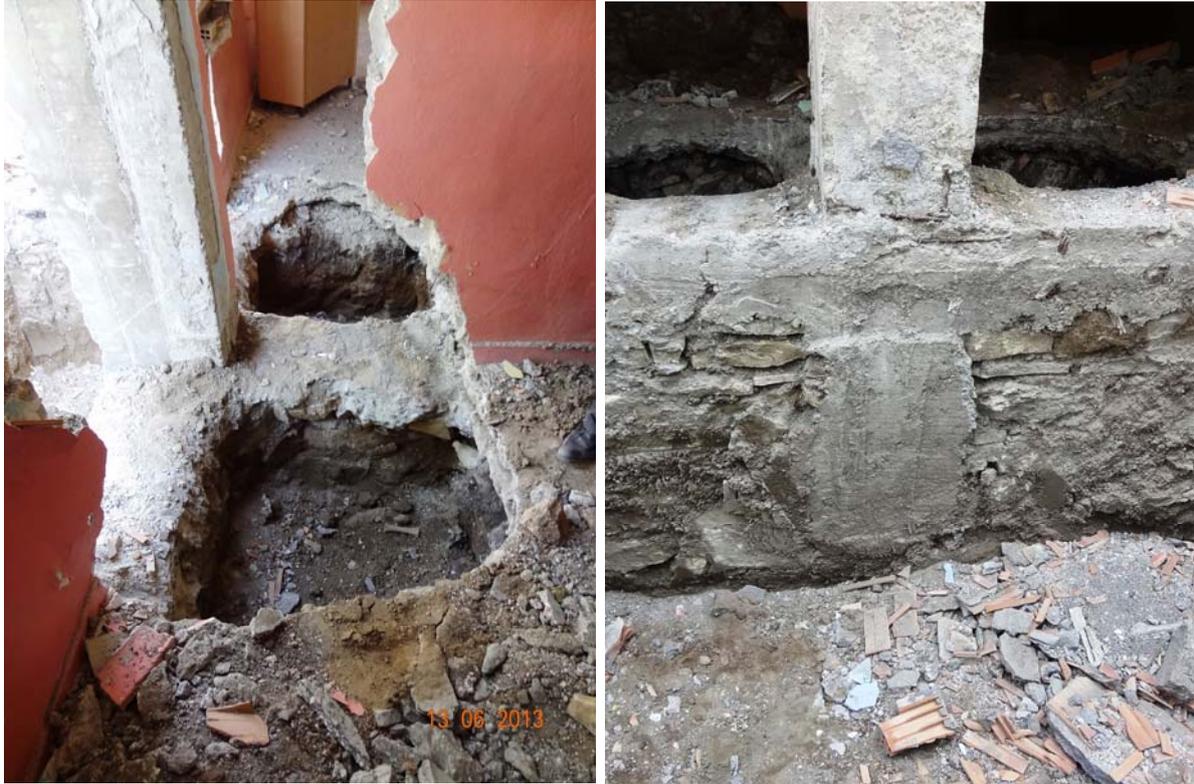
- b. Since very limited investigation is carried out due to the difficulties on foundations of buildings, various differences are detected, when foundations are excavated. Consequently, a lot of modification is necessary in the foundation strengthening. Not very seldom, it is found that geometry of foundations were not compatible with the drawings developed at design stage. (Figure 9, 10, 11 and 12).

Figure 9. Foundation found in application of the strengthening intervention

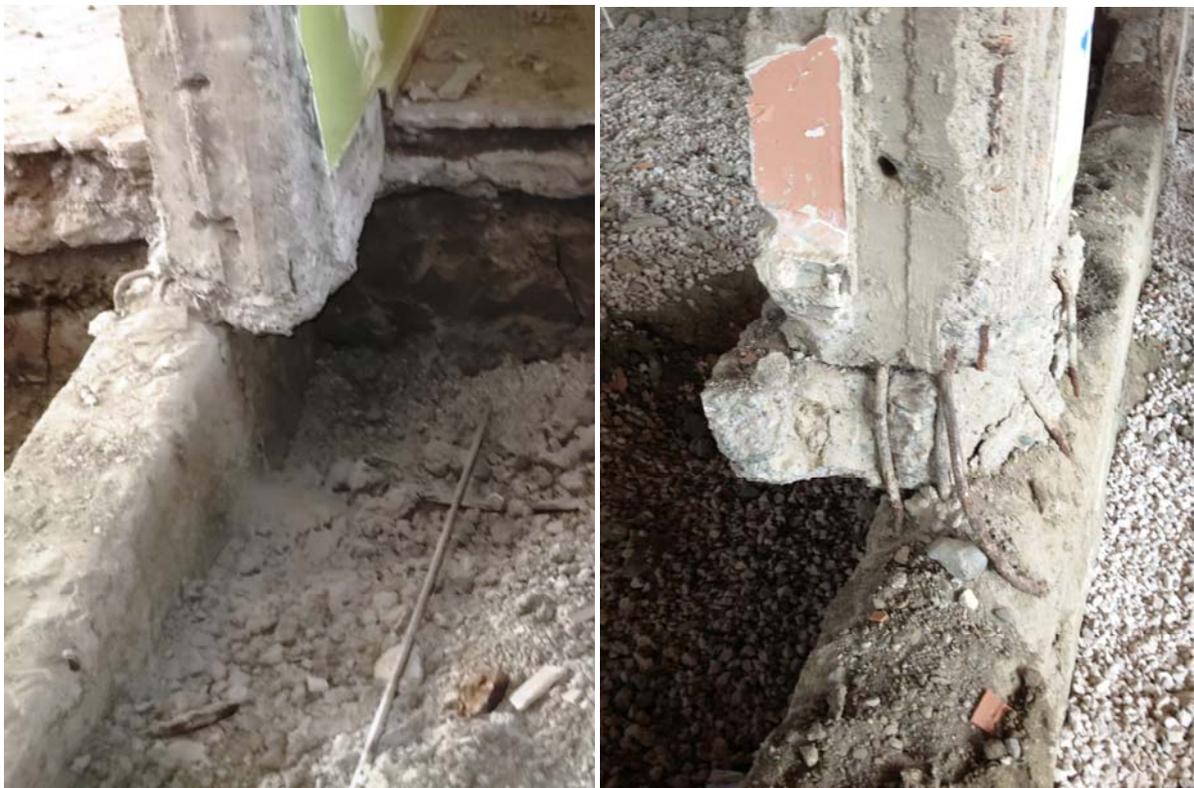
Figure 10. Foundation found in application of the strengthening intervention

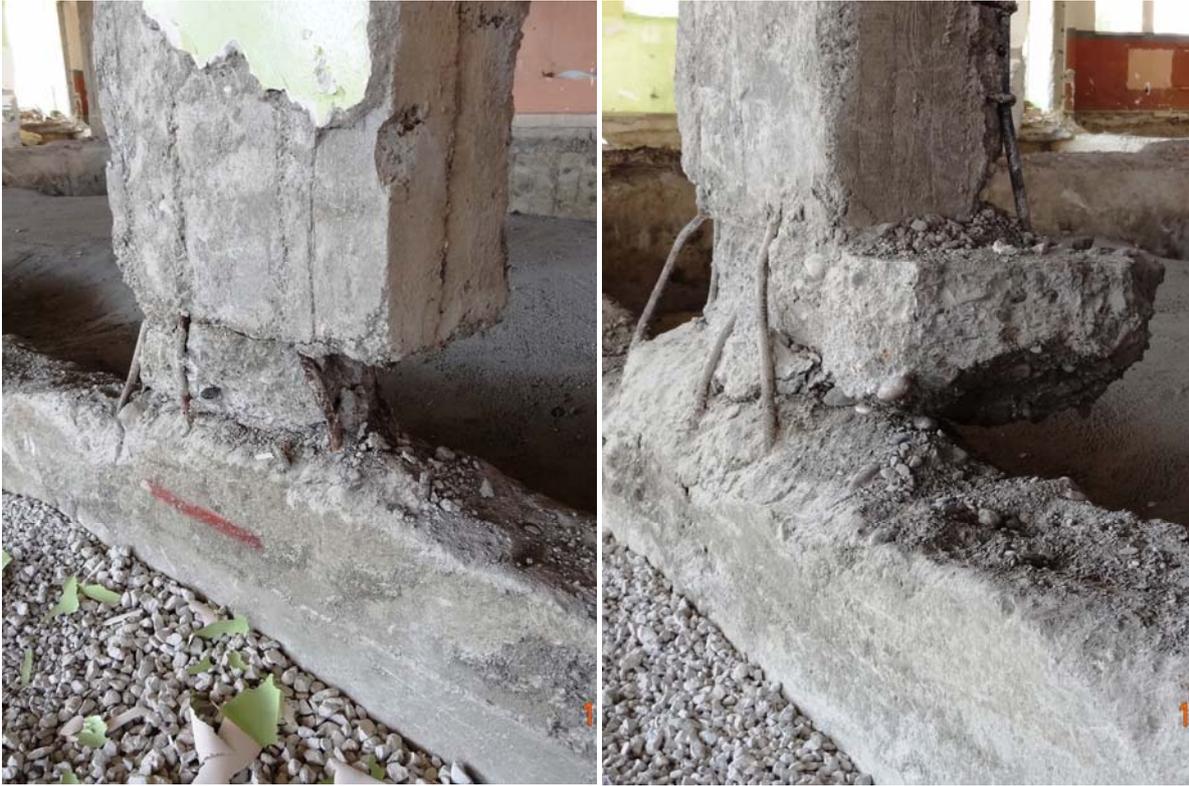
Figure 11. Foundation found in application of the strengthening intervention

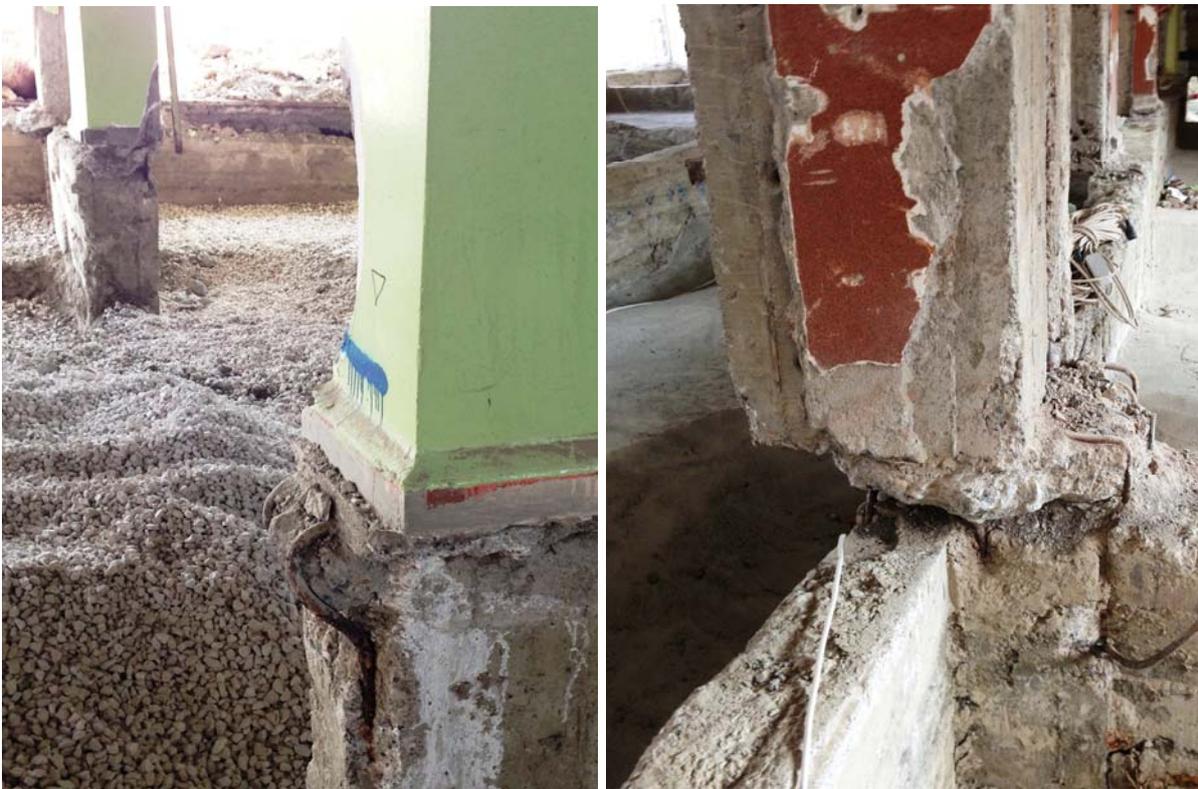
Figure 12. Foundation found in application of the strengthening intervention
