## EXPERIMENTAL STUDY ON A SHAKING TABLE TEST OF A CONFINED MASONRY STRUCTURE

Tatsuo NARAFU<sup>1</sup>, Hiroshi IMAI<sup>2</sup>, Chikahiro MINOWA<sup>3</sup> and Toshikazu HANAZATO<sup>4</sup>

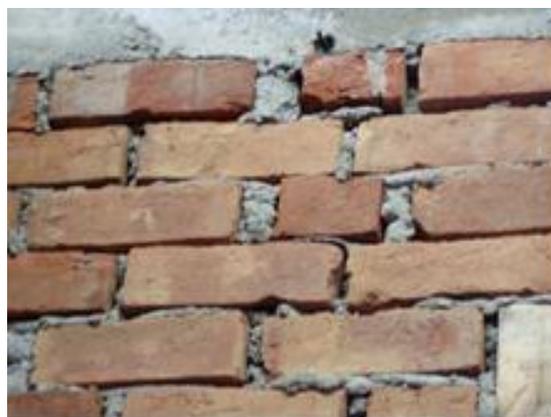
Figure 3 Finishing of brick laying

Joint mortar is not completely filled, some are lacking and others are forcing out. Thickness of joint mortar is not even.

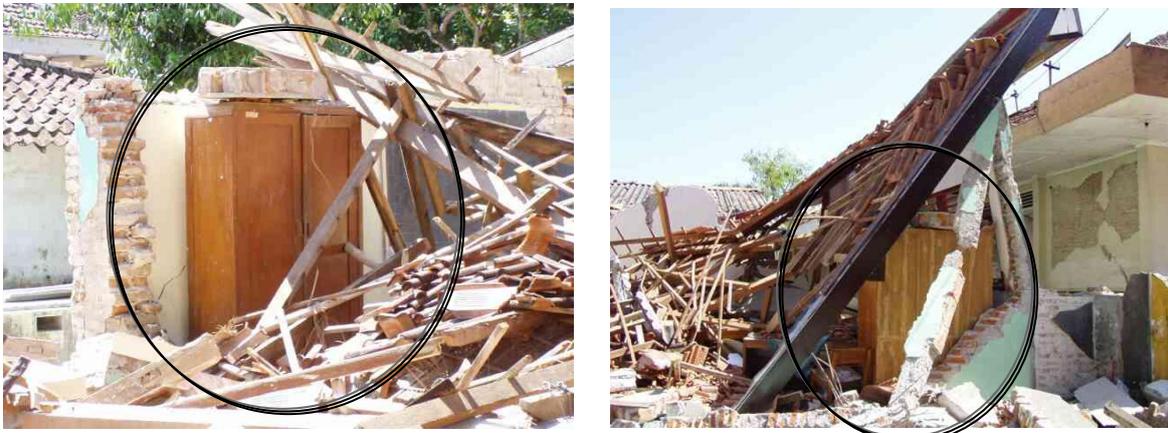
Figure 5 Furniture withstood in totally collapsed school buildings in Bantul, Yogyakarta Special Province, Indonesia, which experienced the strongest shaking motion by the Central Java Earthquake 2006

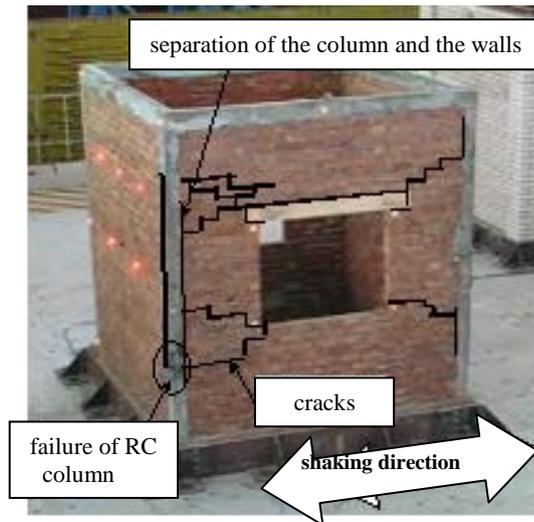
Figure 7 shows damages caused by Input No.3. Cracks occurred in the front wall in diagonal direction from corners of the opening and separation between the walls (front and left side) and adjacent RC column occurred as well. A failure was observed in the RC column. Cause of the failure is analysed to be a defect at a joint between concrete placing (Figure 8).

Figure 7 Damaged caused by Input No.3

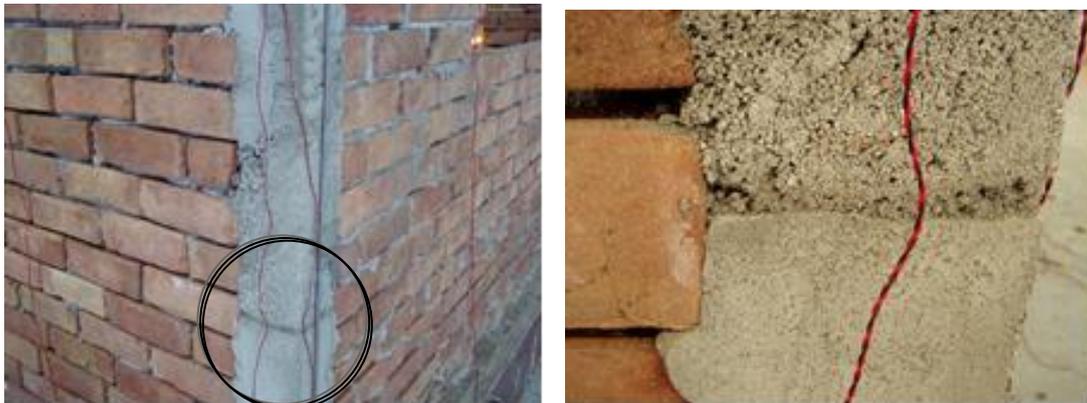
Figure 8 The column between the front and left side wall (left) and detail of joint of concrete placing (right)

The specimen withstood MMI 8 shaking motion two times without cracks, and MMI 9 two times with cracks. As is shown in Figure 5 and 6, many buildings in developing countries suffer heavily damage from shaking motion MMI 7 or smaller. The main cause of the difference seems to be quality of construction works such as brick laying works, concrete placing works. The defect of concrete placing in Figure 8, which caused total collapse of the structure, is a typical case.

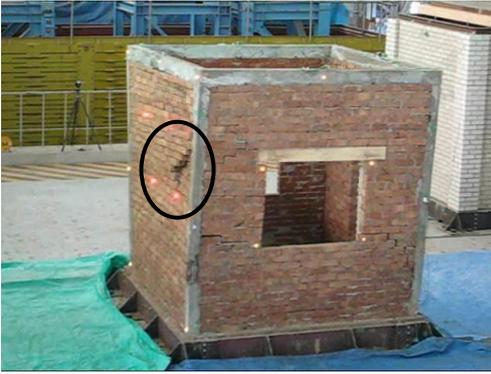
9-1 First collapse of walls occurred in the left side wall

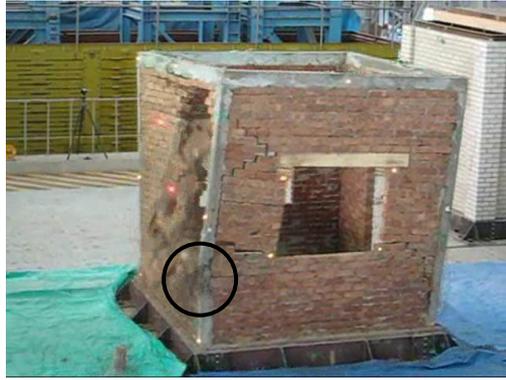
9-2 The adjacent RC column started to collapse

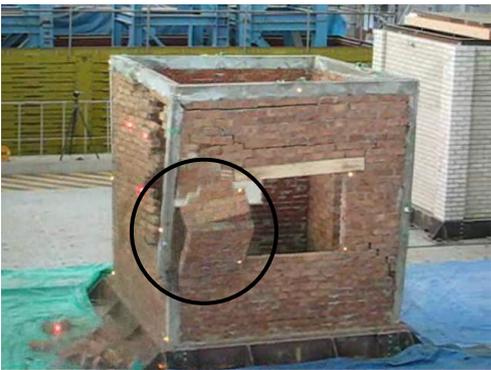
9-3 Collapse of the front wall started

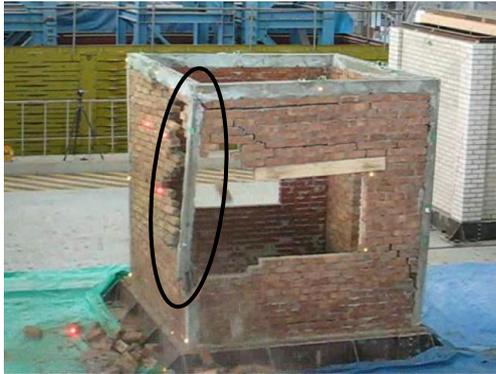
9-4 The upper part of adjacent RC column fell down largely

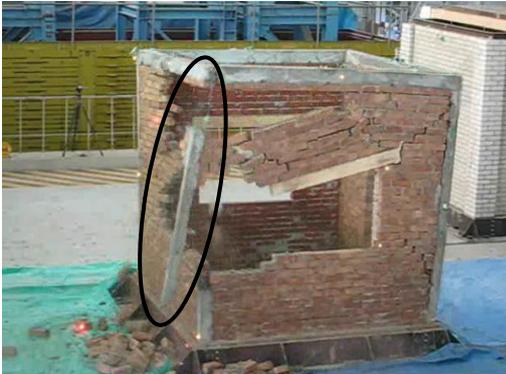
9-5 Falling down of upper part of an RC column

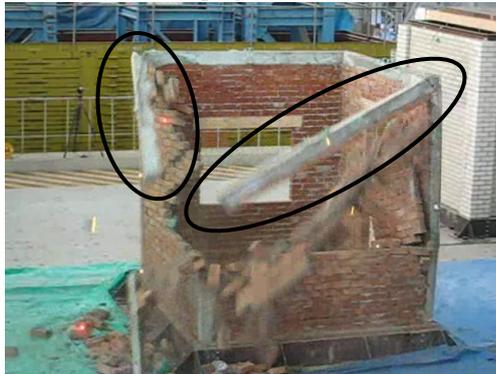
9-6 Collapse of two walls with beams above

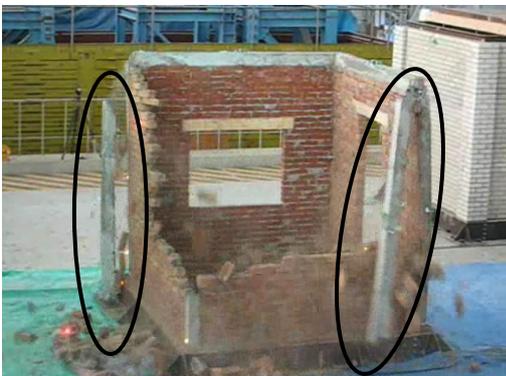
9-7 Falling down of two beams

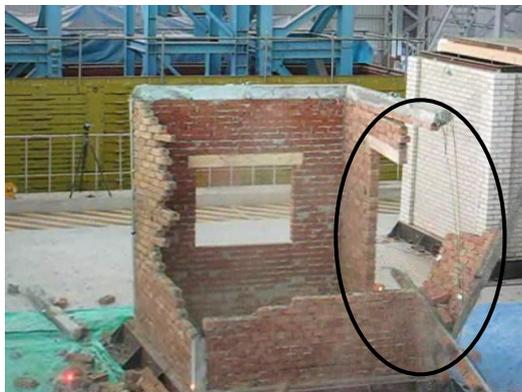
9-8 Falling down of right side wall

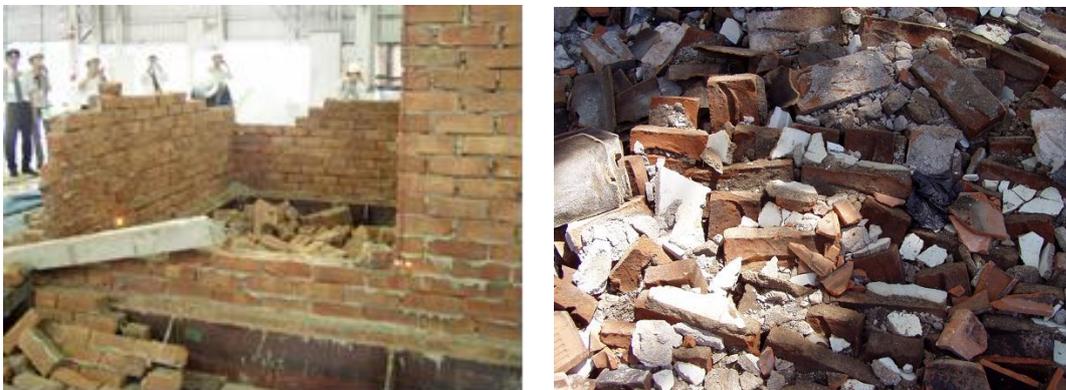
The left picture of Figure 10 shows debris of the specimen. Several bricks were still connected together by joint mortar. On the contrary debris of actual buildings damaged by earthquakes was usually separated into pieces like in the right picture of Figure 10. It is usually observed people start collecting reusable building materials like bricks, roof tiles from the debris in developing countries shown in Figure 11. Bricks could be reusable because joint mortar could be removed easily without breaking bricks. It implies bonding strength of mortar is not so strong. It is assumed weak bonding of mortar is one of the reasons of vulnerability of masonry walls in developing countries.

Figure 10 Debris of the specimen for the shaking table experiments (left) and debris of housing destroyed by Central Java Earthquake 2006 in Bantul, Yogyakarta Special Province, Indonesia (right)
