THE CEPHALONIA(GREECE) EARTHQUAKES OF JANUARY 26 & FEBRUARY 3, 2014: EFFECTS ON SOIL AND BUILT ENVIRONMENT

Nikos THEODOULIDIS¹, Christos KARAKOSTAS¹, Vassilios LEKIDIS¹, Kostantia MAKRA¹, Basil MARGARIS¹, Kostantinos MORFIDIS¹, Christos PAPAIOANNOU¹, Manos ROVITHIS¹, Thomas SALONIKIOS¹, Alexandros SAVVAIDIS¹

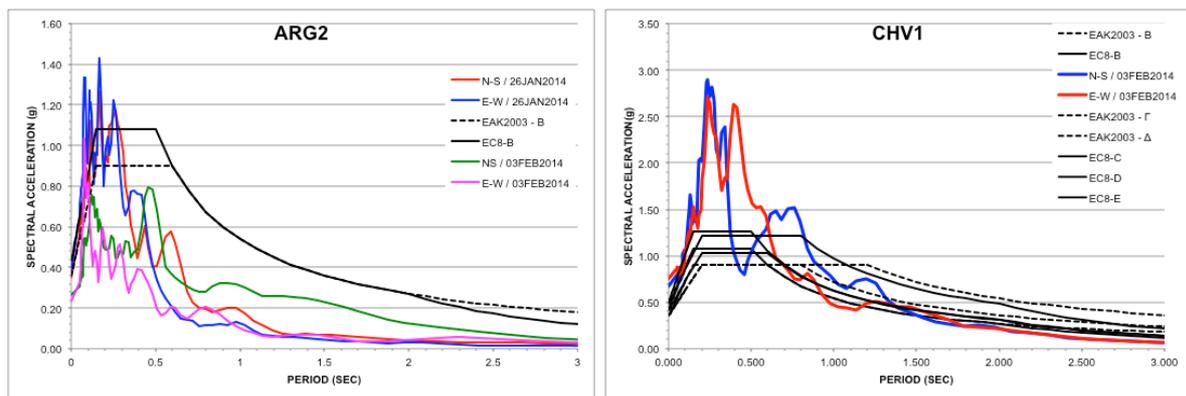
In Fig. 2, response spectra corresponding to horizontal components of the first and second earthquake recorded at ARG2 and of the second shock at CHV1 accelerographic stations are compared with the design elastic spectra corresponding to the greek seismic code-EAK2003 and EC8. In Argostoli (ARG2) spectral values of the first event are higher for short periods ($T<0.4$ sec), while the NS component of the second event exhibits higher spectral values for intermediate and long periods ($T>0.7$ sec). Response spectra observed at ARG2 station are quite well covered by the elastic design spectra, for soil category B, foreseen by both EAK2000 and EC8. On the other hand, for the CHV1 site the observed spectral values seem to be far beyond any code prediction regarding short to intermediate periods ($0.1\text{sec}<T<0.8\text{sec}$), for any soil category. Strong ground motion modeling could explain any possible origin of this frequency content, whether it is source or/and site effect factor.

Figure 2. Horizontal component response spectra ($D=0.05$) obtained from the recordings of the 26/1 and 3/2/2014 earthquakes at Argostoli (ARG2) and of the 3/2/2014 earthquake at Chavriata (CHV1) with respect to the elastic design spectra of greek seismic code (EAK2003) and Eurocode 8 (EC8).
