URBAN HERITAGE VALUE AND SEISMIC VULNERABILITY MAPPING: CHALLENGES FOR ENGINEERING AND ARCHITECTURAL ASSESSMENTS. CASE STUDY OF A PROTECTED AREA IN BUCHAREST, ROMANIA

Emil-Sever GEORGESCU¹, Cristina Olga GOCIMAN²,
Iolanda Gabriela CRAIFALEANU³, Tiberiu FLORESCU⁴, Cristian MOSCU⁵,
Mihaela Stela GEORGESCU⁶, Claudiu-Sorin DRAGOMIR⁷

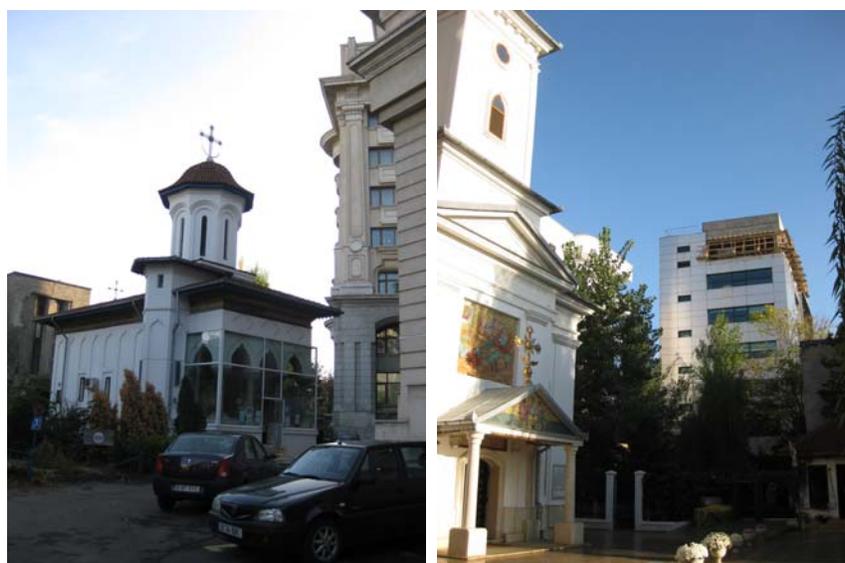
Figure 2. Left: Schitul Maicilor Church, major heritage, that was moved in the 1980's from the demolished precinct to let space for Parliament, and left hidden between new high-rise blocks and old houses. Right: St. Ilie Rahova Church, major heritage, that was translated from the present Blvd. Unirii path and left surrounded and aggressed by neighboring blocks (Photo E. S. Georgescu)

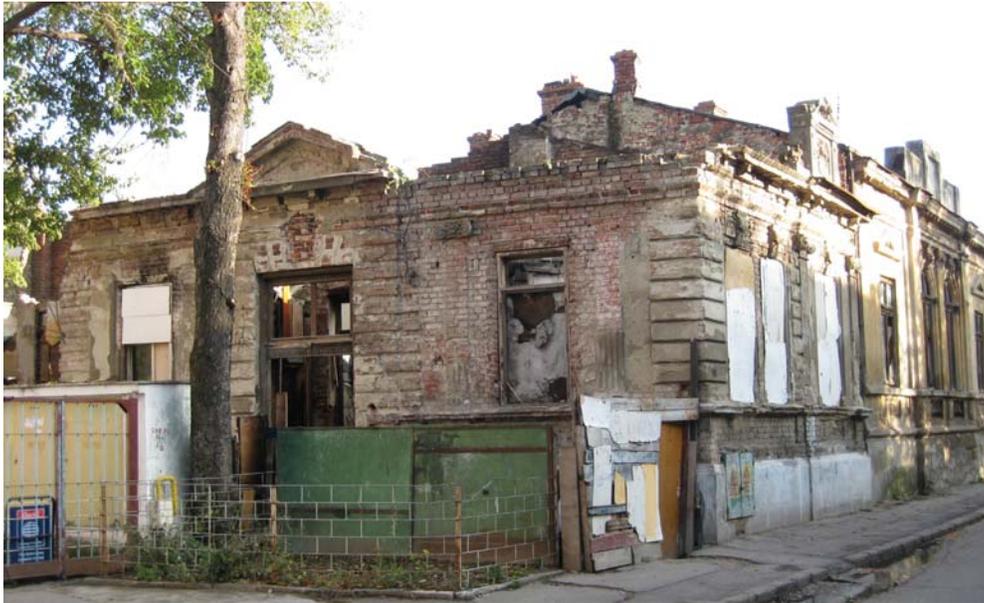
Figure 4. Masonry houses that resisted earthquakes but are now threatened by lack of maintenance, as the ownership situation and financial ability are at stake on Str. Justiției (Photo E. S. Georgescu)

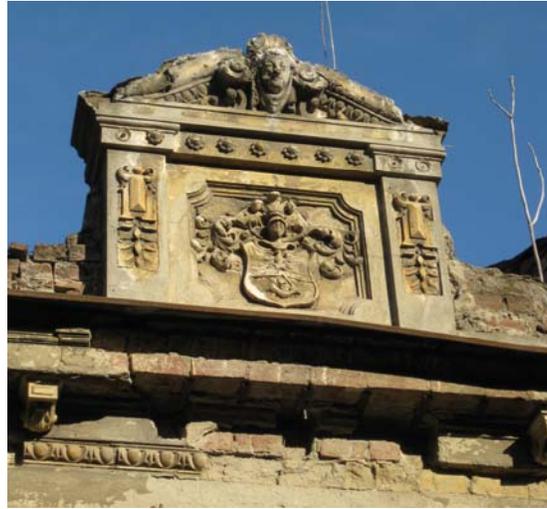
Figure 5. Detail of the XIX-th century endangered architecture of the Figure 4 building (Photo E. S. Georgescu)

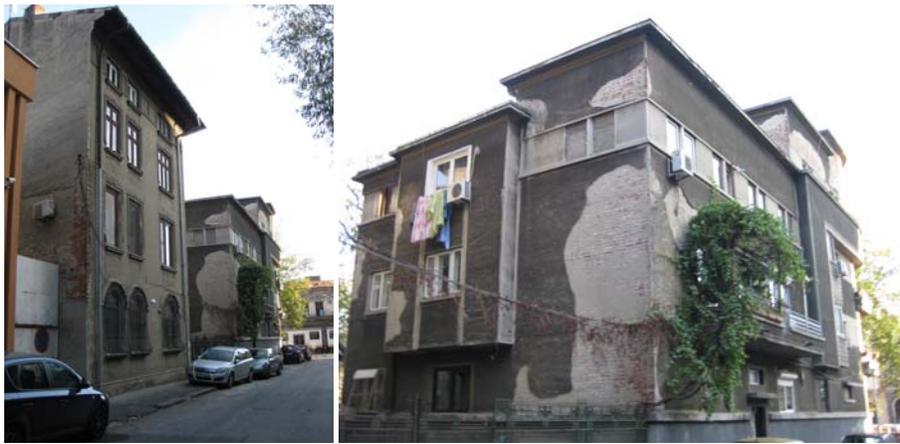
Figure 6. Reinforced concrete and masonry mid-rise residential buildings of the 1930's proving lack of maintenance (Photo E. S. Georgescu)

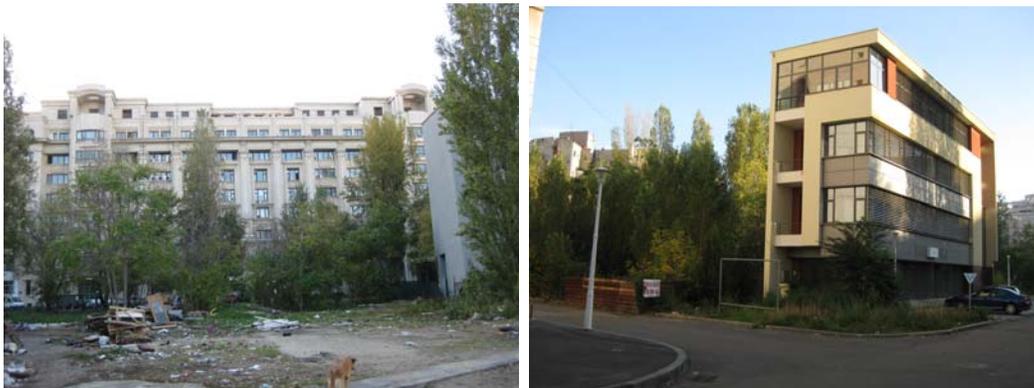
Figure 7. Example of a fully destructured area behind the 1980's high-rise buildings used for ministries and government agencies, with some new buildings and land for sale (Photo E. S. Georgescu)

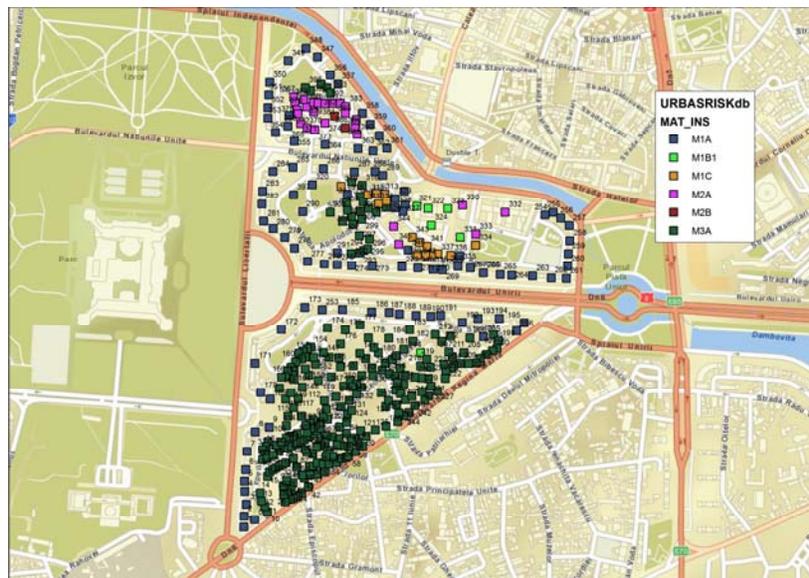
Figure. 10. Mapping of material / structural identifiers for structural vulnerability, with color codes in the study area, in front of Parliament Palace (left of figure). ESRI, World Street Map (2014).
