**EVALUATION OF THE SEISMIC PERFORMANCE OF AN EXISTING  
REINFORCED-CONCRETE BUILDING DAMAGED BY THE 2007  
NIIGATA CHUETSU-OKI EARTHQUAKE  
- DAMAGE RATING OF THE BUILDING CONSIDERING THE  
FAILURE MECHANISM OF COLUMNS -**

Yukiko NAKAMURA<sup>1</sup>, Daisuke KATO<sup>2</sup> and Kamolchanok BUNSIRISHAI<sup>3</sup>

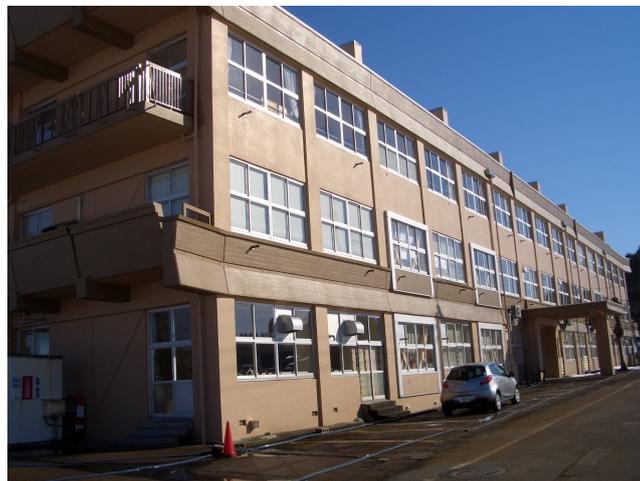
Figure 3 Wide view of S-building

S-building is a three-story reinforced-concrete framed structure with piles containing classrooms. The building is shown in Figure 3. The building consists of 16 bay frames in the longitudinal direction and two bay frames in the transverse direction. The typical bay length in the longitudinal direction is 4.1 m. The bay lengths in the transverse direction are 7 and 2.8 m. Figure 4 shows the floor plan with the damage class of each vertical member. The damage classes are defined by Post-earthquake Damage Evaluation and Rehabilitation (JBDPA, 2001); there are five damage classes, I (visible narrow cracks on a concrete surface) through V (buckling of reinforcing bars, cracks in core concrete, visible vertical and/or lateral deformation of columns and/or walls, and visible settlement and/or leaning of the building). In the figure, “B” denotes a ductile member in flexure failure and “S” a brittle member in shear failure. The residual seismic capacity ratio index  $R$  calculated from the observed damage class in a simplified procedure was 63.1 percent on the first floor, 71.96 percent on the second floor and 95.7 percent on the third floor. Therefore, the damage levels of the Guideline for Post-earthquake Damage Evaluation and Rehabilitation are moderate damage on the first and second floors and light damage on the third floor.
