SECOND EUROPEAN CONFERENCE ON EARTHQUAKE ENGINEERING  
AND SEISMOLOGY, ISTANBUL AUG. 25-29, 2014

## Seismic response of historical monuments and structures: The state of the Cathedral of SS. Massimo e Giorgio (L'Aquila, Italy) after the earthquake of April 6th, 2009

Marta Brancaleoni<sup>1</sup>

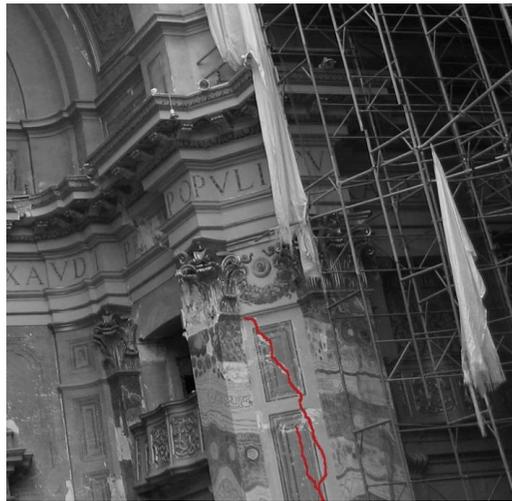
The pillars of the main nave, that support the false ceiling made with *camera canna*, present cracks with vertical development visible along the height of the pillar, as well as at the base with spalling and/or fall of the elements of the plasters, especially the parts that compose the corner. All elements indicate that the damage is to be associated with excessive vertical load. The described damage occurs in a diffuse way, but in a very different extent in distinct areas. The three pillars remaining in the area of the presbytery are extremely damaged, in particular towards the apse, while the same signals are present to a much lesser extent, although well detectable, in the pillars of the nave, with further regression less evident, but noticeable as one moves away from the presbytery.

Figure 7 – Vertical cracks on the transept pillar.

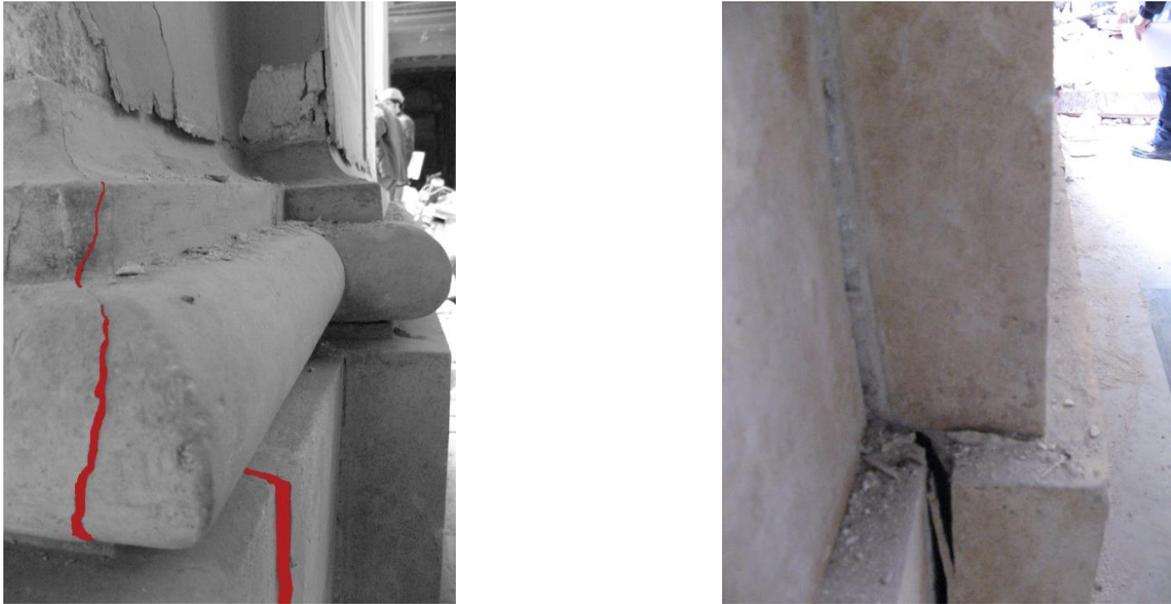
The evidence is that the pillars suffered from increase of vertical, in addition to horizontal, seismic action<sup>5</sup>. This increase is particularly relevant for the pillars of the transept that bear the pendentive of the fake dome. The masonry of these pillars does not have an ordinary setting and the mortar presents poor grading of the aggregate and an inadequate tooling. The mortar usually used for masonry joints can be classified on the basis of the binding materials: lime mortar, gypsum mortar and cement mortar. Lime mortar can be found in the original brickwork and at large in all the work done before the XIX century. Gypsum mortar and cement mortar can be found in the most recent structural strengthening. The quantity of mortar per masonry unit is not enough to guarantee a proper connection between the stones, one of the reasons for the damage occurred to the structure during the seismic events. Similar behaviors can be found in several of the masonry buildings in L'Aquila. It is easy to understand how one of the main load-bearing elements of the fabric reached the ultimate compression strength and collapsed: The collapsing of the pillar caused consequently the collapse both of the roof elements and the wall next to it.

Figure 8, 9 – Vertical cracks on the transept pillar.

The remaining pillars of the transept undergone unloading, when the roof collapsed, and hence remained standing, although showing significant damage.

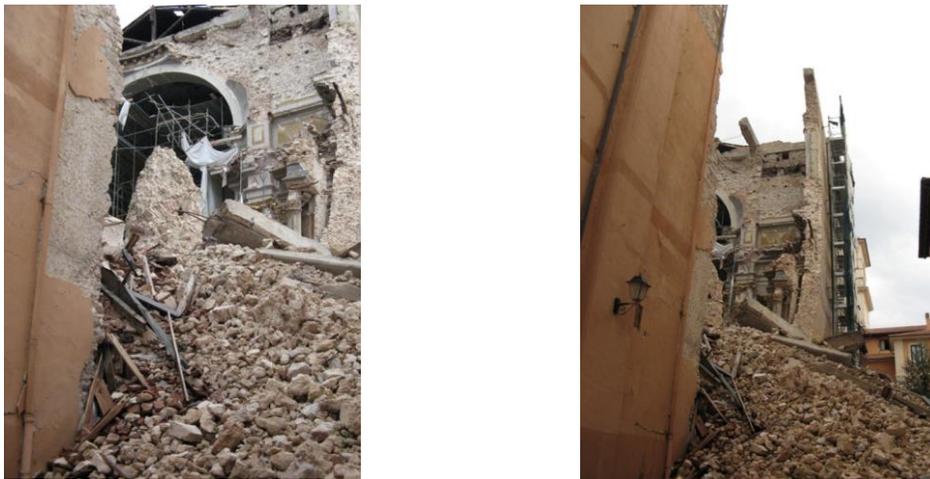
Figure 10, 11 – Collapsed masonry.

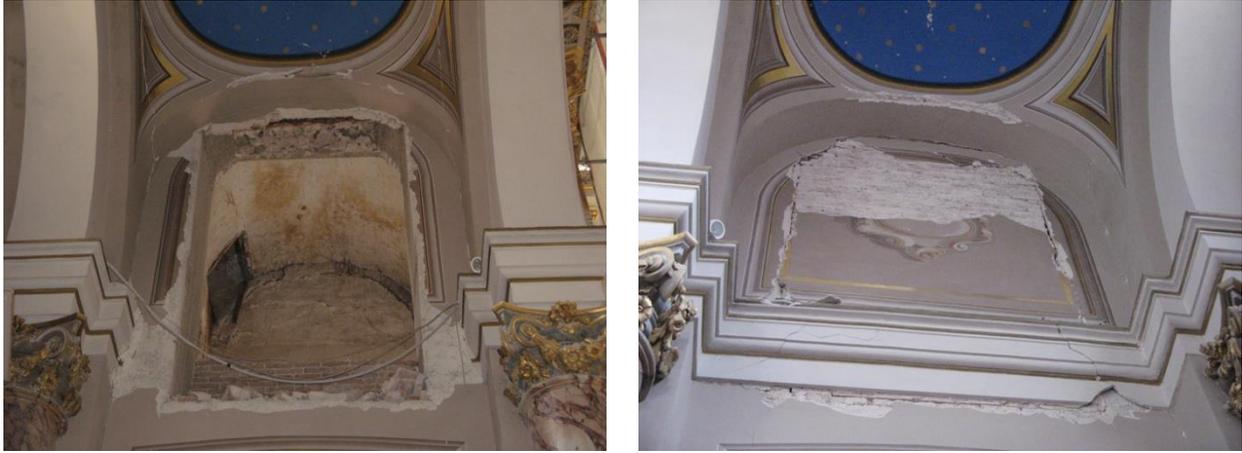
The remaining parts of the church, although not collapsed, show significant damage, distributed in non uniform levels. Even the side chapels present crackings. On the left side of the nave, in correspondence to the altars in the side chapels, it failed the infill wall within openings that over the centuries have been closed. These closures are probably related to the

elevation of the building in late XVI century and the following reconstruction after the earthquake of 1703. The fall of plaster occurred in all spaces.

Figure 12, 13 - Collapsed infill walls in the lateral chapels of the left side nave.

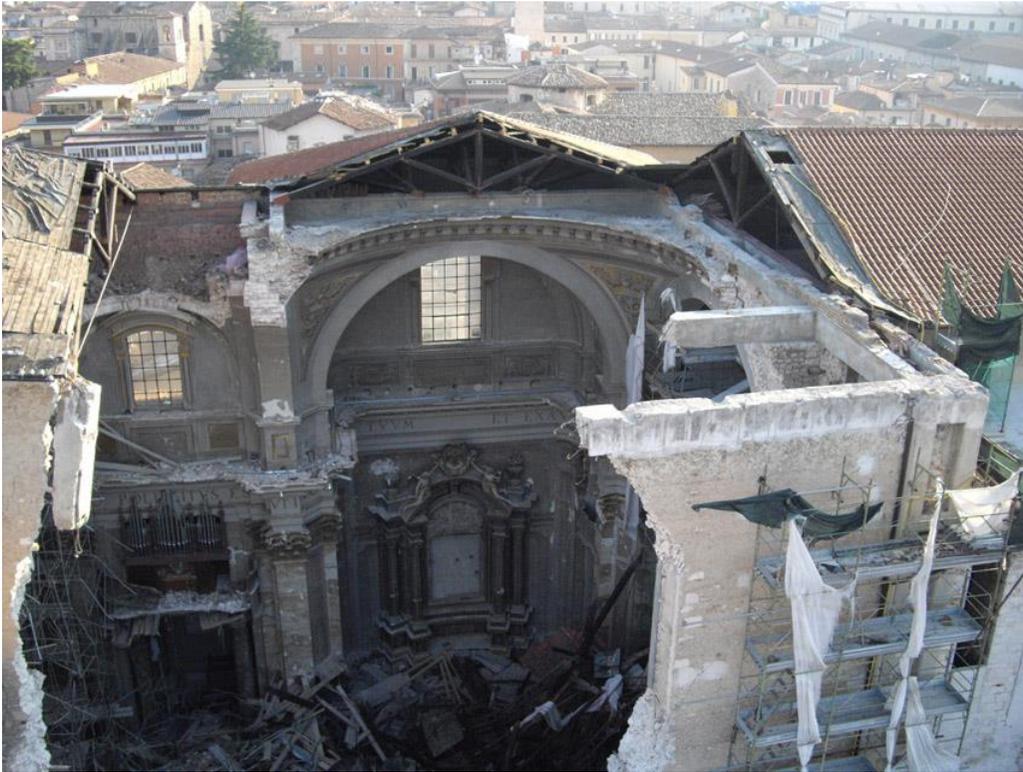
Figure 14 - R.c. string-courses framing the transept opening.

Observed behavior is threefold, regarding respectively the string-courses in the collapsed area, the second the double shaft pillars and last the summit string-courses of the perimeter walls. In the first case the patent ineffectiveness in preventing collapse should be not addressed in a negative manner: as the very term states, a “stringer” is aimed at carrying tensile forces, like an internal “rope”, present in certain areas of the masonry structures texture, e.g. connecting wall tops to each other. Here the collapse is due to the lack of a vertical bearing element, the transept pillar that reached its limit load capacity, on which the contribution of a stringer is nihil. Nor one should think that a role was played by the weight of such r.c. elements: simple quantitative evaluations show how minor is the relevance of this additional load with respect to those induced by the masonry itself and in particular by the massive pendentives surrounding the transept.

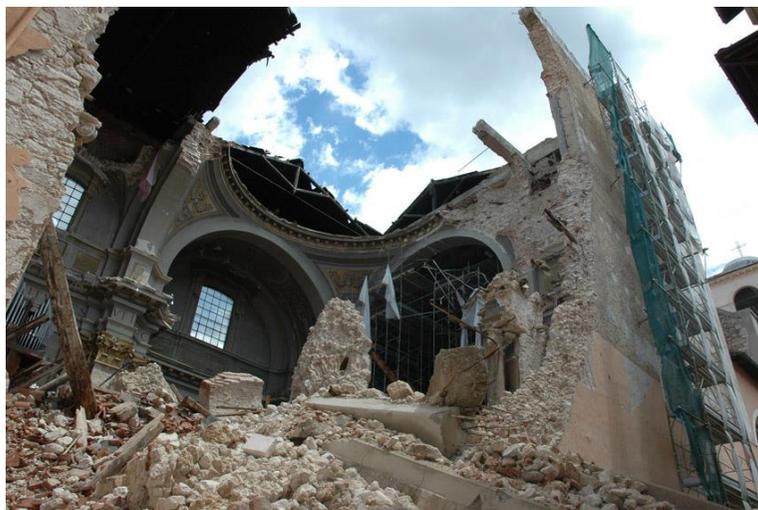
Figure 15 - R.c. string-courses in the area of the collapsed left side wall.

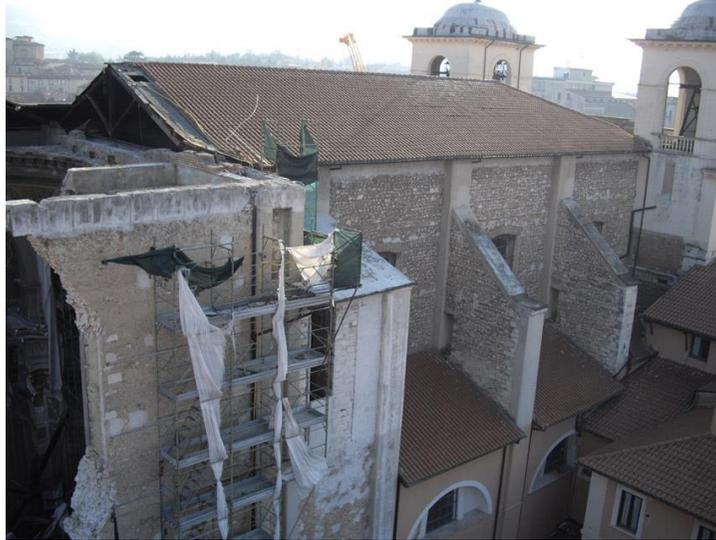
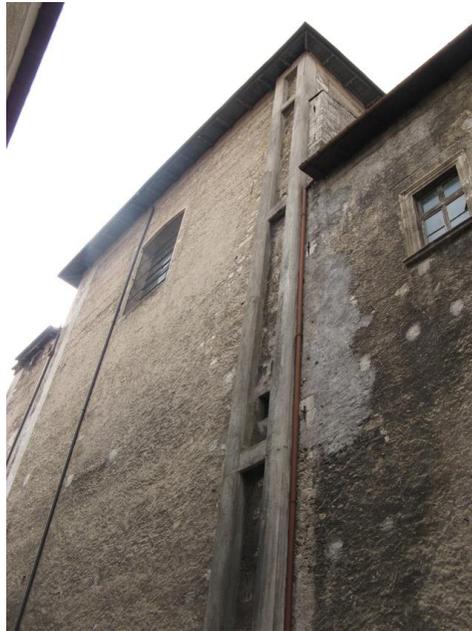
In the case of the double shaft columns the rationale underlying such strengthening is not completely clear. One may think them to be aimed at increasing the vertical bearing capacity of the walls or, more probably, at increasing the out of plane bearing capacity of the same. If no certainty can be stated about the objectives, it is a fact that these works, badly conceived and manufactured, are addressed to an element that revealed not to be the weakest. Again, on the whole a strengthening that revealed to be of minor or no influence in the collapse mechanism, either positively or negatively.

Figure 16 - Double shaft columns, left side wall.

Figure 17 - Double shaft columns, left side wall.

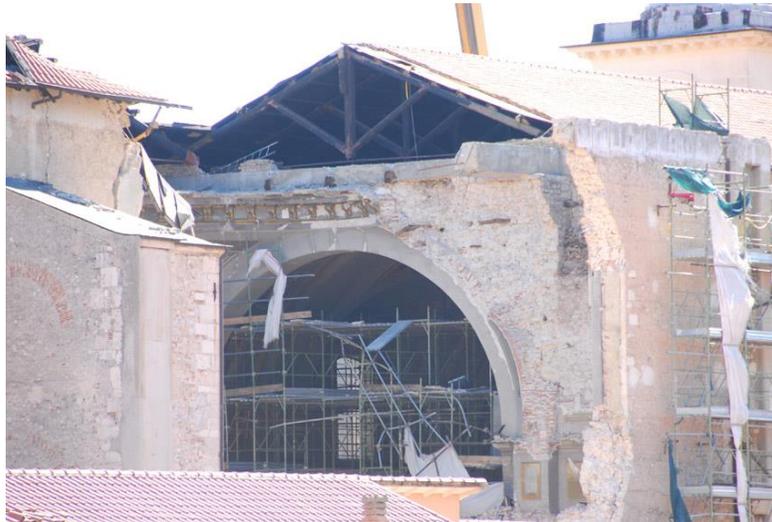
Last, the evaluation of the behavior of the summit string-courses of the perimeter walls. Here one can safely state that they did play a positive role, made clear by the well visible, thin and diffuse cracks they show in the perpendicular direction with respect to the string axis, present throughout the building and more evident in the apse. Unmistakable sign of having undergone significant tensile force that the masonry structure would have been unable to withstand. This allowed the vertical cracks in the walls of the apse to remain limited and to close in the upper levels, closet to the course. It was hence developed an effective tie function that has most probably prevented the complete apse collapse.

Figure 18 - Summit string-courses, transept.
