FRAGILITY CURVE OF THE BRIDGE MEMBER AT NATIONAL ROAD BASED ON THE DAMAGED DATA DUE TO THE 2011 OFF THE PACIFIC COAST OF TOHOKU EARTHQUAKE

Susumu NAKAMURA¹

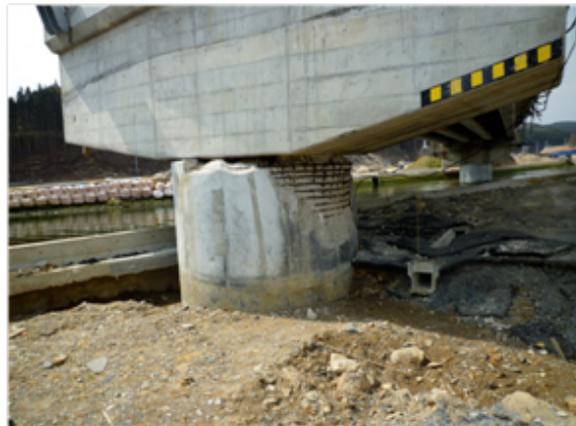
Photograph 1. Example of collapsed pier of Utatsu bridge at route 45 of the national road

The locations of 960 damaged bridges among bridges of the national roads located in Iwate Prefecture, Miyagi Prefecture, and Fukushima Prefecture are shown in Figure 1. Among the damaged bridges, the damaged bridges due to tsunami were 141. The serious damage such as collapse of bridge pier occurred. As an example, collapsed pier of Utatsu bridge at route 45 of the national road was shown in Photograph 1.
