## PERFORMANCE OF MASONRY MONASTERY STRUCTURES IN THE M 6.9 SIKKIM EARTHQUAKE OF 18 SEPTEMBER, 2011: A LESSON

Sutapa JOTI<sup>1</sup> and Keya MITRA<sup>2</sup>

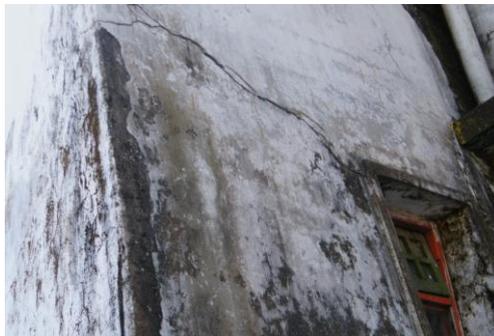
New Rumtek Monastery (Rumtek Dharma Chakra Center) was built in the 1960's. Though the main temple did not suffer severe damages, two six storied buildings in the monastery precinct, the Nalanda Institutes, constructed in 1972, sustained significant damages. These buildings sustained damages primarily at wall corners, and at sill, spandrel and pier masonry panels (Fig. 4).

Figure 4. Corner crack

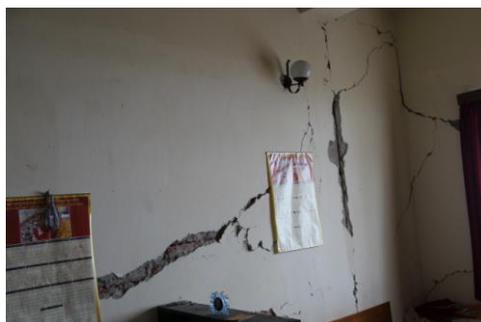
Major diagonal cracks developed in the wall panels. There were cracks in the spandrel masonry panels on all floors, with the cracks running in different directions (Fig 5).

Figure 5. Diagonal crack

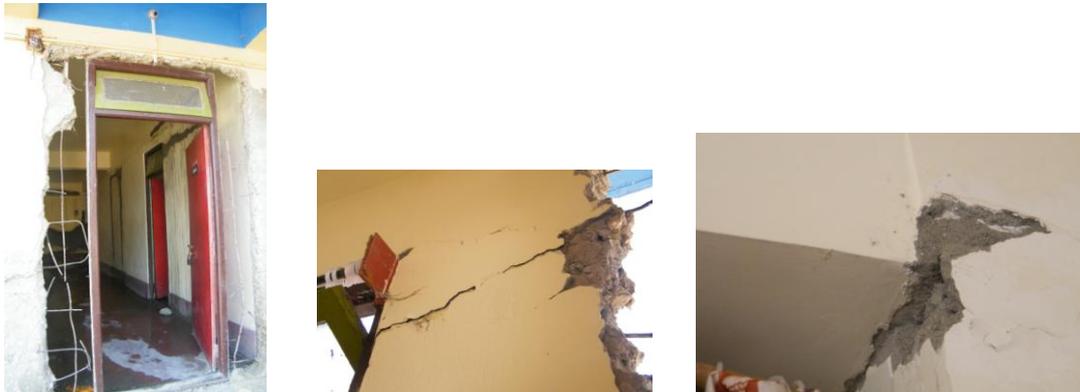
Non-structural elements such as window glass panels were broken as a result of the shaking. Building interiors also sustained damages at intersections between two walls, at roof-wall junctions, and also at lintel levels, evidently due to absence of lintel beams. There are instances of separation of door and window frames from the walls due to inadequate connections between these (Fig.6).

Figure 6 Detachment of door frame (left), Crack on pier masonry panels, (middle), Crack on spandrel masonry (right)

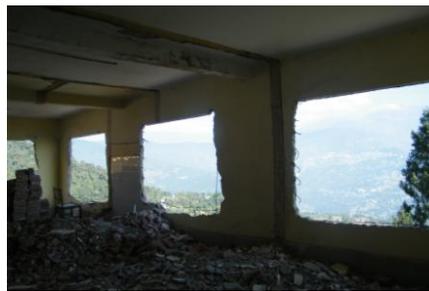
The Guest house suffered major damages wherein some parts of the RC wall due to poor quality of concrete and inadequate reinforcement (Fig.7).

Figure 7. Collapse in the wall

These damage patterns indicate a general absence of earthquake resistant features in the structure, such as lack of horizontal bands to contain the wall panels against out of plane failures, inadequate number of reinforcement bars in the columns, improper detailing and dimensions of the stirrups and poor workmanship. Other glaring inadequacies include poor tying of stirrups and insufficient lap lengths, 90° degree hooks instead of 135° hooks, which led to spalling of concrete from the beams and columns.

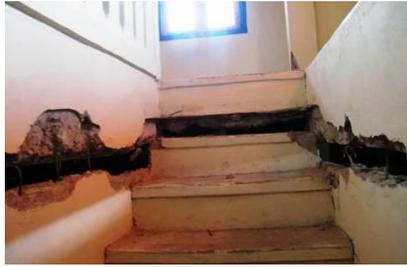
The Old Rumtek Monastery, Phodang Monastery, Labrang Monastery, Phensang Monastery, Pemayangtse Monastery are more or less similar in plan configuration. All of these are square or rectangular in plan and have single units. Except Pemayangtse, all the monasteries made masonry infilled RC frame extensions to their original structures. The upper floors had a number of floating columns at the upper levels. These proved disastrous for the structures, resulting in major damages to these upper floors. The top most floor of Old Rumtek monastery had spalling of cover concrete in the floating columns, along with cracks at the beam column junctions, indicating poor flexural performance. Similar damages were noticed in Phodang Monastery. An instance of separation of RC staircase from the floor slab was observed in the Old Rumtek Monastery. Long horizontal separation cracks were observed between the staircase beams and the infill walls of the staircase well. The beams also lacked adequate shear reinforcement and did not have proper ductile detailing (Fig. 8). Staircase

Figure 8. Disconnection of stair with floor    Figure 9. Separation of unconnected wooden staircase

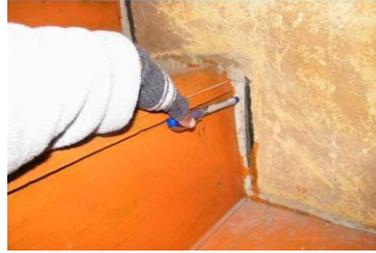
separation was also observed in Pemayangtse Monastery due to lack of connection between the wooden staircase and the masonry walls (Fig.9).

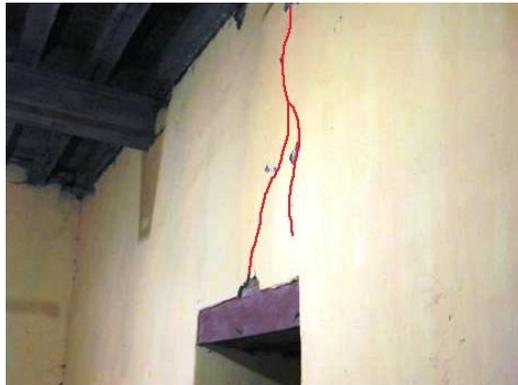
This monastery sustained damages primarily in the western and northern facades, at wall corners, sill, spandrel and pier masonry panels of openings. The corner of the north and west face sustained shear cracks in the masonry walls originating at the corner and progressing diagonally along the wall surfaces. Cracks at the first floor window sill levels were seen to progress both diagonally and vertically along the wall face along with cracking in spandrel masonry panels above lintel level. (Fig.10).

Figure 10. Crack on spandrel masonry

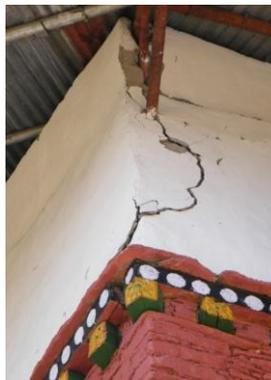
Damages in the building interior were seen again at wall intersections and at wall roof connections. due to flexible diaphragm action of the unconnected timber beam roof structure. At the wall corners, corner cracks were seen to stretch from the inside to the outside face of the walls due to lack of connections between the walls in two orthogonal directions. The wooden roof beams are not properly connected with the supporting walls, thus forming flexible diaphragms with evidence of separation cracks between the wall and the roof (Fig.11).

Figure 11. Flexible diaphragm action

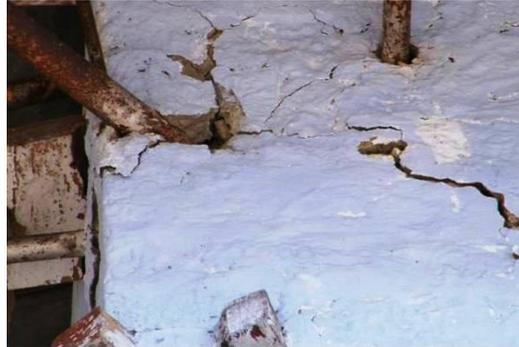
Lack of confinement of the window openings by horizontal and vertical bands resulted in the formation of diagonal cracks starting at the corners of the lintels and proceeding horizontally across the pier masonry panels (Fig.12).

Figure 12. Cracks on wall masonry

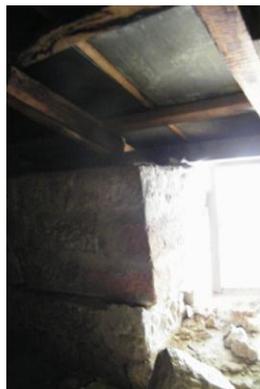
The Enchey monastery is distinctive and somewhat different from the others. The three-tiered monastery resembles a Chinese Pagoda. The monastery was first built in 1840. It was destroyed in a fire in 1947 and rebuilt in 1948. This monastery suffered damages in the 2006 earthquake and it was repaired with some attention to seismic resistance in the damaged portions only. As a result, this monastery did not suffer any significant damages except for the partial collapse of a random rubble masonry wall at the top floor, around an opening in the wall (Fig.13).

Figure 13. Collapse of random rubble stone masonry wall at top floor

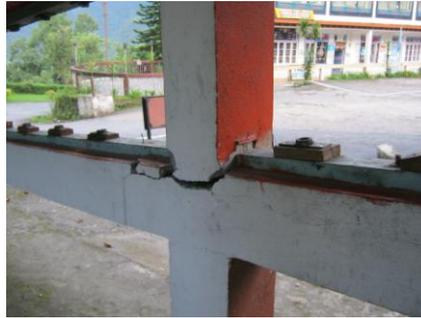
Long shear cracks were noticed both on outside and inside surfaces of the external walls. Short column effects caused serious damages at the top floor and also on the first floor verandah level (Fig.15).

Figure 15. Short column

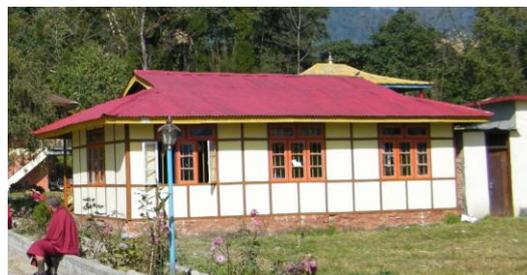
However, the outhouse of the monastery, made of traditional *Ikra* house having simple configuration with light weight walls, and pitched roof did not suffer any damage at all pointing at the inherent earthquake resilient attributes of vernacular construction in earthquake hazard prone areas in parts of North-eastern India.(Fig.17).

Figure 17. Outhouse of traditional Ikra style

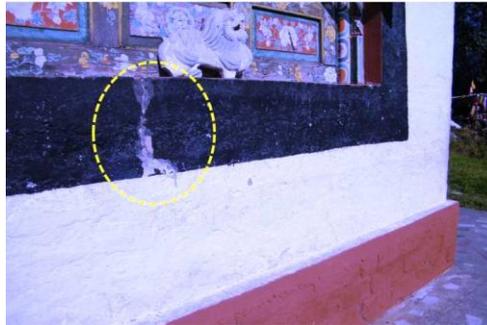
wooden beam support made the structure stable and safe. Some vertical cracks in the sill masonry were noticed due to the absence of sill bands (Fig.18).

Figure 18. Vertical crack on sill

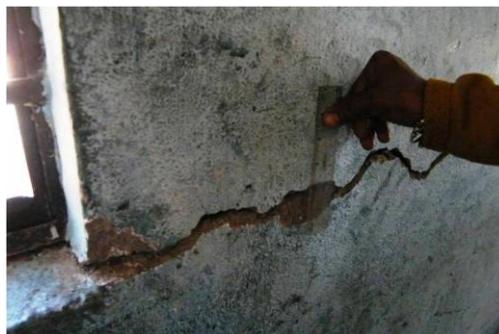
In the first floor of the two storied brick built outhouse, a continuous deep horizontal crack developed on the wall facing the monastery at the window sill level due to the absence of sill bands (Fig.19).

Figure 19. Horizontal Crack on sill level

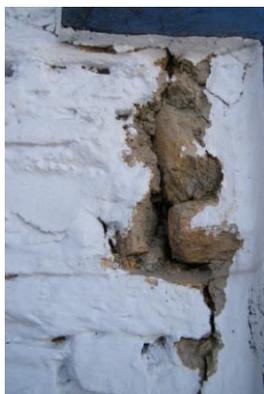
Labrang Monastery was built in 1814. Unlike many monasteries which were gutted by fires, this one still retains its original shape and structure. It is a cross in plan, symmetrical about both axes, and double storied with a pitched roof. The roof is made of a truss, covered by corrugated G.I sheets. It has projected wooden verandahs on each side at first floor level. Since the walls are of random rubble stone masonry, no proper bonding exists within the wall masonry; or even between adjacent walls. This appears to be the reason for the development of long vertical zigzag cracks during the earthquake. Shear cracks in the masonry wall facades and wall corners originated from the roof where the accelerations are the highest. Numerous such vertical cracks were noticed. The corner cracks are due to poor connections between the walls. The cracks in pier masonry move down along the wall. (Fig. 20). Similar cracks appear also in the spandrel masonry. Cracking of plaster in first floor wall surface, and shear cracks in the skirting level were noticed (Fig. 21).

Figure 20. Crack on pier masonry    Figure 21. Cracking of plaster

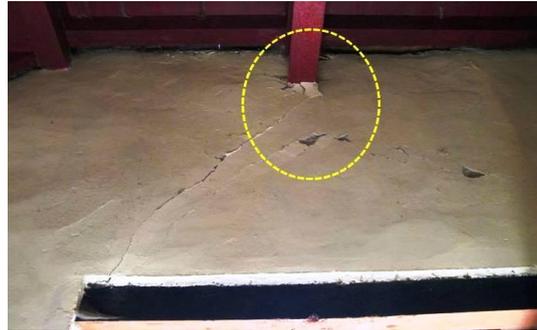
The wooden roof beams resting on stone masonry walls created a flexible diaphragm which was unconnected with the walls and resulted in separation cracks appearing between the walls and roof (Fig.22).

Figure 22. Improper connection of roof beam and wall
