## LESSONS LEARNED FROM THE 28 NOVEMBER 2013 BORAZJAN, SOUTH OF IRAN EARTHQUAKE

### ABSTRACT

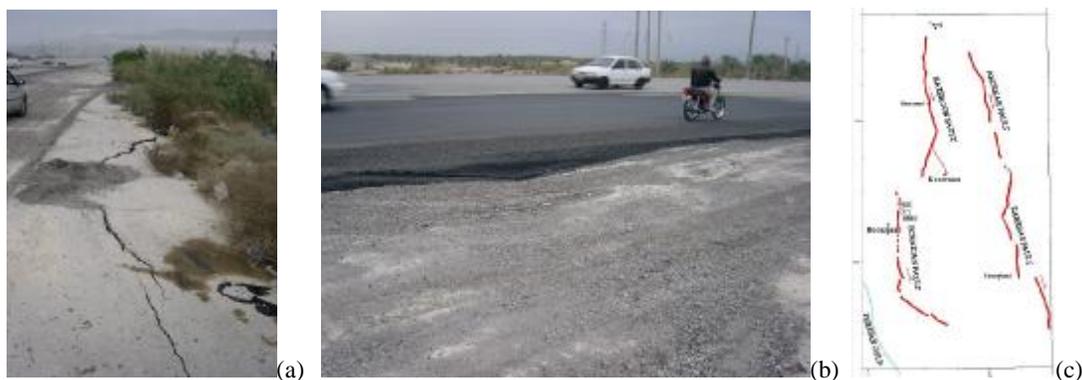
Some limited surface deformation were developed due to the earthquake, among others were the lateral spreading of the ground and local settlement of the road between Borazjan and Dalaki (Figure 4a, b). Also, some changes were observed on the underground water level following the earthquake. These changes caused blockage of a spring and opening of another spring near the epicenter. At the entrance road to Rahdar village which is the nearest residential area to the epicenter, a sulfur smell was spread around, which according to local people had been created after the earthquake.

Figure 4. Lateral spreading (a), and a local ground settlement and the poured Asphalt after the earthquake (b) on the road between Borazjan and Dalaki. Borazjan fault which is a portion of Kazeroon-Qatar fault (c).

The fault plane solution of the recent earthquake shows that there is a strike-slip mechanism of its causative fault which is the Borazjan fault (Figure 4c). The Borazjan fault is a portion of the Kazeroon-Qatar basement fault which extends from the Dinar Mountain in the north toward south to the east of Bushehr and the Persian Gulf. This fault has been existed since the pre-Cambrian period and its creation is the production of the Katangan Orogeny. Many earthquakes confirm the recent activity of this fault. In the Zagros geological literature, this master fault determines the boundary between the northwestern Zagros (Lorestan Zagros) and the southeastern (Fars Zagros).

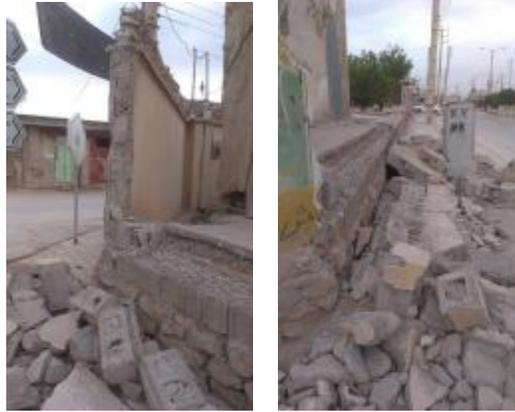
New buildings in Borazjan city are constructed in accordance with modern construction technology. However, in most cases long yard walls of the buildings are constructed by unreinforced cement blocks. This type of walls is generally vulnerable against the lateral seismic forces of even moderate earthquakes. Figures 6 and 7 show cases of damages to buildings in Borazjan due to the earthquake which are generally falling of the cement block or stone walls and also damage or fall of the building facades.

Figure 6. A yard wall of a vocational school made of cement block is fallen in Borazjan city.

### **Lesson 4. Necessity of implementing appropriate measures to prevent fall of yard walls**

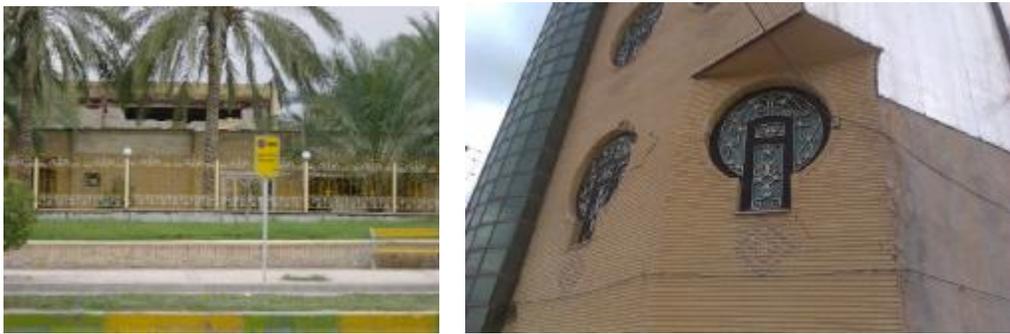
Figure 7. Part of a fallen wall and façade in a building in Borazjan (left), and developed cracks on a brick façade in Borazjan (right).

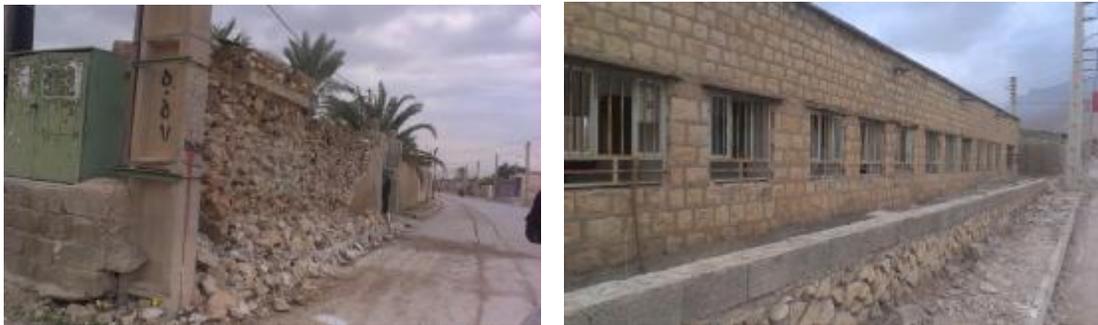
Residential buildings in villages have a relatively more hazardous situation. This is because firstly they generally lack tie beams and tie columns, and secondly they use unreinforced stone or block walls as bearing walls. In some cases, mud mortar is used in stone walls which make them vulnerable to even small or weak earthquake motions. It is interesting to note that the stone walls, especially in bearing walls are constructed in double layers and in some cases even thicker. It was observed in many cases that one of the layers in these walls is collapsed while another layer is still remained (Figure 8- left). The roofs of these buildings are mostly jack arch type.

Figure 8. Failure and collapse of one of the layers of the wall while the other layer is remained (Rahdar village) (left), a fallen wall of the Rahdar village school made of cement block. The debris had been removed at the time of the visit (right).

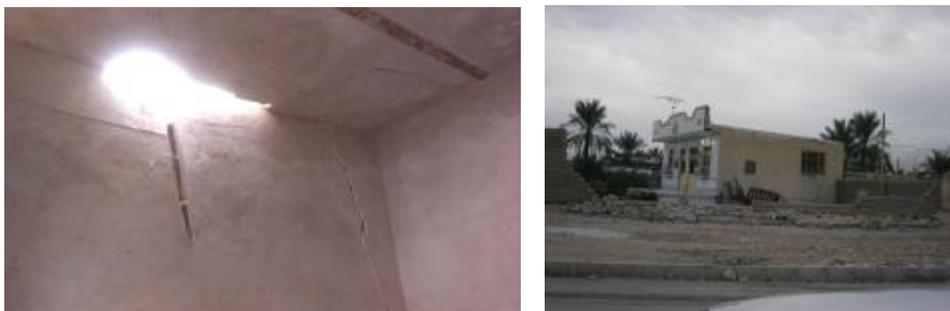
Figure 9. Damages in Rahdar village. Partial collapse of the jack arch roof (left), and the fall of yard wall (right).

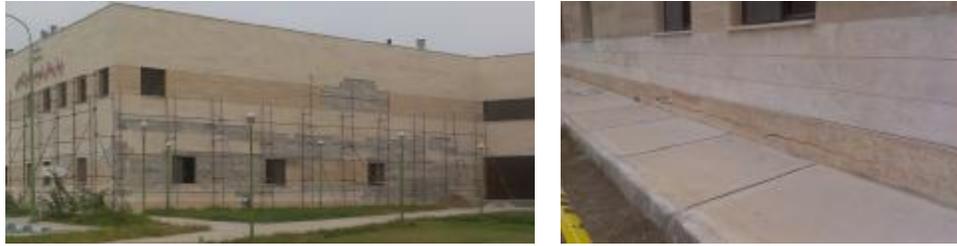
What had exposed the hospital to the public eyes more than anything else, was the fall of façade stones from the external walls. This type of damage could be seen in different parts with different degrees (Figure 11-left). Also some cracks and damages to the walls near the ground level were evident (Figure 11-right).

Figure 11. A view of the fallen façade stones (left), and a long horizontal crack near the floor of the Borazjan new hospital building (right).

### **Lesson 3. Necessity of appropriate installation of stone facades, tile works, and false ceilings**

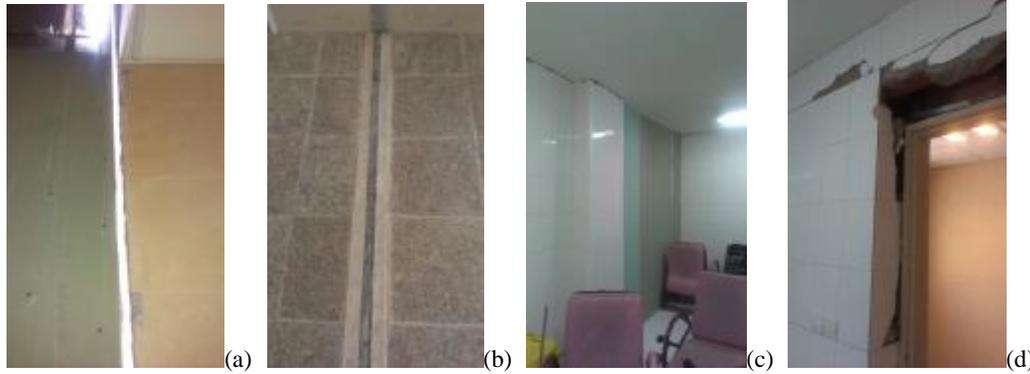
One of the obvious damages was observed in the separation joint areas of the upper floors. At the time of the visit, these locations had been repaired in such a way that new gypsum boards on the walls (Figure 12a) and new mosaics on the floor had been replaced (Figure 12b). In addition, separation of partitions from the frames and as a follow up breaking of brittle materials such as tiles were among the non-structural damages which had taken place in several places (Figures 12c and d). False ceilings had fallen down in several locations which had been replaced before the visit.

Figure 12. Non-structural damages to the Borazjan new hospital building. Rapid installation of new gypsum boards (a), and replacement of new mosaics at the separation joints (b) following the earthquake; detachment of partitions from the frames (c), and breaking and falling of tiles on some of the ground floor rooms (d).

It did not seem that a minimum separation joint was adapted in the Borazjan new hospital building. Noting that this building has 4 stories and its minimum height should be at least 12 m, the minimum joint between the two blocks should be at least 12 cm. This amount of joint did not seem to have been implemented, at least from what could be seen from inside of the building (Figures 12a and b). Anyhow, taking into consideration that the vibration in this building blocks has been intensified during the earthquake, the two adjacent blocks have strongly pounded each other and have caused significant local damages.

### **Lesson 2. Necessity of appropriate construction of separation joint and its filling materials**

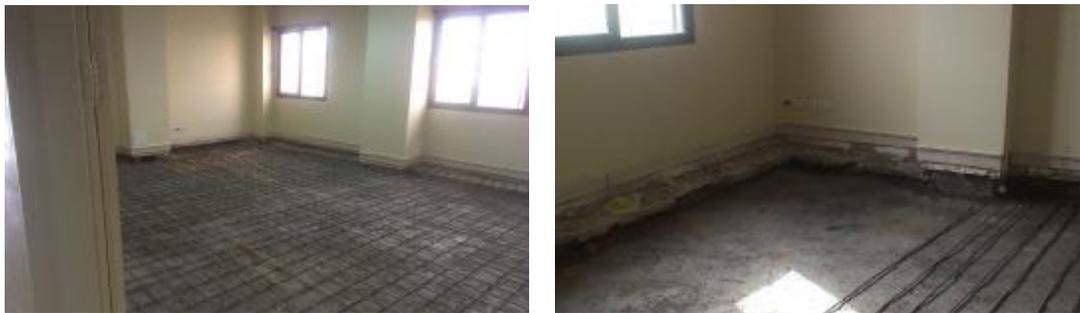
In addition to above damages, what seemed to be more impressive was the ground settlement in parts of the ground floor of the new hospital building. These settlements were observed with different degrees, from a small vertical displacement at the floor of the corridor to large settlements in some of the rooms on the ground floor. According to the hospital authorities, signs of settlements had been seen in those rooms before the earthquake. The earthquake occurrence caused large settlements in those rooms to a degree that it was necessary to fill the floors and bring them to the normal level. For this reason, during the visit, the floors of those rooms had been reinforced by steel bars to rebuild the floors (Figures 13a and b). The hospital site location on satellite images shows that the site is located on a fluvial basin (Figure 14). Therefore, if the ground is soft sediment, it can magnify the earthquake acceleration in the site. In this case, a comprehensive geotechnical study must be carried out and if necessary, special measures (e.g., soil consolidation and inclusion of the acceleration magnification factor in the structural design) have to be taken into consideration so that these problems are avoided in normal conditions and during the earthquakes. An important point in this regard is the study on the site selection of important and vital structures which as much as possible should be selected in places that are far enough from geological hazards such as faulting, landslide, liquefaction, settlement, etc.

Figure 13. Large settlements took place on some rooms of the ground floor of the Borazjan new hospital building. Reinforcements are placed to rebuild the floors and bring them back to normal level.

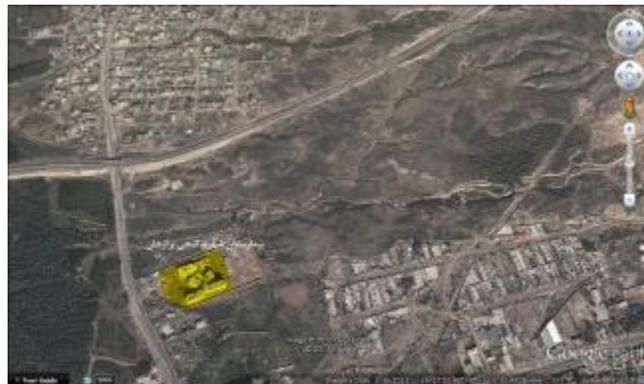
Figure 14. Satellite image shows that the Borazjan new hospital building is located on a fluvial basin.

The main reason for the significant non-structural damages of the Borazjan hospital building is related to the building site. This building is constructed on the fluvial basin. The soil of the fluvial land is a soft sediment type and can intensify the earthquake waves and as a result increases the motion acceleration at the foundation. The soft soil of the site intensifies the building blocks vibration. If this phenomenon is not accurately investigated in advance and during the design process, and if necessary technical measures are not taken into account to prevent it, then it will result to the damages that were actually observed. These damages were in particular as follows:

Thus, in selection of appropriate site for important projects more attention should be paid and necessary technical measurers have to be implemented, if it is compulsory to build in hazardous or potentially hazardous places.
