EARTHQUAKE INDUCED DAMAGE OF BURIED PIPELINES: A CASE STUDY

Aldís SIGFÚSDÓTTIR¹, Rajesh RUPAKHETY², Ragnar SIGBJÖRNSSON³

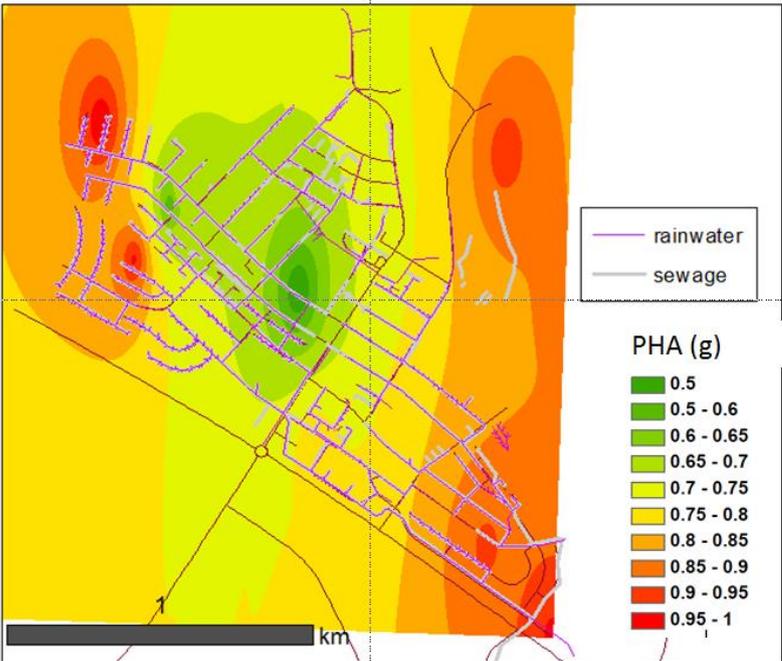
The large ground velocities resulted in significant strains in the ground which proved detrimental to the buried pipelines. The damaged pipelines were studied in detail after the earthquakes. This included video footages collected by camera-equipped robots that surveyed the inside of the pipes. In this study, the collected damage data is organized and systematically classified for easier interpretation. Several factors such as the material of the pipes, the location and type of joints, the year of construction, and the type of damage observed have been compiled. In addition, a geo-referenced database with the location, type, and extent of occurred damage is being created. The layout of the studied pipelines is shown in Figure 2 along with the peak resultant horizontal acceleration (PHA) interpolated from the recordings of ICEARRAY.

Figure 2. Layout of the underground pipeline in the town of Hveragerdi. The filled colours indicate the peak resultant horizontal acceleration.

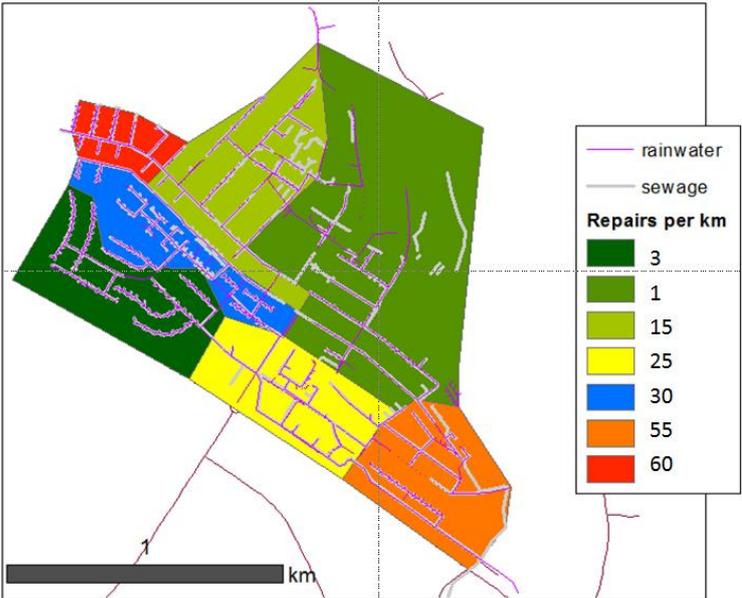
Preliminary analysis studying the rate of repair per unit length of the pipe has been completed. The obtained repair rates are variable in the region, ranging from 3 to 60 repairs per km of pipe (see Figure 3).

Figure 3. Repair rates of buried pipelines in different sections of the town.

It is also observed that the repair rate is strongly correlated to the peak ground velocity, but not correlated to the peak ground acceleration. The response of buried structures is not controlled by the inertial actions induced by earthquake ground motion. The inertial action in such structures is actually negligible. On the other hand, the ground velocity, being directly related to the ground strain, is more responsible for damaging buried pipelines. The results of this study confirm this. It is planned to study in more detail the type of damage, and their relation to the ground motion parameters, the local soil conditions, and the parameters of the pipes, such as, diameter, material, and age. Such results will be included in the full paper.
