THE FAILURE PERFORMANCE OF THAMES WATER PIPELINE AT FAULT CROSSING IN KOCAELI EARTHQUAKE

Aiwen LIU¹ Shiro TAKADA² and Qiumei HE³

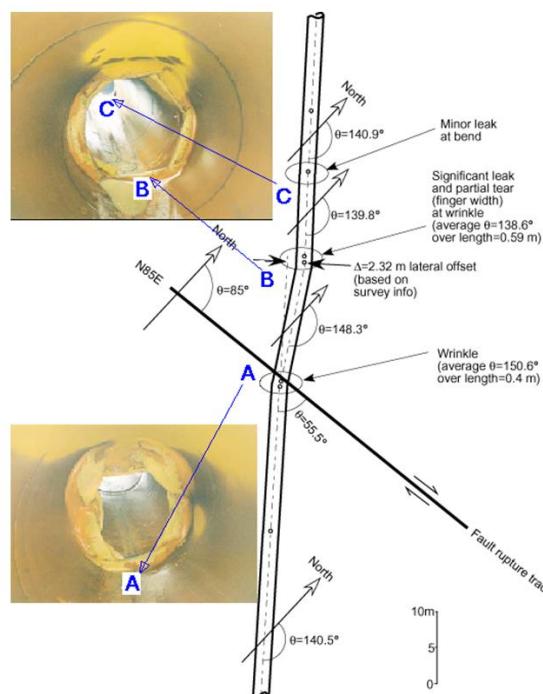
Kocaeli Earthquake (Mw 7.4) occurred on the North Anatolian fault in the northwestern Turkey on August 17, 1999. The Thames Water butt-welded steel pipeline is a raw water pipeline from Yuvacik Dam to Kullar water treatment plant, with 2.2 m diameter and 0.018 m thickness. The water pipeline crossed the Sapanca Segment of the North Anatolian fault and was damaged at the fault crossing. Within a few days after Kocaeli earthquake, this pipe was exposed to allow a better understanding of the nature and extent of pipe damage. A manhole was cut into the pipeline at the excavation to allow for access and emptying of the pipeline. Damage was observed at three locations: Point A, Point B and Point C. As shown in Figure 1, a small surface leak was observed in the pipe at point A near the fault crossing; a significant leak occurred at point B and the minor leak happened at Point C (Eidinger, 2001). Usually a water pipeline suffers two leakage points under the fault displacement, the failure performance of THAMES water pipeline with 3 leakage points is studied in this paper.

Figure 1. Damage of Thames Water Pipeline at the fault crossing

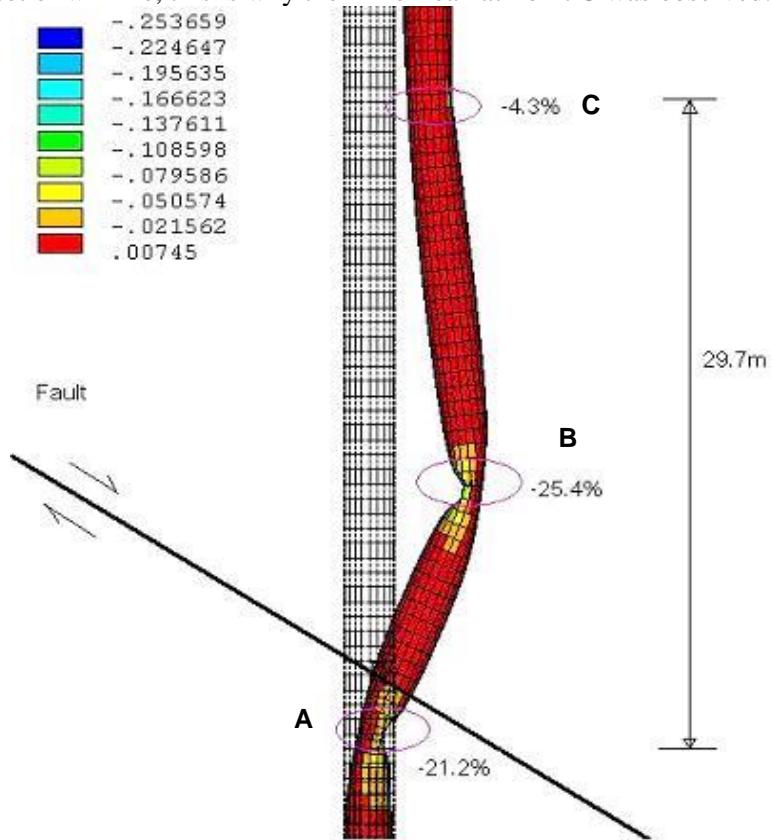
Considering that THAMES water pipeline was on service with 10 Mpa pressure, the bending stiffness of pipe is larger than a hollow pipe, the wall of pipe is purposely increased from 0.018m to 0.028m in the pipe FEM model. As shown in Figure 2, the simulation result is agreed with the real damage performance of Thames water pipeline. It is very clear that three buckling points occurring in the pipeline. Buckling point A is very near the fault crossing on the rigid soil side. The others (Points B and C) are located on the soft soil side. The compression strain of Point B is the largest of three buckling points, agreeing with the significant leak observed at Point B. Although the compression strain of Point C is the smallest, about 4.3%, it is also larger than the theoretical strain (0.0098) to reach the onset of wrinkle, this is why the minor leak at Point C was observed.

Figure 2. Numerical Simulation for Thames Water Pipeline

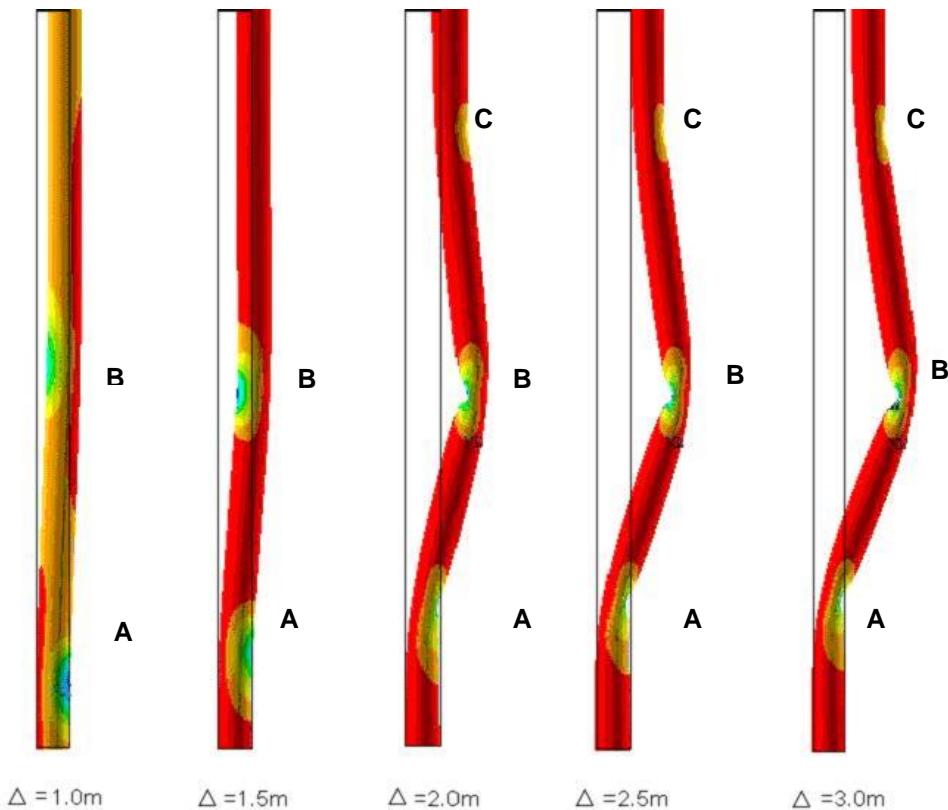
North Anatolian fault is a nearly strike-slip fault, and the fault displacement was up to 3 m. It is clear that the amount of fault offset imposed on the pipeline was large enough to initiate the wrinkles of the pipeline because that the crossing angle is 125° . The locations of two closest observed wrinkles (Point A and Point B) are what would be expected due to high bending moments in the pipeline. The question is why the third wrinkle occurred. Figure 3 shows why and how the third buckling point occurred. Buckling points A and B occur at the beginning of fault movement. They can be thought as two hinges in the pipeline. The pipe segment between these two hinges behaves like a rigid beam. With the increase of fault displacement, this pipe segment would rotate around the hinges (Points A and B) under the compression loading. Because the different soil conditions on two sides of the fault, the lateral displacement of point B on the soft soil side becomes larger than the lateral fault movement, therefore the third buckling point occurs.

Figure 3. Deformation process of Thames water pipeline with the fault movement (Δ)
