CYCLIC PERFORMANCE OF RC BEAMS WITH WEB OPENINGS

ABSTRACT

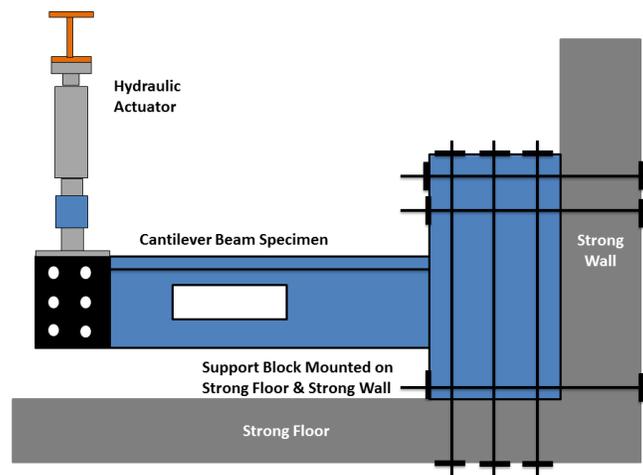
Figure 1. Test setup of $\frac{1}{2}$ beam in the laboratory.

With the objective of gaining insight into the cyclic response, hinge development, cyclic degradation and performance of the opening region of RC beams in Special Moment Resisting Frames (SMRF), an extensive experiment testing program is currently underway at the Structural Engineering Testing Hall (SETH) Laboratory at the University of CA, Irvine. Two out of six beam experiments will be presented in this paper. The beams are replica of typical SMRF beams located in an existing structure designed per ACI 318-95 & UCB 97 recommendations. Beams were constructed as half specimens (50% of the original length) as shown in Fig. 1. Other dimensions and structural reinforcement are scaled at 80%. Reverse cyclic vertical loading was applied at the beam tip. The reinforcement of the two specimens varied slightly. Comparison of a beam with and without an opening are presented hereafter. Heavy instrumentation via internal and external sensors such as strain gauges, Linear Variable Differential Transducers (LVDTs), and String Potentiometers enabled insight into the beams rotation, overall load displacements as well as shear and flexural interaction.

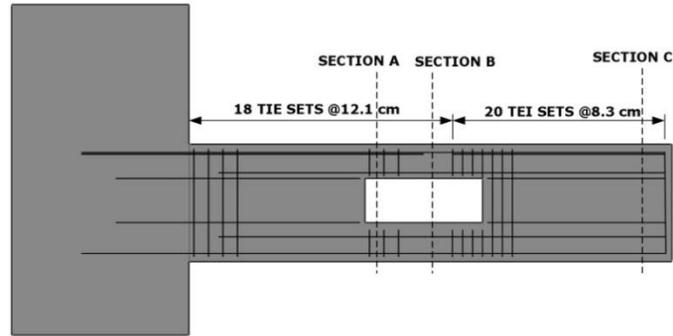
Figure 4. Side view of beam reinforcement for Specimen 1.

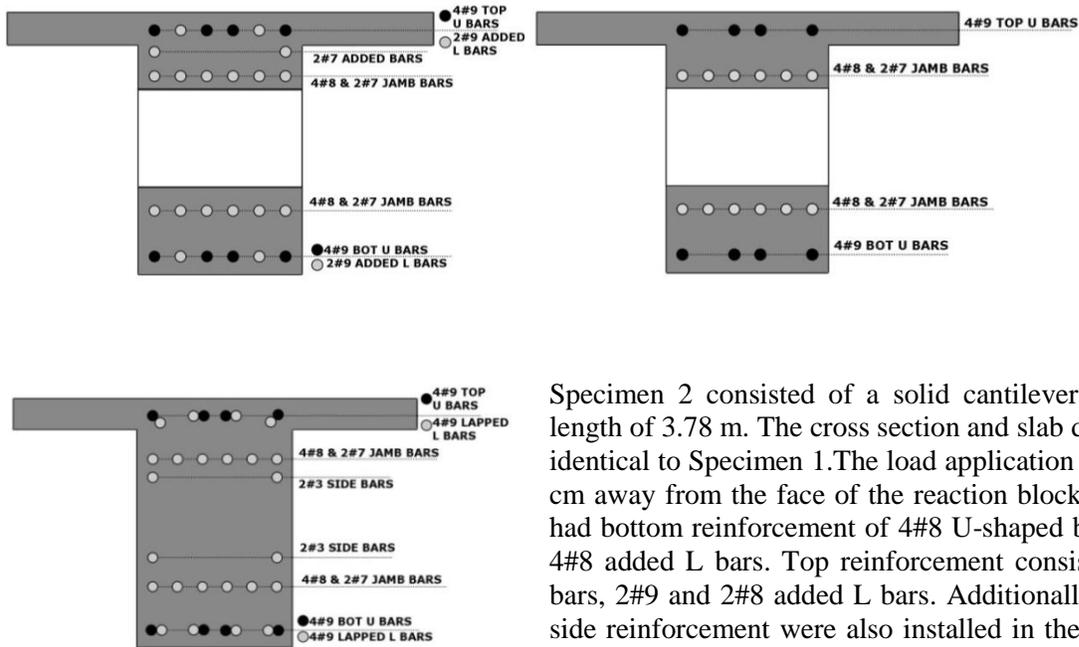
Figure 5a,b & c. Specimen 1 reinforcement at section A (top right) section B (top left) and section C (bottom).

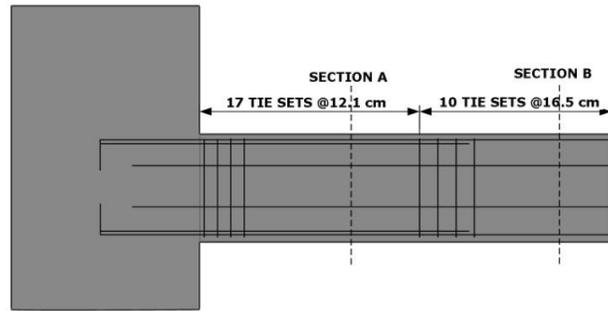
Figure 6. Side view of beam reinforcement for Specimen 2.

Specimen 2 consisted of a solid cantilever beam with a length of 3.78 m. The cross section and slab dimensions are identical to Specimen 1. The load application point was 317 cm away from the face of the reaction block. Specimen 2 had bottom reinforcement of 4#8 U-shaped bars as well as 4#8 added L bars. Top reinforcement consisted of 4#9 U bars, 2#9 and 2#8 added L bars. Additionally, 4#3 bars of side reinforcement were also installed in the beam. Shear reinforcement in Specimen 2 consisted of #4 bars at varying spacing. Slab reinforcement was identical to Specimen 1. A side view of Specimen 2 reinforcement is shown in Fig. 6. Fig. 7 shows the section view of the beam at the mid and end points.

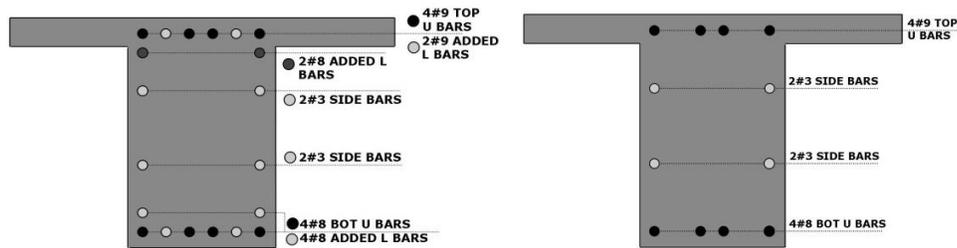
Figure 7a&b. Specimen 2 reinforcement at section A (left) Specimen 2 reinforcement at section B (right)

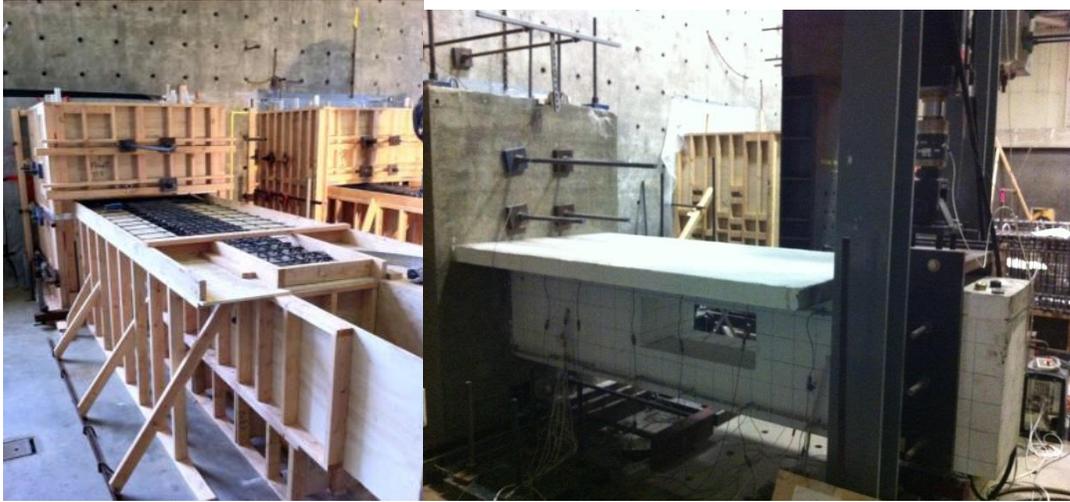
Figure 8 a&b. Completed formwork (left) and test set up (right).

All cantilever beams were anchored in a reaction block with dimensions of approximately 2.7m in height, 1.8m in width and 1.5m in thickness. The reaction block was custom-designed for each test specimen to accommodate the force and moment requirements of the beam end reactions. The reaction block was anchored in the strong wall and strong floor via 12 high-strength dywidag bars (six in each direction) with diameters of 41.9 cm posttensioned to 48.3 MPa. The reaction block was simultaneously constructed along with the cantilever sections, since dense reinforcement spacing required a staggered erection procedure. The formwork was constructed using high strength plywood, supported by wood bracings and cross beams as shown in Fig 8a.

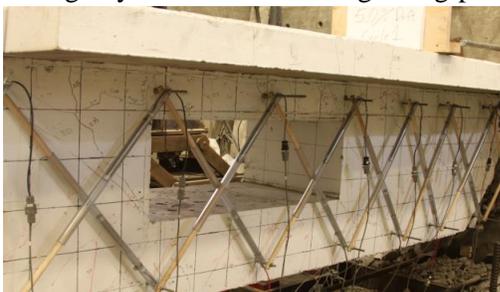
Figure 9. Close up of LVDT housing and extension.

A total of 71 (Specimen 1) to 52 (Specimen 2) internal and external sensors were installed on the test specimens to monitor beam displacements, rotations and internal strains during testing. The instrumentation consisted of 120 ohm Strain Gauges, LVDTs with gauge lengths ranging between +/- 2.5 and 7.6 cm and String Potentiometers with a displacement range of +/- 31.7 cm. All LVDTs were placed in plastic housing and combined with wooden extension rods to allow a larger span width as well as a protection from concrete spalling and cracking along the beam (Fig. 9). LVDTs were installed in longitudinal and diagonal configurations on both sides of the beam to measure flexural and shear deformations respectively. The string potentiometers installed on the reaction block (below and above the beam) were used to monitor and measure eventual reaction block rotations. No rotation was observed during any test. The remaining string potentiometers were installed below the beam and attached to the

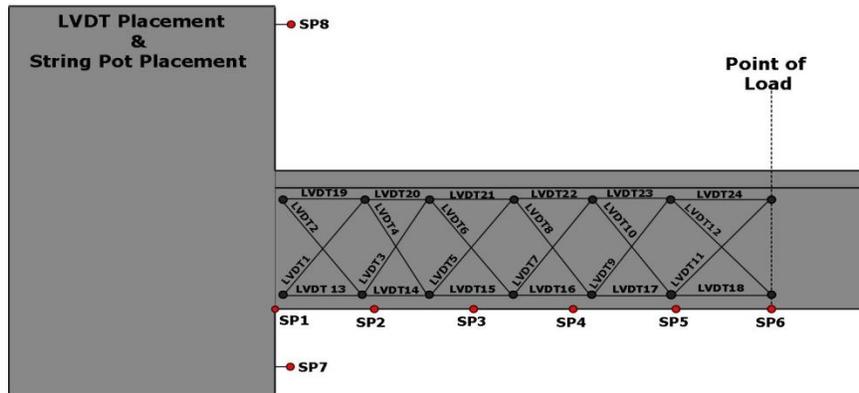
Figure 10. Typical schematic of LVDTs on face of beam and typical placement of string pots under beam and on reaction block.

Specimen 1's instrumentation consisted of 36 strain gauges, 28 LVDTs in longitudinal and diagonal placement and 7 string potentiometers below the beam and along the reaction block. Specimen 2's instrumentation consisted of 20 strain gauges, 24 LVDTs in longitudinal and diagonal placement and 8 string potentiometers below the beam and along the reaction block. A schematic of external sensor location is shown in Fig. 10.

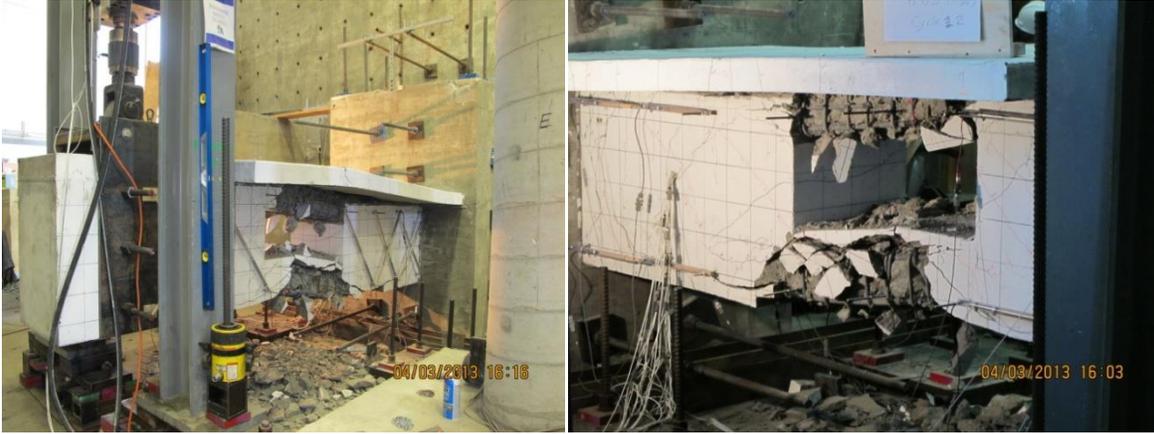
Figure 11a&b. Deformation of Specimen 1 during a downward cycle (11a). Close up of opening after test completion (11b).

Specimen 1 showed an early crack development around the opening which then led to the development of the plastic hinge at the opening section. First observed cracks formed diagonally away from the corners of the opening. With increasing displacement levels, significant flexural cracking occurred along the bottom chord of the opening, leading to significant concrete spalling and strength degradation around the opening section. Only very minor cracking was observed at the beam/column interface. The top slab experienced significant cracks along its entire width at the location of the opening and separated from the beam during the bending cycles. Fig.11 presents the beam opening section at complete failure (4.5% drift). Excessive concrete spalling, and rebar buckling is visible in the photograph and the opening section was no longer able to transfer any applied loading in to the reaction block.

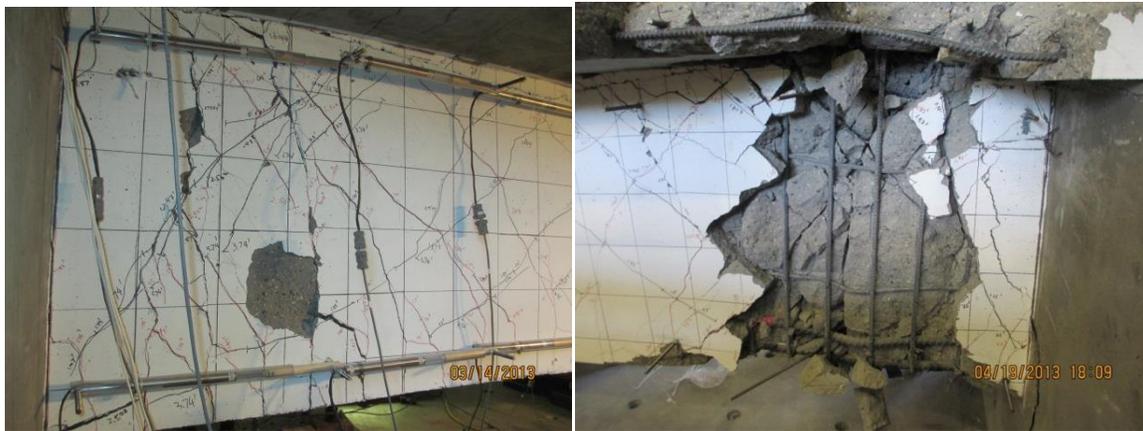
Figure 12a&b. Specimen 2: Cracks during testing (12a) and at failure (plastic hinge at beam/block interface 12b)

Photographs of Specimen 2 (no opening) during testing and upon test completion are shown in Fig. 12. Specimen 2 formed a plastic hinge and failed at the beam/column interface. Large diagonal cracks formed over the entire beam depth during testing. Fig.12 shows an almost parallel pattern of cracks across the beam section. Crack widths along the beam were very small (< 1 mm), cracks near the beam end opened up to widths of 2.5-5.1 cm before concrete spalling occurred and bigger pieces detached from the specimen. Significant buckling was observed in the bottom rebar of the beam as well as in the top slab reinforcement. The top slab detached from the beam after the plastic hinge formed and showed significant cracking along its entire width. However, in general the top slab added a significant amount of stiffness and capacity to the specimen and increased its capacity for the uplift cycles by approximately 40% on average.

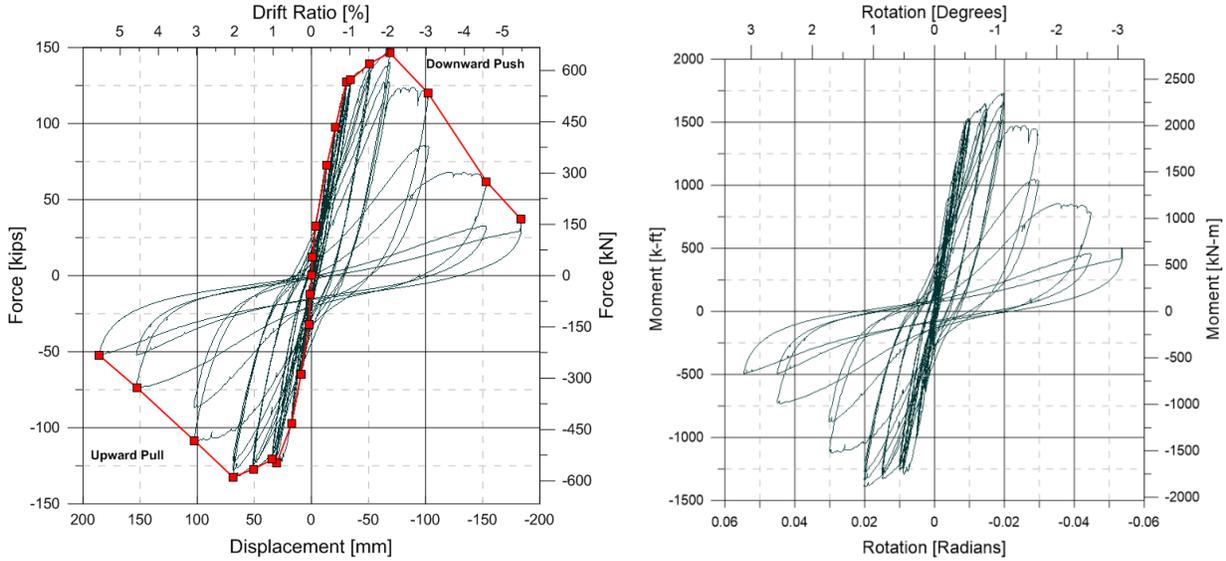
Figure 13 a&b. Force-displacement (13a) plot with back bone curve for Specimen 1 (with opening) and moment-rotation plot (13b).

Figs.13a & b display the load versus displacement and moment versus rotation relationship of Specimen 1. No self-weights of the beam and flange are considered in this plot. A positive force in Fig.13 indicates a downward push of the specimen by the actuator, hereafter referred to as compression cycle. Vice versa, when the actuator pulled up on the beam the bottom of the beam was in tension and is hereafter referred to as upward tensions cycle. The tension (upward) cycles tended to show a slightly greater force due to the additional stiffness provided by the top slab (only visible in the in the pre-yielding cycles), thereafter, the load on both cycles tend to be similarly distributed. The yield force for Specimen 1 in compression was approximately 565.5 kN at a vertical displacement of 3.2 cm (0.93% drift). Yield in tension was reached at a force of 541.8 kN at a vertical tip displacement of 2.8 cm (0.82% drift). Specimen 1 reached a maximum capacity of 653.9 kN in compression at a displacement of 6.8 cm (2.14 % drift) and about 587.2 kN in tension at a displacement of 6.9 cm (2.17 % drift). The maximum displacement of Specimen 1 was 185.4 mm in tension, corresponding to a total drift of 5.5%. The failure mode experienced by Specimen 1 was very similar to the failure modes described by Nasser *et al*(1967) and Mansur(2006). High stress concentrations around the corners of the opening lead to the initiation of diagonal cracking. Furthermore, at high displacement levels the chord members displayed a behavior similar to a Vierendeel panel including the development of plastic hinges at each corner of the opening. Overall the failure

occurred in a ductile manner where at the 3% drift ratio the diagonal cracks at the opening widened, severe spalling occurred, and the top slab separated from the beam at the location of the construction joint.

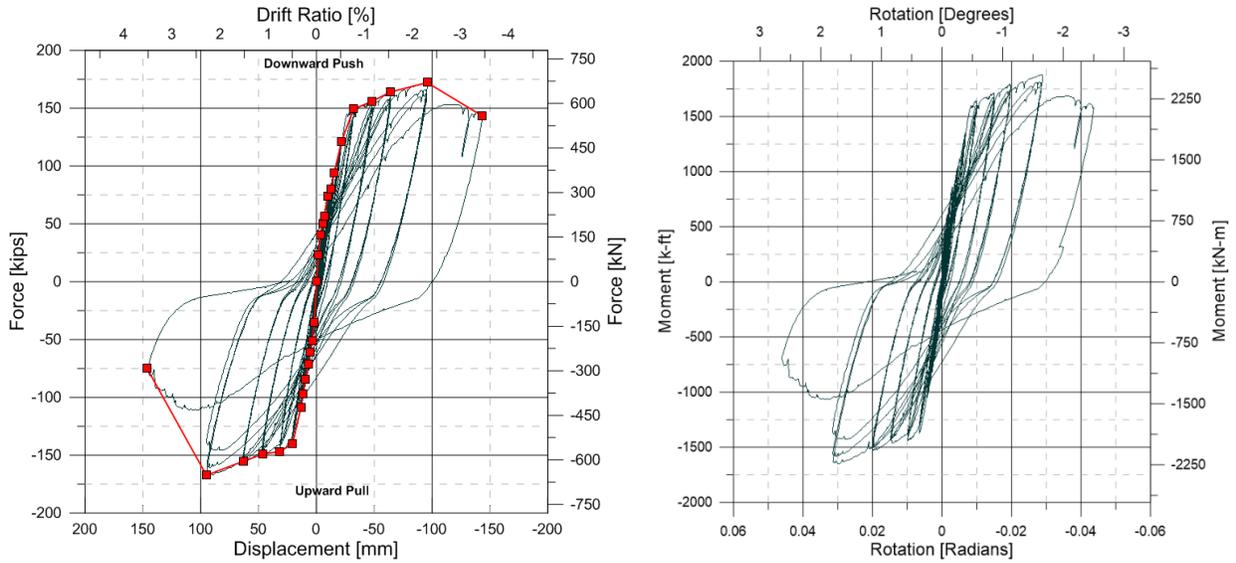
Figure 14. Force-displacement (14a) and moment-rotation (14b) plots with back bone curve for Specimen 2.

Fig. 14 shows the load-displacement and moment-rotation relationship for Specimen 2. A testing protocol similar to the protocol developed for Specimen 1 was followed to enable general comparisons in force and displacement. The yield force for Specimen 2 in compression was approximately 669.9 kN at a vertical displacement of 3.7 cm (1.17% drift). Yield in tension was reached at a force of 656.5 kN at a vertical tip displacement of 2.9 cm (0.91% drift). Specimen 2 reached the maximum capacity of 765.1 kN in compression and 742.9 kN in tension at displacement levels of 9.6 and 9.5 cm (3.0% drift) respectively. The maximum displacement of Specimen 2 was 14.3 and 14.6 mm (4.5 and 4.6 % drift). Table 3 above presents a comparison between the measured moment and the calculated moments for both yielding and ultimate conditions. The expected values were calculated analytical studies using moment curvature analysis. Values for Specimen 1 show a general agreement whereas for Specimen 2 there is a fair amount of a deviation from the measured result, especially in the ultimate moment condition. Model calibration and subsequent analytical studies are in the future scope of this research. Overall, the measured moment values tended to be larger than those based on theory calculations.
