POUNDING EFFECTS DURING AN EARTHQUAKE, WITH AND WITHOUT CONSIDERATION OF SOIL-STRUCTURE INTERACTION

Daniela DOBRE¹, Claudiu-Sorin DRAGOMIR², Emil-Sever GEORGESCU³

ABSTRACT

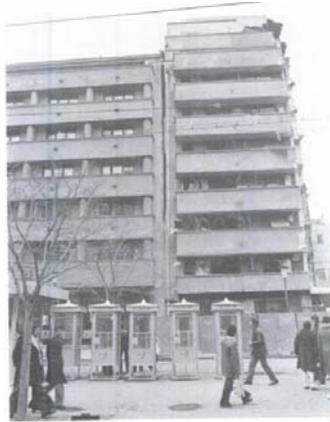
Figure 2. Damage due to pounding of the Casata building with the next structure (Slight tilt of this building to the right) (Fattal et al, 1977)

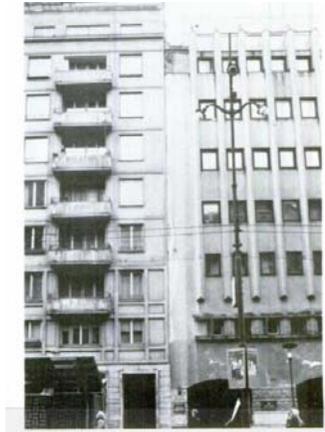
Figure 3. Pounding damage to other structures in the building block next to Casata (Fattal et al, 1977)

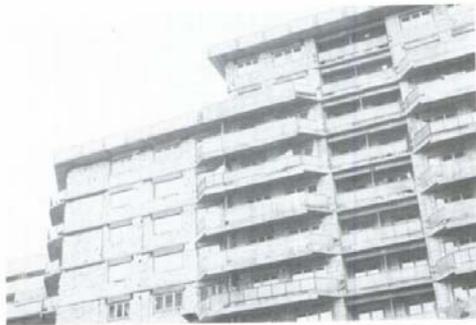
Figure 4. Exterior view of multistory apartment building. General lack of emphasis placed on the quality of masonry construction when used in filler walls, parapets and other non-load bearing applications (Fattal et al, 1977)

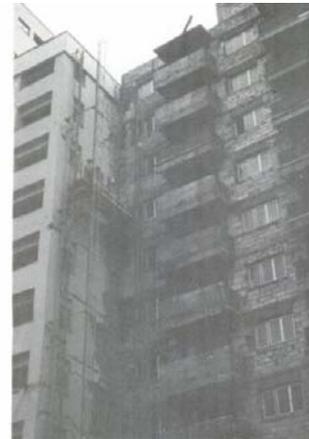
Figure 5. Rear view of building show fig. 4 showing pounding damage including partial collapse of several masonry filler walls and possibly structural damage to a fifth story corner column in the adjacent building (Fattal et al, 1977)

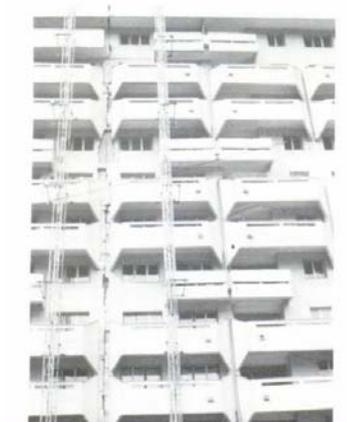
Figure 6. Pounding damage to adjacent buildings (Fattal et al, 1977)

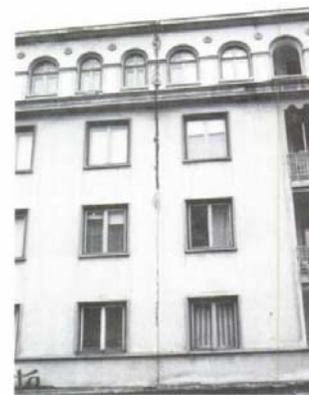
Figure 7. Pounding damage between adjacent buildings (Fattal et al, 1977)

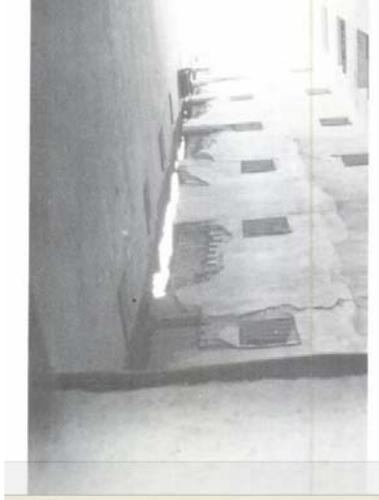
Figure 8. Heavy pounding damage to buildings with adjacent corners. Damage occurred mostly in the frame structure including the rupture of a corner column in the story opposite the top of the next building (Fattal et al, 1977)

A frame building located next to a shear wall structure which showed no visible signs of exterior damage; the most severe pounding damage occurred as a result of the collision between taller frame building and a shorter structure having adjacent corners.

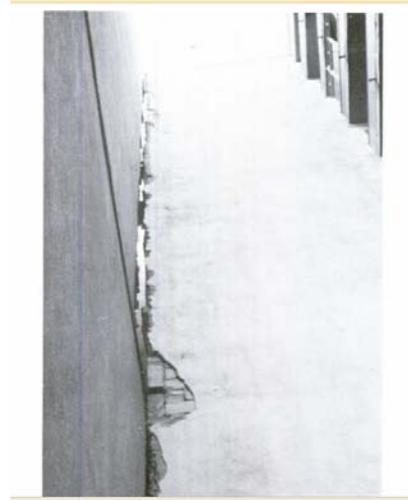
Figure 9. Same pounding damage viewed from the opposite side (Fattal et al, 1977)

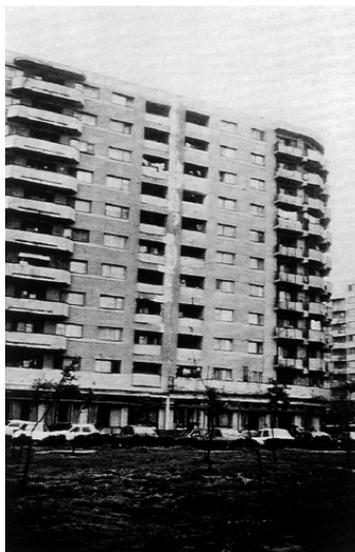
Figure 10. General view of the building Colentina 81, block 84/I, where occurred pounding between two structural parts of this large complex (Pomonis et al, 1990)

In the case of the 1990 Vrancea earthquake, a large 11 -storey apartment block collapsed along the expansion joint/seismic gap, Fig. 10...13 (Pomonis et al, 1990).

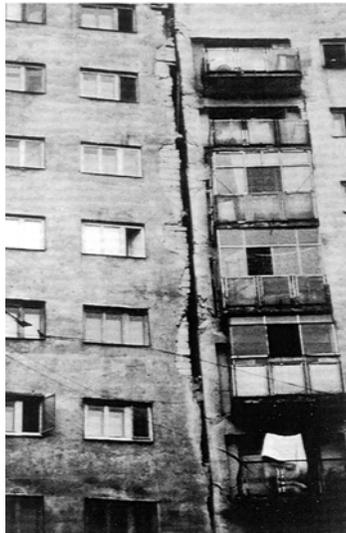
Figure 12. Colentina district, damage down the seismic gap line, due to pounding (Pomonis et al, 1990)

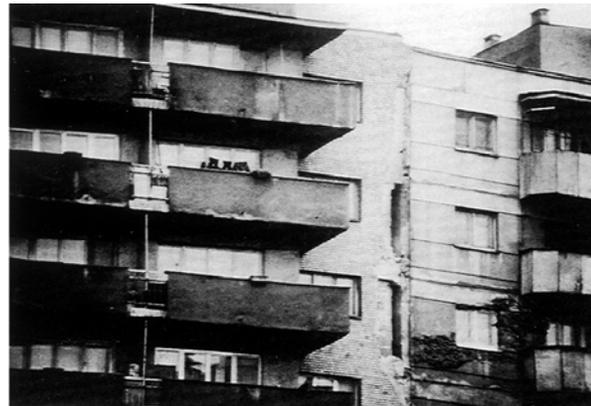
Figure 13. Damage to the expansion joint in another part of Bucharest (Pomonis et al, 1990)
