EXPERIMENTAL EVALUATION OF AGING DETERIORATION OF RUBBER BEARINGS IN HIGHWAY BRIDGES

ABSTRACT

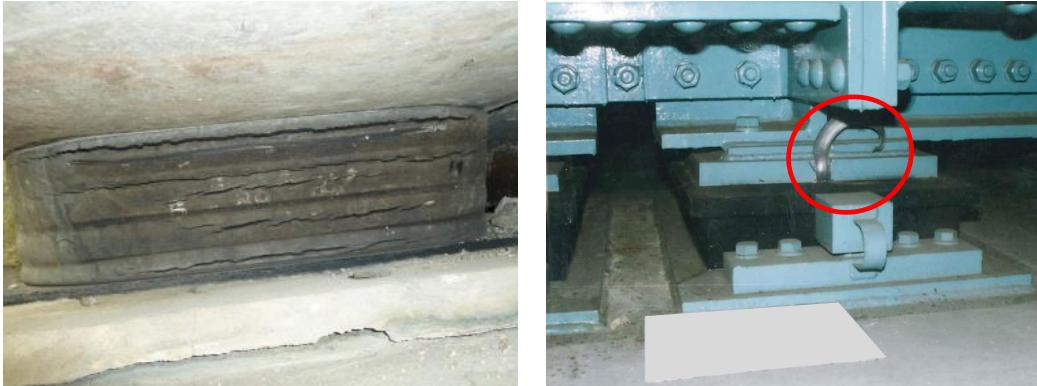
Figure 2. Damage examples of rubber bearing (Left : Crack, Right : Lead extrusion)

deterioration have been found requiring repair as shown in Figure 2. However, the remaining performance of rubber bearings with deterioration damage is not clear. Moreover, since there is no efficient repair method, most of the damaged bearings are being used with continuing observation.

The damages of “Rubber Crack”, “Rubber Broken” and “Lead Extrusion” due to the rubber aging deterioration are approximately 5% of the total. These damages are assumed to increase with time. The right photo in Figure 2 shows a lead extrusion from the upper side of bearing found in the past inspection. This bearing has been already replaced, but the similar damages are reported repeatedly and most of them are waiting to be changed.

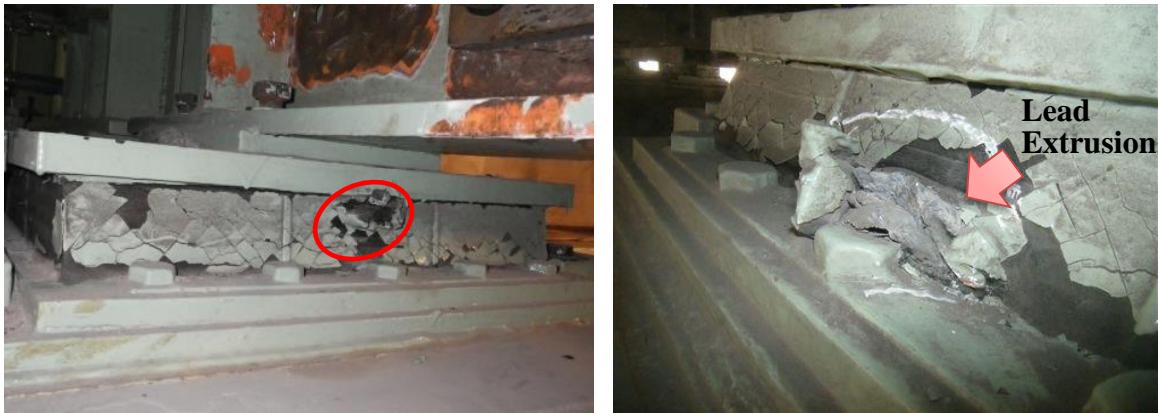
Figure 5. Damage status of lead extrusion

As can be seen in Figure 5, the damaged lead plug partially extruded from the bearings' lateral side in the bridge longitudinal direction. According to the inspection records, the damage were firstly observed as the rubber swollen in 2005 (10 years after installation), and the lead were virtually confirmed from 2008. It is clear that the lead plugs were deformed and finally extruded from the restraint of rubber as a continual progress.

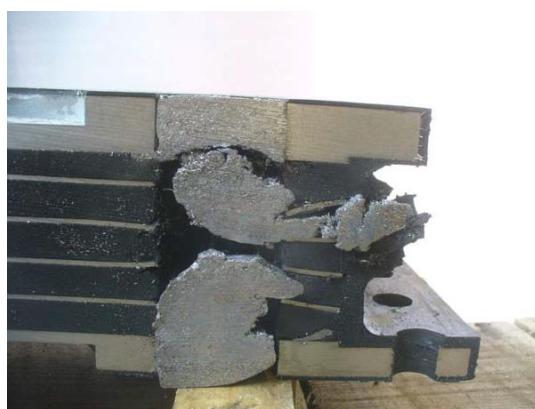
Figure 9. Fragmented lead plugs after DL2 test

In the DL2 tests, bearings were slowly loaded to 5 cycles with amplitude of 250% shearing strain. Damaged bearing also cleared this test without broken. As can be seen from the hysteresis curves in Figure 8, the damaged bearing showed stronger hardening effect and less hysteresis damping than the new bearing. The obvious stiffness hardening in large deformation domain of damaged bearing may due to the age hardening of rubber. By slitting the new bearing open after its DL2 test, the inner lead plugs, as shown in Figure 9, were observed being fragmented.
