A LOGIC-TREE APPROACH FOR THE SEISMIC DIAGNOSIS OF HISTORIC BUILDINGS: APPLICATION TO ADOBE BUILDINGS IN PERU

Carina FONSECA FERREIRA¹, Natalie QUINN² and Dina D'AYALA³

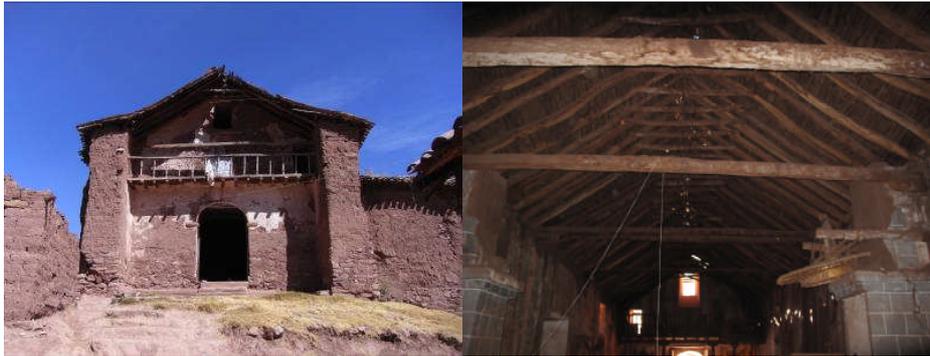
Figure 1. Church of Kuño Tambo built in the 17th century in the province of Acomayo, Cusco, is representative of high lands colonial churches: (Left) South façade; (Right) interior of the nave.

KT was built in the 17th century in the province of Acomayo, Cusco (see Fig.1 and Fig.3). The walls and buttresses are made of adobe with a rubble stone masonry base course. The thickness of the masonry walls range from 0.65m (WIII.3 of Fig.3) to 1.90m (WI.1 of Fig.3). The height of the base course ranges from 1.2m to 1.5m and the height of the adobe walls from 4m to 8.5m, as measured from the top of the base course up to the top of the gables. The height of the walls is not constant due to the fact that they follow the topography of the place. The adobe units are set in mud mortar. The base course, with thickness similar to the thickness of the walls, is made of stones of variable dimensions also set in mud mortar. The roof's structure of the church is a traditional system of roof-trusses known as 'par y nudillo' (rafter and collar tie). The longitudinal walls of the nave and the lateral walls of the baptistery are restrained by means of wooden tie-beams of approximately 0.20m diameter. Some of these tie-beams are fixed to the walls by means of timber anchors.

KT is assumed as a system composed of the following macroelements for the purpose of the final diagnosis: 1) adobe façade of the nave (WI.1); 2) adobe back wall of the nave (WI.3); 3) lateral adobe walls of the nave (WI.2 and WI.4); 4) Rubble stone base course; 5) adobe buttresses (B1, B2, B3, B8, B10, B12); 6) adobe walls of the sacristy (WII.1 to WII.3) / baptistery (WIIL.1 to WIIL.3); 7) wooden tie-beams and anchors; 8) roof wooden structure (Fig.1 Right).

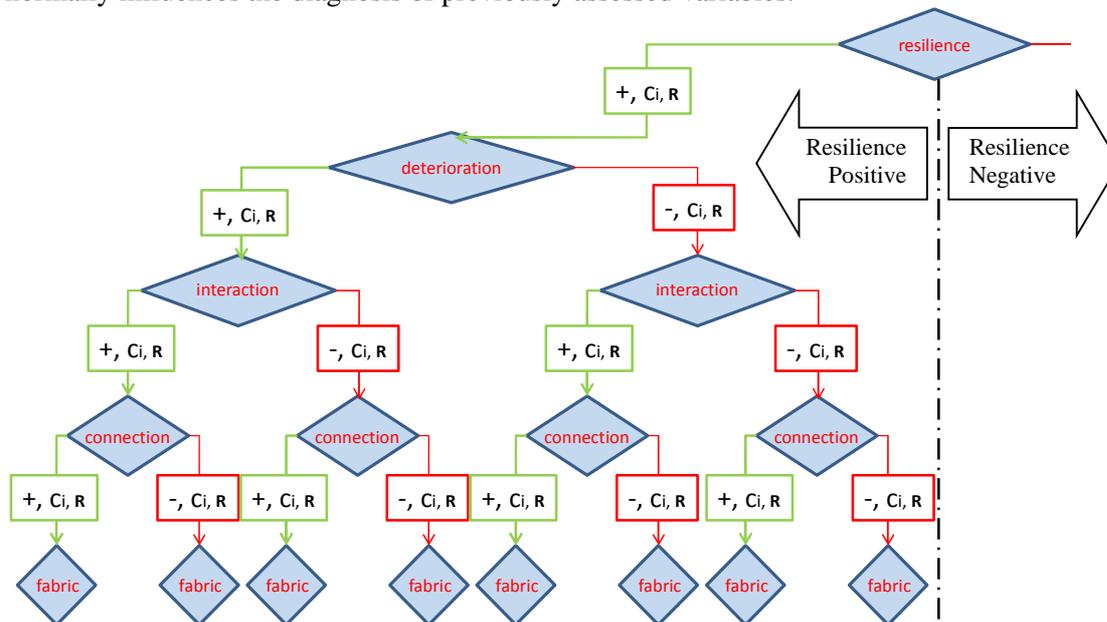
Figure 2. Tree diagram for the diagnosis of historic constructions

The approach for seismic diagnosis of historic constructions proposed here is based on the decomposition of the structures into several structural components or sub-structures (macroelements). A macroelement is a portion of the structure that can be considered independent from the rest, since in the event of an earthquake it will show a distinct seismic response, while interacting with other macroelements (Novelli and D’Ayala, 2011). These macroelements are then assessed according to a number of variables governing the seismic response of the structures. These variables are: i) the resilience of the structure in its undamaged and undeteriorated state, which provides a measure of the quality of the original structural concept; ii) the interaction between macroelements; iii) the type of connections within each macroelement; iv) the quality of the masonry fabric; and v) deterioration, which influences all the other variables. The approach is summarized in the tree diagram of Fig.2, where the diamond-shaped text boxes contain the variables and the rectangular text boxes contain the parameters evaluated for each variable.

The relevance of each variable is described by means of a *R* factor, which varies from 1 to the total number of variables. In the case of the diagram of Fig.2, ‘Resilience’ has relevance equal to 1,

since it is on the top of the assessment, while the 'Fabric' variable has relevance equal to 5. Nevertheless, there is an important component of looping, since the diagnosis of less relevant variables normally influences the diagnosis of previously assessed variables.

The assessment of the constructions or macroelements regarding each variable requires the evaluation of the state in terms of positive (marked as '+' and in green in Fig.2) or negative (marked as '-' and in red in Fig.2) and the attribution of a confidence factor to the judgment made. The confidence factor, C , associated to each possible path of Fig.2 is assumed as an average value of the confidence associated to the diagnosis of all variables, C_i . Hence, C dictates what the relevant paths to follow are. For instance, if two alternative paths have 50% of confidence, i.e. both scenarios are equally likely, then it is necessary to follow both paths during the planning of future interventions. On the other hand, if the confidence factor is higher than 50% for one path, it might be sufficient to only follow this path. Furthermore, alternative paths can be defined for different macroelements belonging to the same case study.

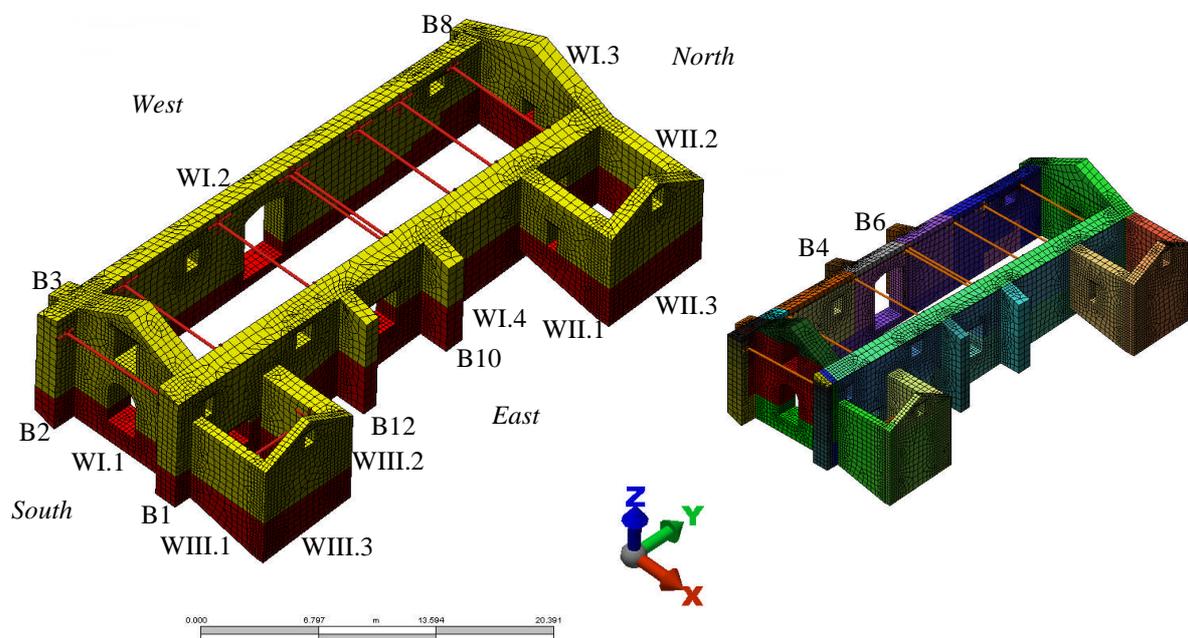
Figure 3. Global model of KT: (Left) present state; (Right) state after buttresses B4 and B6 are reinstated

Pushover analyses are performed with the global numerical model of the church shown in Fig.3 (left). This model corresponds to an interpretation of the present state of the building. Two additional buttresses still standing on the East side of the church, next to buttresses B12 and B10. However, these buttresses are completely detached from the nave and therefore they are not included in the model. Similarly, KT had 4 buttresses on the West side, from which two buttresses are known to have been connected to the nave by interlocking of adobe units. Fig. 3 (right) shows the state of KT if these two collapsed buttresses of the West side are reinstated (buttresses B4 and B6). The roof structure is not modelled since it is difficult to simulate the complex relative rotation and sliding that the typical connections of the roof undergo. Furthermore, the failure of those connections relates to localized damage of the roof rather than failure of the walls, since it is assumed that the tie-beams are not

connected to the roof on the basis of on-site observation. A maximum of 0.3g acceleration was considered in the pushover analyses performed both in the X and Y positive and negative directions, which is the maximum ground acceleration with a probability of 10% to be exceeded in 50 years (return period of 475 years) for the zone where KT is located, according to the Peruvian seismic code (E.030, 2003). More details of the numerical models can be found in Fonseca Ferreira and D'Ayala (2012).

Considering the current state of KT, as shown in Fig.3 (Left) and assuming a good connection among walls, the capacity curves of the walls of KT for in-plane response are shown in Fig.4. The most vulnerable walls are WIII.2 and WII.1 with values of drift that can exceed the DS of significant damage if the reference drift ranges from FaMIVE are considered. These walls are subjected to in-plane inertial forces transmitted by the out-of-plane movement of the longitudinal walls of the nave. Walls I.1, I.2, I.4, II.2 and III.1 can also exceed the DS of significant damage if the lowest thresholds from FaMIVE are considered. A similar situation occurs for walls I.3, II.3 and III.3 as far as the DS of

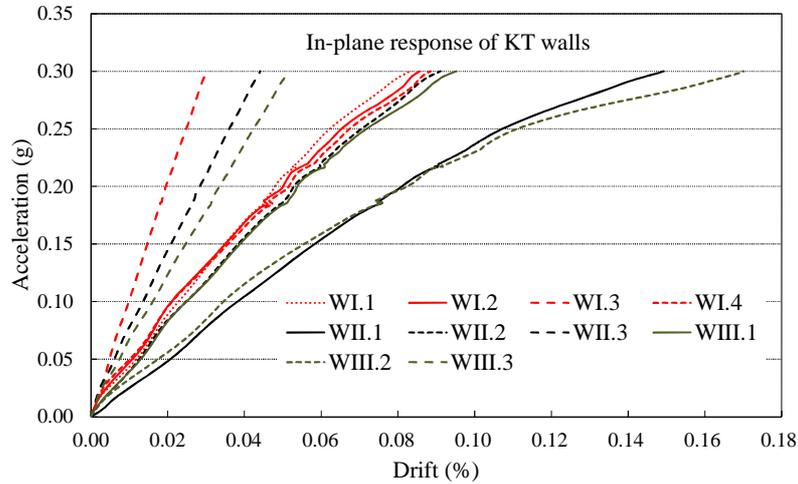
Figure 4. Capacity curves of KT for in-plane response described in terms of acceleration and drift

damage limitation is concerned. The most vulnerable walls have a nonlinear response from approximately 0.055% drift onwards, which indicates that an important reduction in stiffness initiates for an acceleration between 0.2g and 0.25g. A limit state of damage limitation is characterised by negligible permanent drifts, where the structural elements retain their strength and stiffness properties (see e.g. EN 1998-3, 2005). Hence, 0.055% drift might be a lower bound for the DS of damage limitation as far as the walls of KT are concerned. The exceedance of this limit state is especially important in the case of KT, since the church has valuable interior wall paintings.

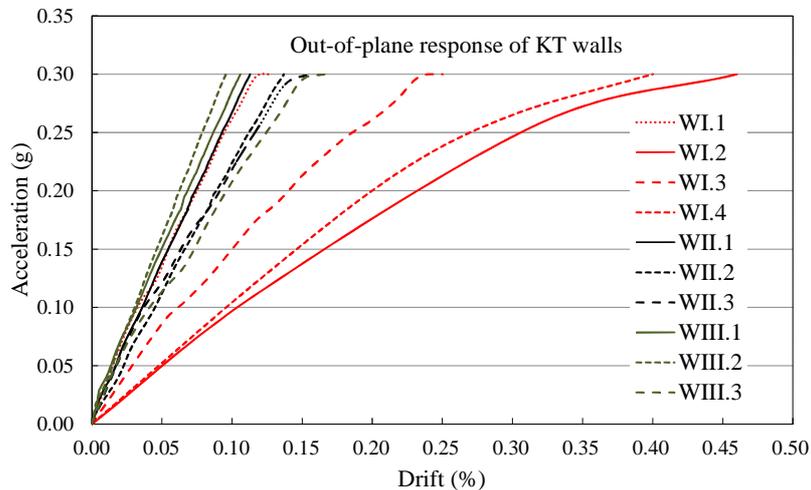
Figure 5. Capacity curves of KT for out-of-plane response described in terms of acceleration and drift

Fig.5 shows the capacity curves for out-of-plane response of the walls of KT. It can be seen that walls I.2 and I.4 exceed the DS of near collapse if the provisions of Eurocode 8 are considered. If the drift range from FaMIVE for combined response is taken into account, all walls of KT can exceed the DS of significant damage. Walls I.2 and I.4 present an important nonlinear plastic response from 0.24% and 0.20% drift onwards, respectively, which corresponds to an acceleration of 0.2g in both cases.

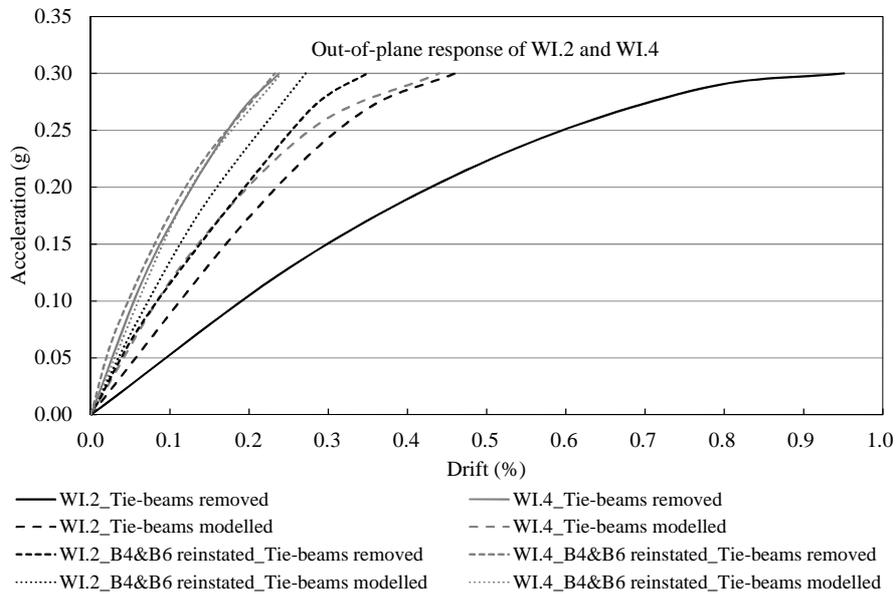
Figure 6. Out-of-plane capacity curves of WI.2 and WI.4 for various hypotheses

The existing lateral restraints of walls I.2 and I.4 appear to be insufficient to avoid severe damage and even the collapse of these walls. Hence, it is important to check whether the lateral response of walls I.2 and I.4 is considerably different when buttresses B4 and B6 (see Fig.3 Right) are reinstated. The out-of-plane drift of these walls is therefore shown in Fig.6 for the following hypotheses: i) tie-beams modelled and not modelled; and ii) buttresses B4 and B6 modelled and not modelled. Hypothesis i) informs on the structural relevance of the tie-beams. It can be seen that if buttresses B4 and B6 are reinstated and the tie-beams are effective, wall I.2 might present significant

damage; however it will not collapse, as per the provisions of Eurocode 8. Similarly, wall I.4 might not present significant damage. It is interesting to notice that the response of wall I.4 when the tie-beams are effective and buttresses B4 and B6 are reinstated is similar to its response when the tie-beams are removed.

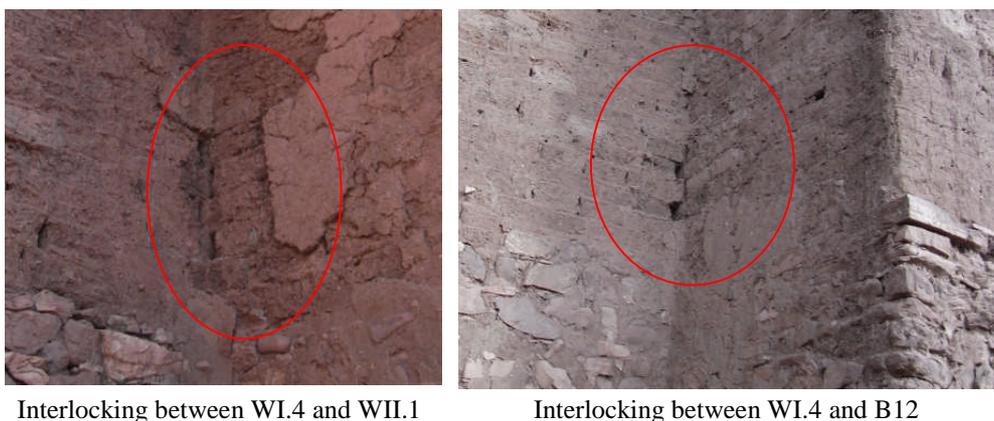
Figure 7. Interaction between KT macroelements

Interlocking of adobe units between the sacristy and the nave and between the walls of the nave and buttresses B10 and B12 was observed on-site, as shown in Fig.7. This might indicate a good level of connection between these macroelements. On the other hand, on-site observation also allows concluding that the baptistery does not have the same level of interlocking, which might suggest a poor interaction with the nave.

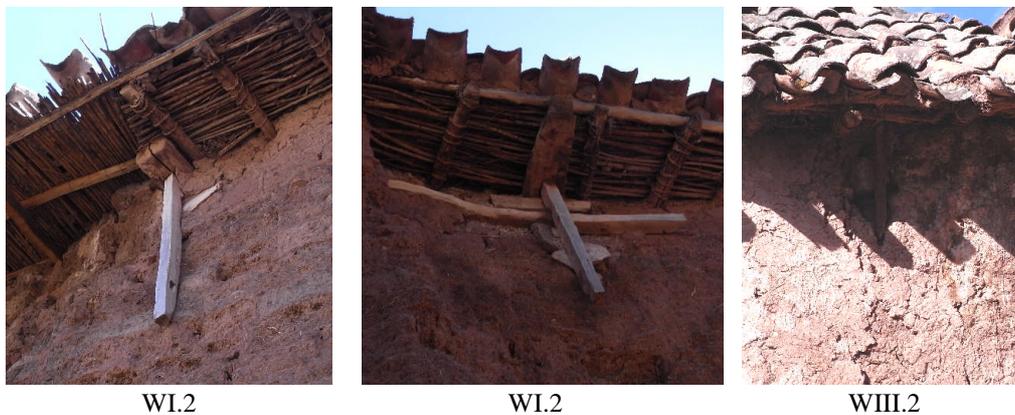
Figure 8. Layout of KT wooden anchors

The rafters of the nave are simply sitting on wall-plates with a modest scarf. Each pair of rafters are connected together by means of leather straps and, in some cases, wrought iron nails. The same type of connection is used to connect the collar beam with the rafters. These joints are very flexible and the elements slender, so the roof structure has a modest in-plane and out-of-plane stiffness. As far as connection 2 is concerned, there are at least 3 different types of timber anchors in KT, as shown in Fig.8. However, the connection of the key with the tie is rather poor and the key is slender and unable to avoid excessive stress concentrations, especially when the anchor is done with only 1 vertical key. This variable is therefore considered negative with 90% of confidence.

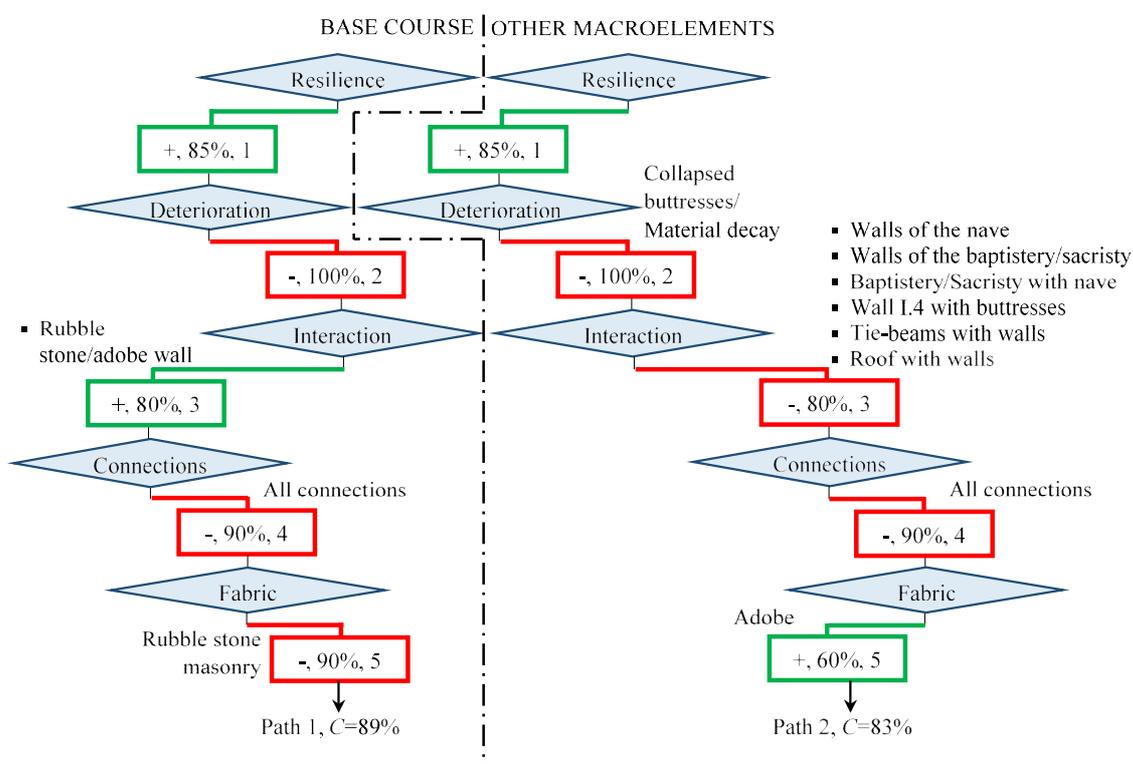
Figure 9. Logic-tree diagnosis of KT

The diagnosis of KT is illustrated in Fig.9. ‘Resilience’ is the most relevant variable, since the structure still sound; even though interaction between macroelements and connections are poor and

maintenance is neglected. 'Deterioration' is the second most relevant variable due to the collapse of buttresses B4 and B6 and generalised material decay due to inappropriate water drainage and use of poor masonry plasters. The collapse of buttresses B4 and B6, which are believed to have been well connected with WI.2 by interlocking of units, substantially increased the seismic vulnerability of WI.2. Material decay also contributes to a poor interaction of macroelements by decreasing the strength of the material at the interfaces. Furthermore, the capacity of the connection of the tie-beams with the adobe walls is further compromised by the presence of moisture at the top of the walls.

The most important structural vulnerabilities of KT are related to poor interaction conditions between the macroelements, if the collapsed elements are reinstated. The connections within the roof structure and between the tie-beams and the anchors are also very poor. However, the quality of the connections might not be as critical as the interactions between macroelements, provided that these interactions promote a box-like response. This explains the fact that a higher relevance is attributed to the 'Interactions' variable than to the 'Connections' variable. Two alternative paths are obtained. Path 1 regards to the base course and path 2 to the other macroelements.
