GEO-REFERENCED INVENTORY TOWARD SEISMIC SAFETY OF EXISTING BUILDING STOCK – CASE STUDY KARPOSH MUNICIPALITY IN SKOPJE

Golubka NECEVSKA-CVETANOVSKA¹, Roberta APOSTOLSKA², Veronika SENDOVA³,
Marija VITANOVA⁴ and Julijana BOJADJEVA⁵

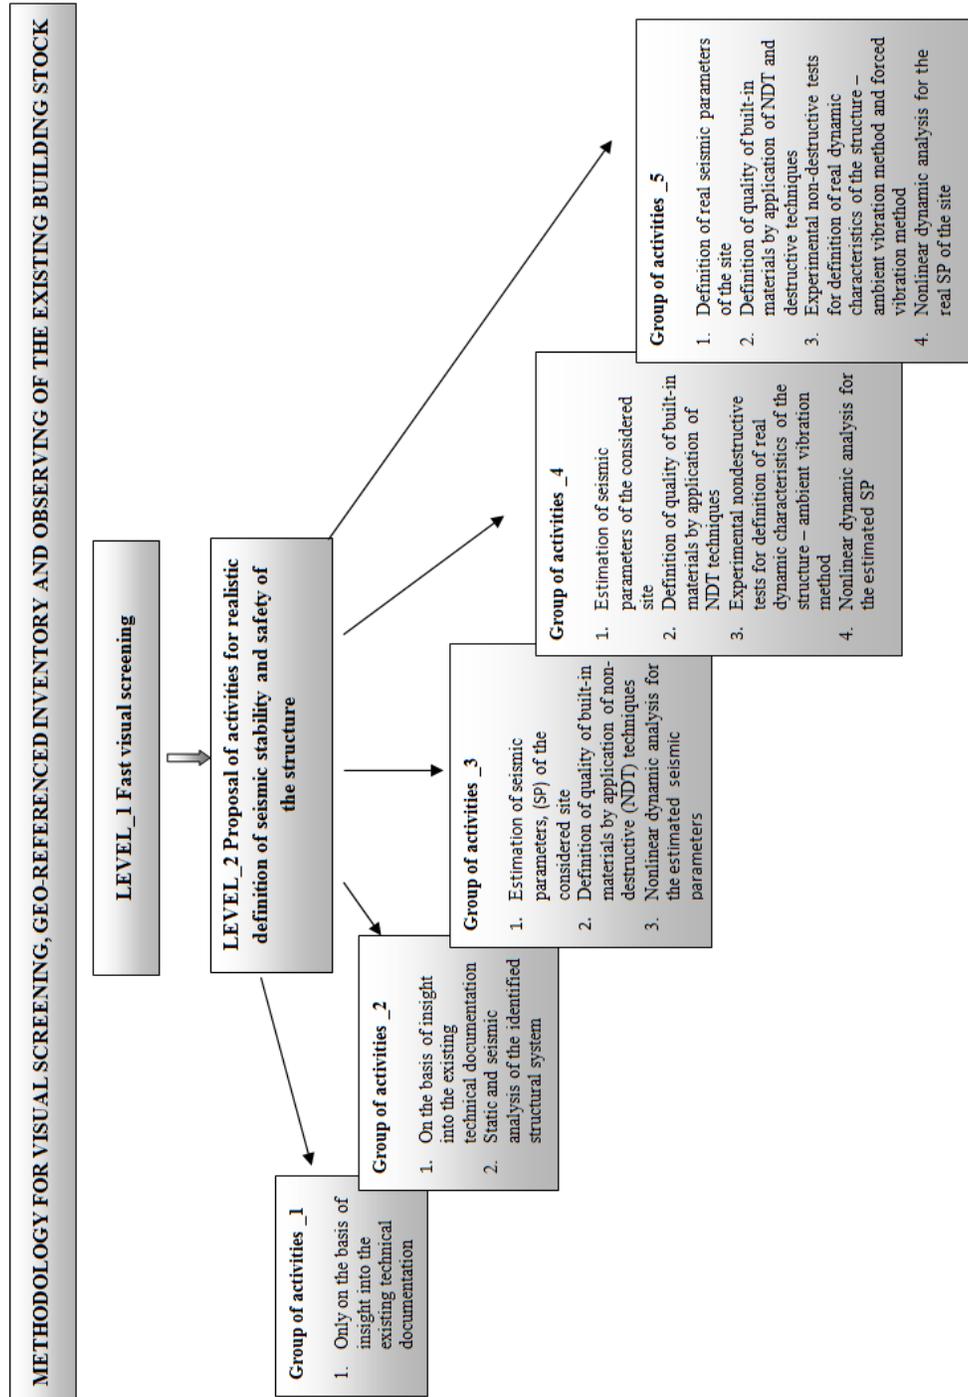
Figure 1. Block diagram of the methodology for visual screening, geo-referenced inventory and observing

Based on the data obtained by field screening, five groups of activities have been selected to be realized for the purpose of realistic definition of the seismic stability and safety of the structures, which have been the subject of screening, (Fig. 1). A corresponding group of activities to be realized has been defined for each screened structure depending on its current conditions (existing conditions,

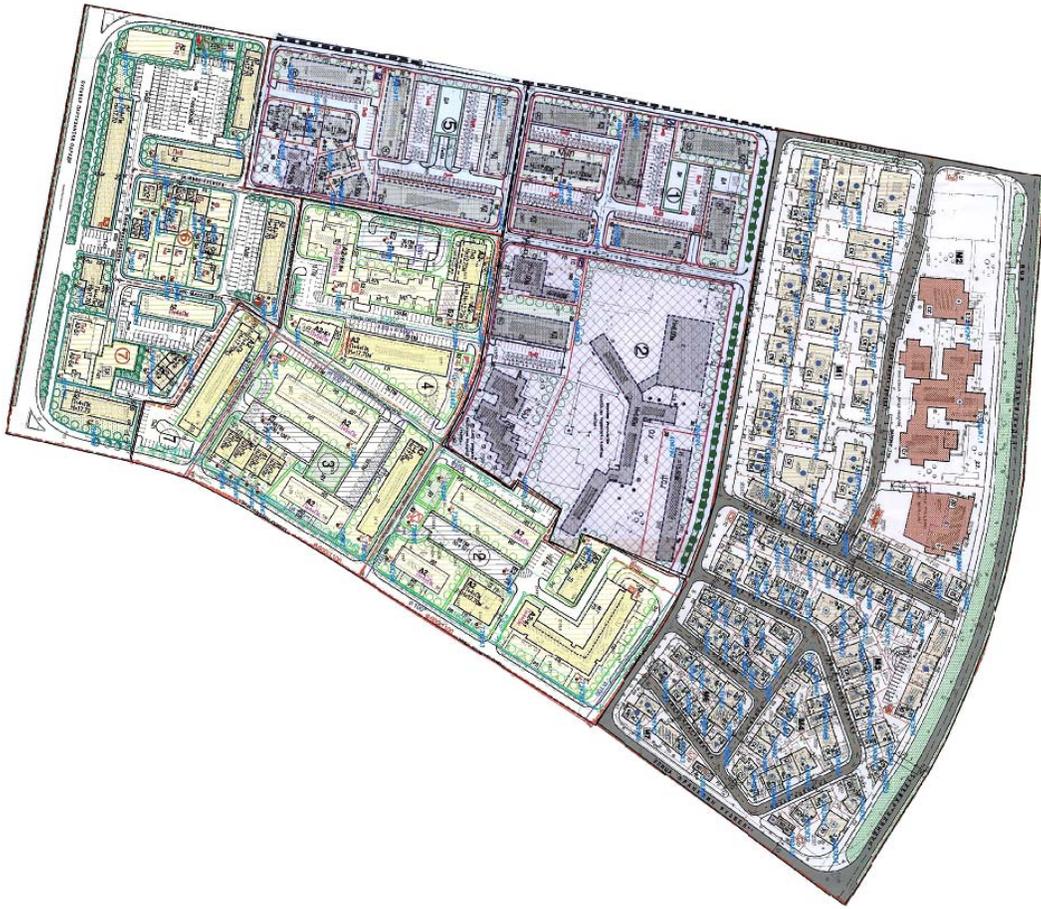
Figure 4. Karposh Municipality with marked blocks

A visual inspection of 161 structures was performed along Partizanski Odredi Str., Franklin Roosevelt Str, Ilindenska Str. and Nikola Tesla Str. This location consists of 14 individual blocks marked as Block 1, Block 2, Block 3, Block 4, Block 5, Block 6, Block 7, Block M1, Block M2, Block M3, Block M4, Block M5, Block M6 and Block M7.

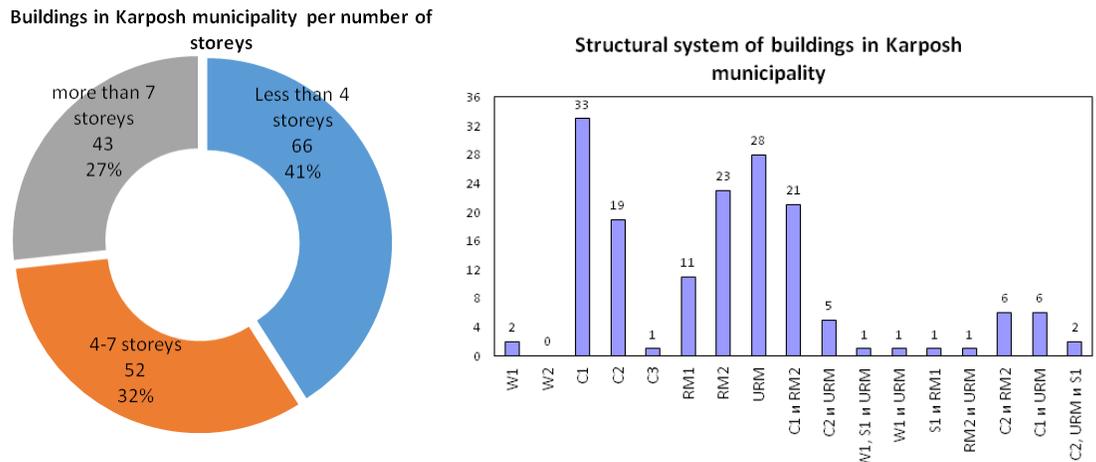
Figure 6: Review of structures in Karposh municipality classified according to a) number of storeys and b) structural system

Out of these, 161 structures, 66 structures (41%) have up to 4 storeys, 52 structures have 4 to 7 storeys (32%) and a total of 43 structures with over 7 storeys (27%), Fig. 6a. Most of the structures, 33 structures (20%) represent reinforced concrete frame structures, 28 structures (17%) represent masonry structures without reinforced concrete belt courses, 23 structures (14%) represent masonry structures with rigid floor structures, 21 structures (i.e., 13%) represent a combination of a reinforced concrete structural system and a masonry structure with rigid floor structures, 19 structures (i.e., 12%) represent a mixed reinforced concrete system (frames with walls), while the remaining structural systems are

present less than that: 11 structures represent masonry structures with flexible floor structures, 6 structures represent a combination of a mixed reinforced concrete system (frames with walls) and a masonry structure with a rigid floor structure, 5 structures represent a combination of a mixed reinforced concrete system (frames with walls) and a masonry structure without reinforced concrete belt courses, 6 structures represent a combination of a frame structure and a masonry structure without reinforced concrete belt courses, 2 structures represent timber structures, 2 structures are a combination of a mixed RC system (frames with walls, masonry structure without RC belt courses and a steel frame), 1 structure is a concrete structure with unreinforced infill, 1 structure is a combination of a wood structure, a steel frame and a masonry structure without RC belt courses, 1 structure is a combination of a steel frame and a masonry structure with flexible floor structures, 1 structure is a combination of a timber structure and a masonry structure without RC belt courses and 1 structure is a combination of masonry structure with rigid floor structures and a masonry structure without RC belt courses (Fig. 6b).

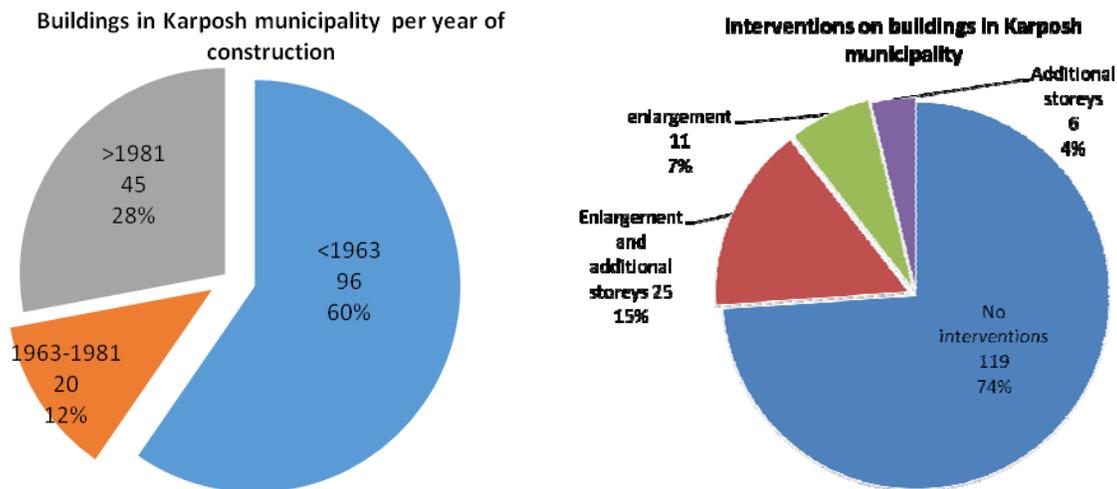
Figure 7: Review of structures in Karposh municipality classified according to a) year of construction and b) year of interventions

Classification of the building structures in the Karposh municipality according to the year of construction is presented in the Fig.7a and according to the year of interventions in the Fig. 7b.

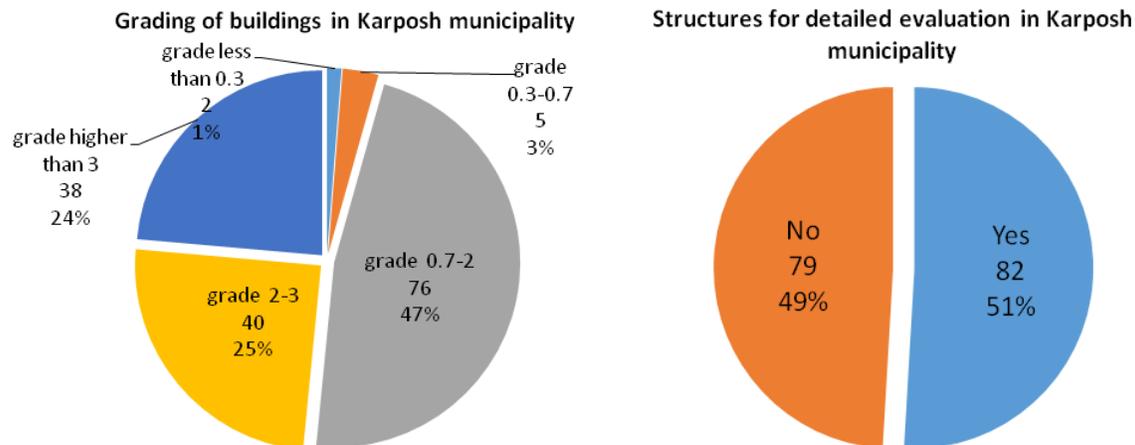
Figure 8: Review of structures in Karposh municipality. a) classified according to grades obtained from the evaluation and b) classified according to whether they need a detailed evaluation

Expected damage potential for the building evaluated according to the rapid visual inspection methodology presented in this paper is presented in Fig. 8a. Classification according to whether the structures need a detailed evaluation is presented on Fig. 8b.
