## A STUDY ON SEISMIC BEHAVIOR OF MECHANICAL COUPLINGS FOR FIRE PROTECTION SPRINKLER PIPING SYSTEMS IN HOSPITAL

### ABSTRACT

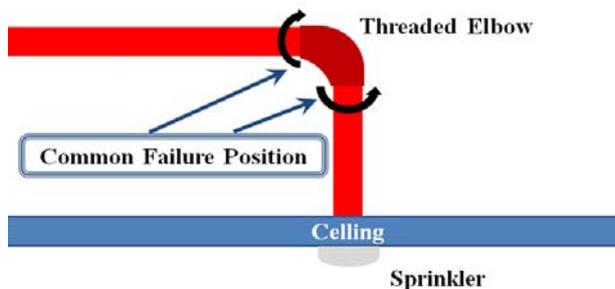
Figure 2. Common Failure in Screwed fittings

Among the numerous problems due to seismic damage of nonstructural components, water leaks or flooding resulting from broken sprinkler piping systems is an important issue for hospitals because of the effect of water damage on the suspended ceiling systems and other room fixtures associated with medical functionality. The earthquake experiences show that piping rarely collapsed entirely, but once the first leak occurs in fire protection sprinkler system, amount of water will flow out and cause flooding, secondary injury, and loss of medical function. Such damage occurred at the Olive View Medical Center, the Holy Cross Medical Center, and Northridge Hospital in the San Fernando Valley during the 1994 Northridge earthquake (G&E, 2009). From a literature review of earthquake damage, common failures of sprinkler piping systems occur at the screwed fittings, anchorages, and sprinkler heads. As shown in Fig. 2, the most frequently seismic damaged part of the sprinkler piping systems is the screwed fittings of the small-bore drops neighboring suspended ceiling systems (Ju et al., 2011; Arash et al., 2012). An example was observed in a critical hospital during the 2010 Jiashian earthquake in Taiwan, where a reduction of medical functionality was caused by flooding due to a broken small-bore pipe of the sprinkler system (Fig. 3).

Based on the aforementioned experiences, the seismic damages to the screwed fittings might result from the excessive angular movement or surging shear loadings. According to NFPA13 (NFPA, 2010), the “flexible joints” are regarded as seismic resistance devices for piping joints to accommodate excessive angular movement induced by strong earthquakes. Following the definition in NFPA 13, hereinafter a flexible joint is the one that allows axial displacement, rotation, and at least 1 degree of angular movement of the pipe without inducing harm on the pipe.

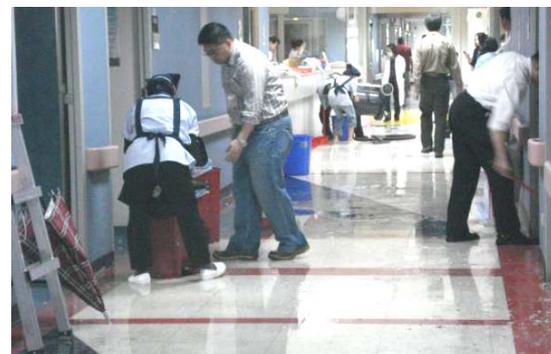
Figure 3. Flooding at a hospital caused by the leakage of the sprinkler system.

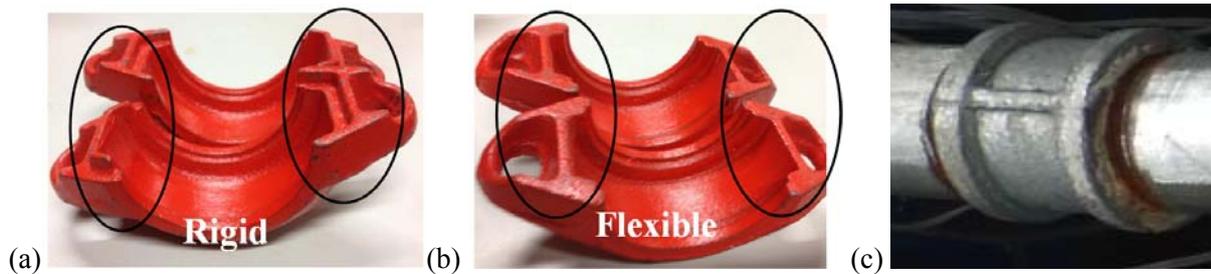
Figure 4. Piping joints: (a) rigid and (b) flexible mechanical joints; (c) screwed fitting.

Grooved couplings belonging to mechanical joints are the common types of flexible joints (Fig. 4b). As mentioned in the section C13.6.8 of the 2010 edition of ASCE 7 (ASCE, 2010), couplings could be recognized as flexible joints through the seismic evaluation as specified by FM 1920 (FM Approval LLC, 2007). However, the dynamic performance of flexible couplings presented in the shaking table tests of a partial piping system was unanticipated (Lin et al., 2014). In order to improve

The structural integrity performance of flexible mechanical joints was superior to rigid ones. Although the rigid joints provided higher stiffness due to the tighter shape of the recess of couplings (Figure 4a), the houses were broken at the same time of first leakage. On the other hand, the structural integrity of flexible mechanical joints maintained after leakage until the loading achieved the ultimate displacement ( $v_u$ ) obtained from monotonic testing. The damage state of flexible joints was that the grooved pipes were separated from housings (Figure 9b and 9c).

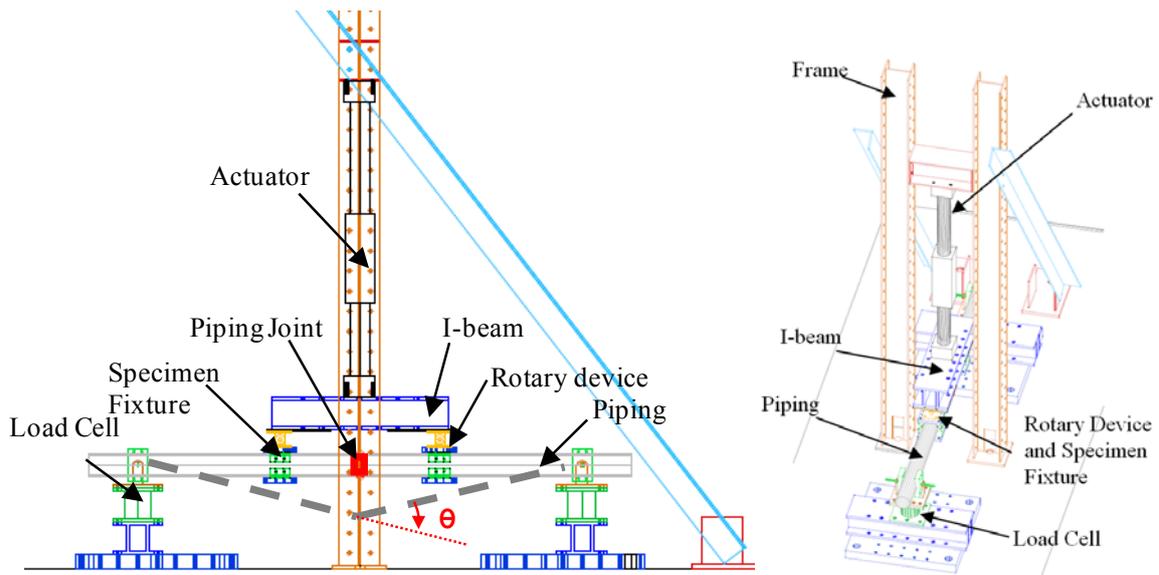
Figure 5. Configuration of bending tests in front view and isometric view

Figure 5 and Figure 6 depict the configuration for cyclic pure bending tests. Based on the four-point configuration, the tested piping joint at the middle of each specimen was subjected to a cyclic pure bending under displacement control. From top to bottom, the test configuration was composed of a reference frame with a height of 5.0 m, a 25-ton capacity hydraulic actuator, a force-adapter assembly connecting the actuator to the tested specimen, the tested specimen with internal pressure approximately equal to the rated working pressure of  $7.0 \text{ kgf/cm}^2$ , a hinge support at one side of the specimen and a roller support at the other side, and one load cell under each support. Although the maximum distance between hangers specified in NFPA 13 are 3.66 m and 4.57 m for 1.0 in. pipe and 1-1/4 in. pipe or larger respectively, the support spacing in the test was adjusted to be 3.0 m for all sampled pipe dimensions based on the space limitation of the laboratory.

In order to apply vertical forces without imposing additional moment upon specimens, the force-adapter assembly between the actuator and the specimen was composed of a horizontal I-beam with a length of 1.3 m, rotary devices and specimen fixtures. Pure bending area was formed between the specimen fixtures with a center-to-center distance of 1.15 m. In addition, as a result of the significant stress concentration effect on the loading points for 1.0 in. pipe, the specimen fixtures were replaced with U-bolts to mitigate the imposed deformation within the fixture contacting area.

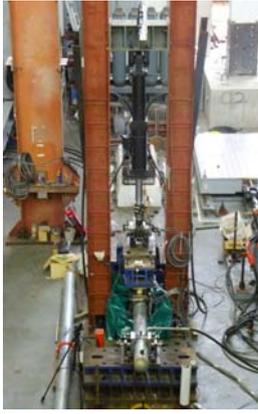
Figure 6. Actual test configuration

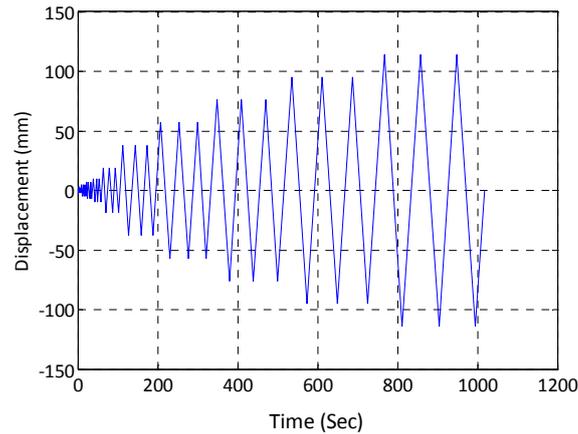
Figure 7. Input motion of cyclic testing for CSP6 specimens

The fragility of piping joints were investigated under monotonic and cyclic pure bending loads. According to the cyclic displacement schedules proposed by ISO-16670 (ISO, 2003), the loading protocol was designed based on the ultimate displacement ( $v_u$ ) obtained from monotonic testing. Figure 7 depicts an example of cyclic loading protocols of fragility testing and the amplitude of each reversed cycle in the percentage of  $v_u$ . The reverse loading with each amplitude was applied for three cycles. The amplitude of the loading protocol varied from 1.25% of  $v_u$  to 120% of  $v_u$ .

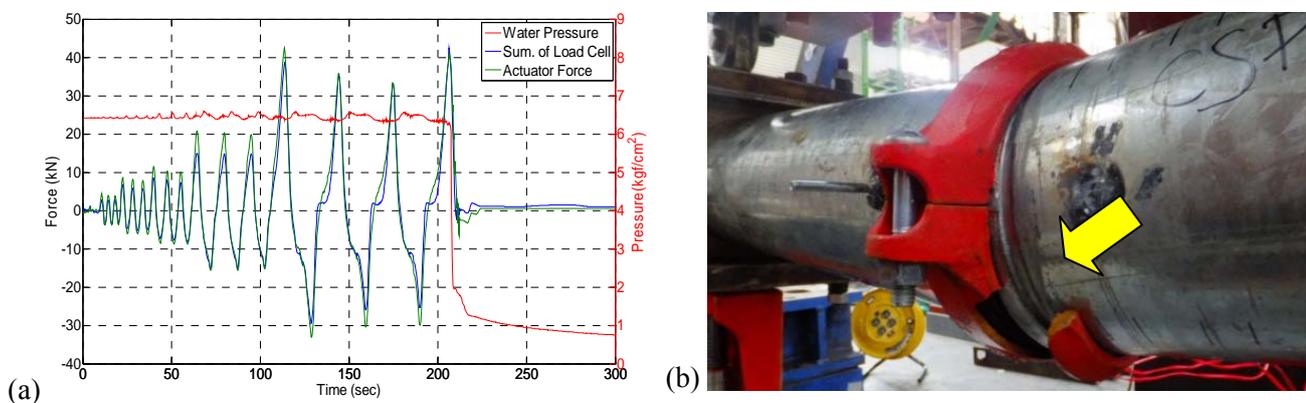
Figure 8. Test results of CSP6-RIG: (a) Loading and water pressure; (b) The damage state at first leakage.

In terms of the first leakage performance, the rigid and flexible mechanical joints presented quite close capacity in the fragility tests under pure bending loads. Figure 8a and 9a depict the time series of the contained water pressure, the applied actuator force and the summation of vertical reaction forces measured by load cells in two examples of the fragility tests for 6 in. rigid mechanical joints (CSP6-RIG) and 6 in. flexible mechanical joints (CSP6: FLX) respectively. The rigid and flexible joints leaked at similar testing time namely similar angular loading, which were 4.45 degree and 4.65 degree respectively. However, the damage states at the first leakage of two kinds of joints were quite different. As shown in Figure 8b, the rigid mechanical joint leaked owing to the broken housing. However, the leakage at flexible joints resulted from the gap between gasket and grooved pipe, not the damage of coupling or piping.

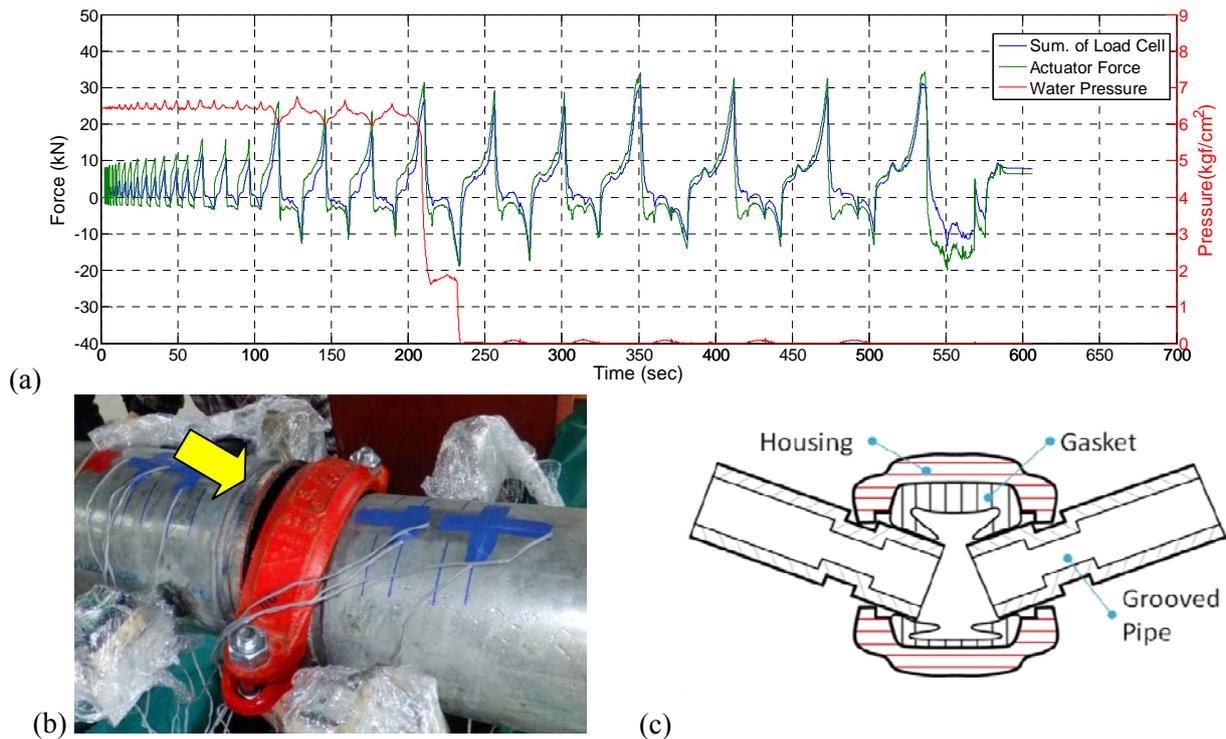
Figure 9. Test results of flexible coupling specimens: (a) Loading and water pressure; (b) The damage state of structural integrity; (c) The cross section sketch of the damaged coupling.

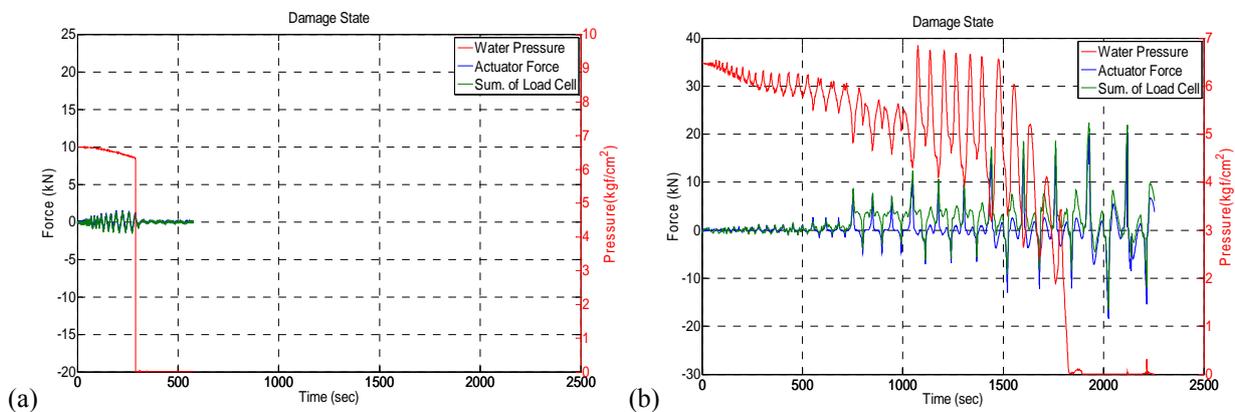
Figure 10. Loading and water pressure during tests: (a) screwed fitting; (b) flexible coupling.

In the case of piping joints for 1 in. pipe, the flexible couplings could resist much higher moment imposed under cyclic pure-bending loading against both the first-leak and structural-failure states compared with the performance of screwed fittings. Figure 10 depicts the time series of the contained water pressure, the applied actuator force and the summation of vertical reaction in two examples of the fragility tests for flexible mechanical joints and 1 in. screwed fittings. The water pressure of the pipe with flexible coupling reversely changed without leakage under cyclic pure-bending loading, while the one of the pipe with screwed fitting remained stable but suddenly dropped at the rotation angle ( $\theta$ ) of  $1.35^\circ$  due to the damaged thread of the fitting (Fig. 10 and Fig. 11a). Among three tested samples of flexible coupling for 1 in. pipe, only one failed at the rotation angle ( $\theta$ ) of  $18.4^\circ$  owing to the separation of the coupling from the piping, while no structural damage occurring on the coupling and piping (Fig. 11b).

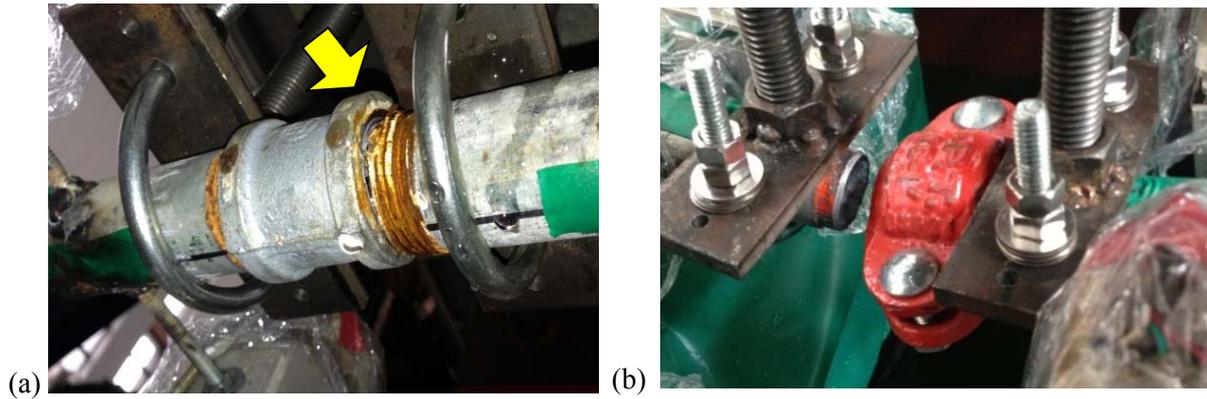
Figure 11. Damage states under pure bending loads: (a) screwed fitting; (b) flexible coupling.

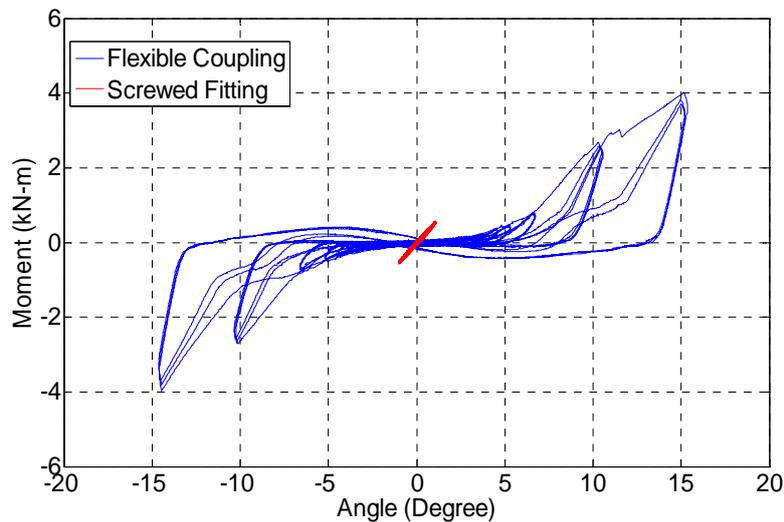
Figure 12. Moment- $\theta$  curves of a flexible coupling and a screwed fitting with piping diameters of 1 in.

Figure 12 depicts the Moment- $\theta$  curves for two types of joints under cyclic pure-bending loading. The stiffness of the screwed fitting is about 1657.85 kN-m/degree. For flexible couplings, the behavior of the hysteresis curve can be simulated by a bi-linear model with stiffness of 81.93 and 2853.33 kN-m/degree for the first and second linear ranges respectively. The dramatically increasing stiffness was owing to the contact of two separated housings and the resulted higher stress may cause the failure of piping with such flexible couplings as observed in the shaking table tests (Lin et al., 2014).

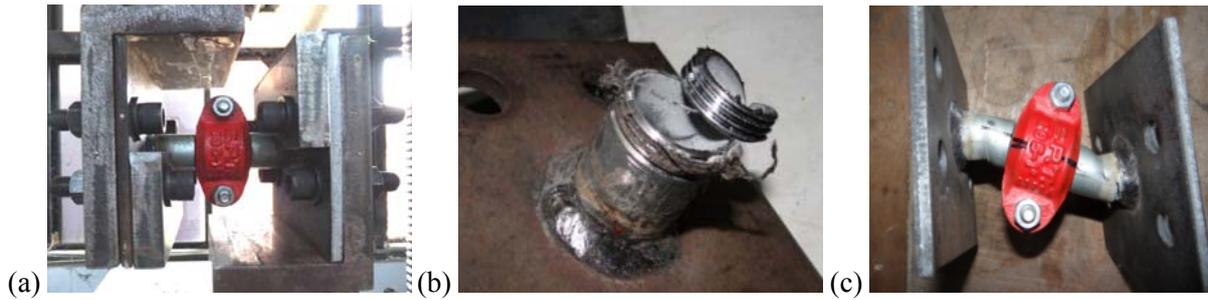
Figure. 13 Shear tests: (a) configuration; damages of (b) screwed fitting; (c) flexible coupling.

In addition to pure-bending tests, the monotonic shear tests for screwed fittings and flexible couplings of 1 in. diameter piping were conducted to further investigate the shear capacity of piping joints (Fig. 13a). From the force-displacement curves of shear tests in Fig. 14, it can be seen that the initial stiffness of screwed fittings is higher than that of flexible couplings; however, these screw fittings were damaged with brittle failures under shear force. Table 2 shows the average and associated standard deviation ( $\sigma$ ) of strength and initial stiffness determined from the pure-bending or shear force tests. The moment strength of screwed fittings at leakage point can be also regarded as their ultimate strength. The ultimate shear strength of the flexible coupling is not adopted since the damage in the test occurred at the piping or at the welding between piping and adapter plates, but not on the coupling itself (Fig. 13c).

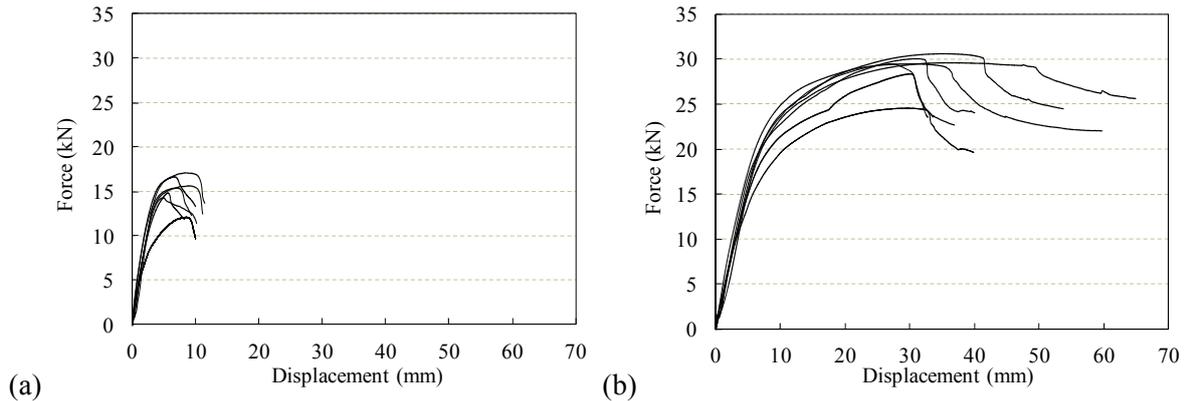
Figure. 14 Force-displacement curves: (a) screwed fitting; (b) flexible coupling.

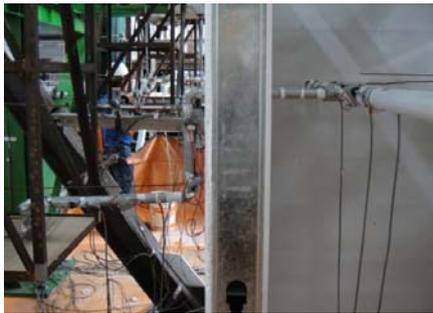
Figure 15. Configuration of the shaking table test

There is an experiment in NCREE to simulate the piping system of the hospital shown in Figure 15 (Kuo et al., 2012). The results of this experiment determine the dynamic characteristics and seismic behavior of the hospital sprinkler piping system. Various failure modes can be observed in this experiment, the slip of hanger, the damage of ceiling and partition wall and the rupture of screwed

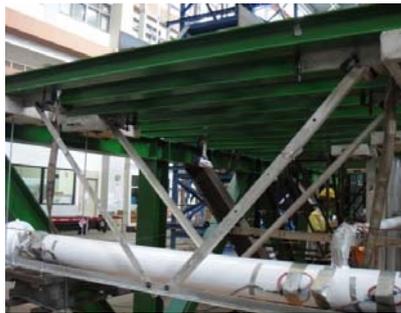
Figure 16. Damaged screwed fitting

fitting which causes leakage, shown in Figure 16. This study established SAP2000 numerical model shown in Figure 17, and used dynamic analysis to simulate the experimental results of the research.

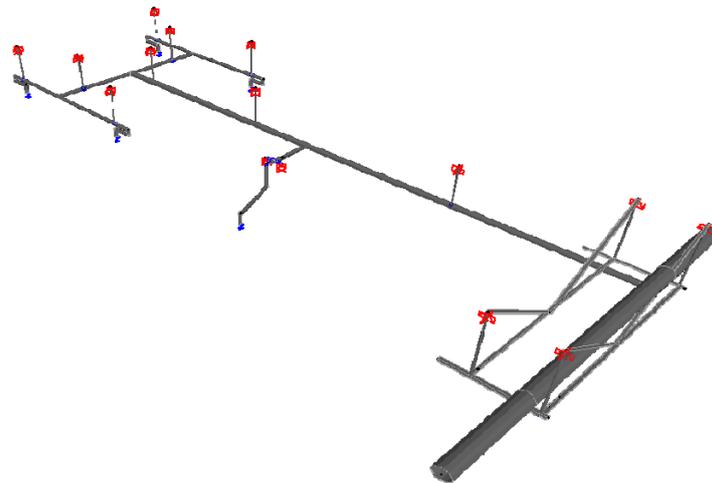
Figure 17. The numerical model simulating the specimen in shaking table tests

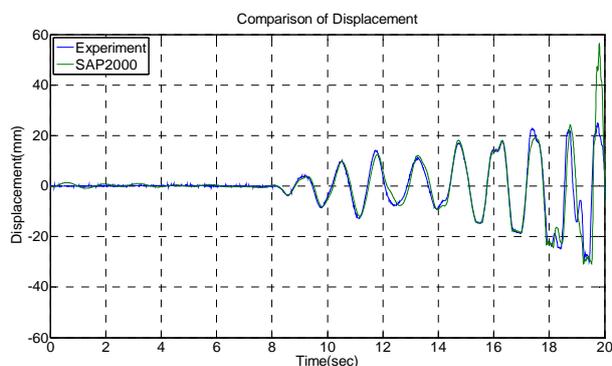
Figure 18. Time series of displacement

Use SAP2000 to simulate this experiment and changing the system partition wall with GAP-Link to, and the displacement of failure point shown in Figure 18, it can be seen 19.8 seconds the simulation is great but after 19.8 seconds the model can't capture the displacement from experimental. It could be the joint destruction and lose its strength. However, in 19.4 seconds at the moment the value shown in Figure 19, has been implemented over the threaded couplings moment capacity 590 kN-mm of cyclic experiment. From the parameters analysis of the vibration table, stiffness of partition wall is about 0.4 kN/mm. In addition, in this linear dynamic analysis simulations, the T-joints bending moment is larger than its capacity of the cyclic experiment, and elbow bending moments and not. It is same as shaking table test results.

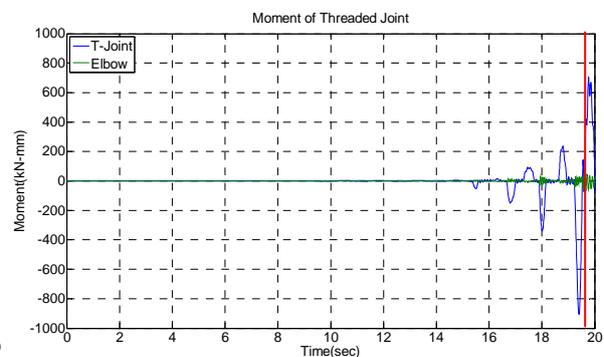
Figure 19. Time series of internal moment

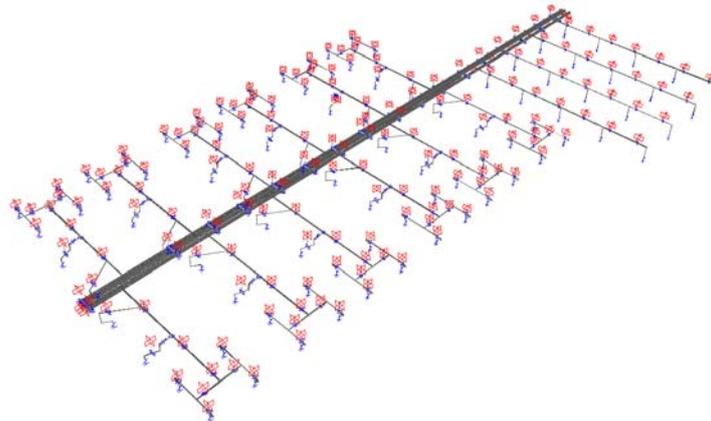
Figure 20. The numerical model of the horizontal piping system

In the dynamic analysis, the strength from ceiling to the sprinklers of the pipeline is hard to capture in the earthquake. Therefore, the parameter analysis is well to analysis the kind of situation. Figure 20 is for the whole hospital piping system model. Table 3 is for the model without partition walls in the parametric analysis. In Case 1 and Case 6 frequency of 1.53Hz frequency of 4.18Hz, and then to change the ceiling sprinklers stiffness to let the frequencies fall in 2, 2.5, 3, 3.5 Hz. When the beam is completely free from the sprinkler system, its displacement of elbows is up to 30 cm, which was unreasonable; And when the ceiling for sprinkler stiffness increases, the moment of joints are rising and then began to decline. Then join the effect of partition wall and set the spacing is 10 mm. The results are shown in Table 4. After adding partition walls, the displacement was decreased.
