THE COLLAPSE OF THE ANCIENT TEMPLE OF ZEUS AT OLYMPIA REVISITED.

ABSTRACT

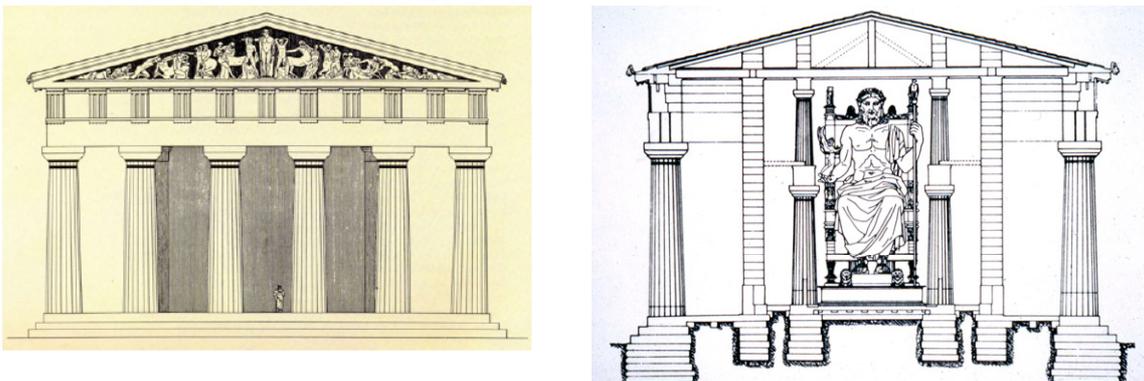
Figure 1 Reconstruction of the West façade of the temple of Zeus and of a cross section

The Temple of Zeus was built from 470 to 456 BC within the sanctuary of Zeus at Olympia, under the direction of the Elean architect Libon. It was the largest Temple of the antiquity in the Peloponnese and later (circa 430 B.C.) it housed the renowned chryselephantine statue of Zeus, sculpted by Pheidias (figure 1). The peristyle of the temple consisted by 6×13 columns, about 10.43 m high and measured 27.5×64.1 m. The temple itself was over 20 m high (figure 1). Within the peristyle were the pronaos (front porch), cella (central room) and opisthodomos (rear porch) built by large limestone blocks. Two rows, each of 7 Doric columns, divided the cella into 3 aisles (see cross section in fig. 1). The platform (crepis), where the temple was standing, is 27.68 m by 64.12 m in size (figure 2) and has 3 unequal steps. The crepis was built on a foundation 2.50 m deep, presumably to reach competent ground. The temple was built by local shelly limestone covered with stucco. It stood at its place for almost a thousand years, saw moments of glory as it was the center of the Olympic festivities and suffered damages induced by natural disasters as well as warfare, invasions and looting.

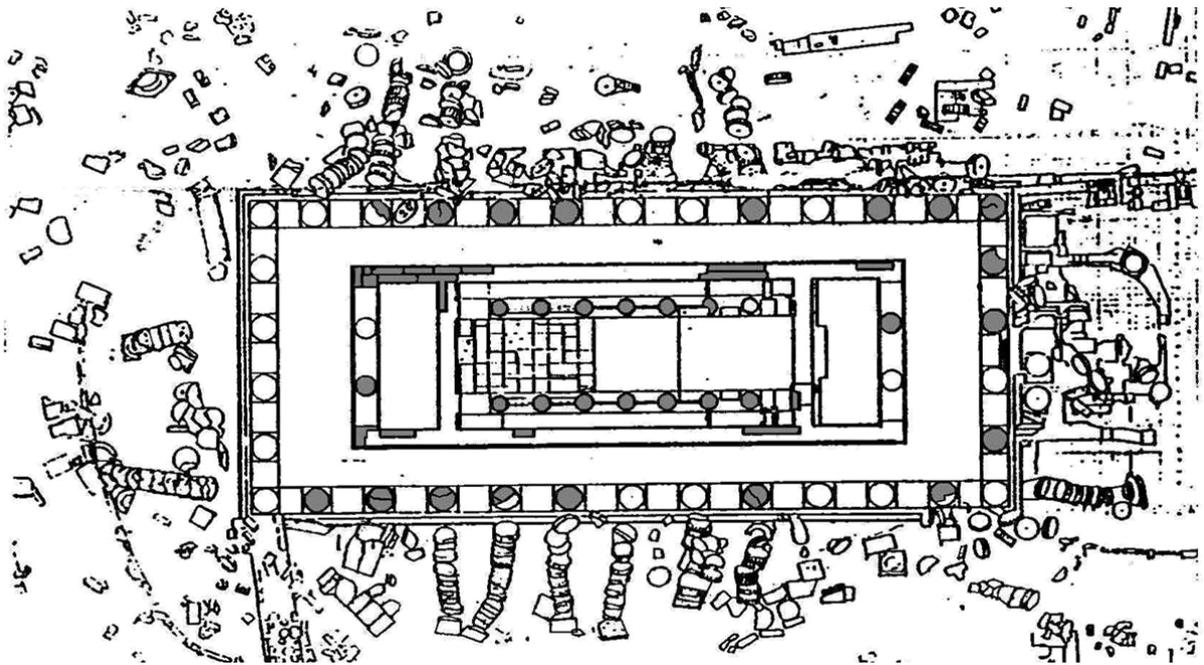
Figure 2. The ruins of the Temple of Zeus as discovered during the excavations of the last quarter of the 19th century undertaken by the German Archaeological School (Curtius and Adler 1892)

earthquake stroke, produced such a pattern of fallen debris. In figure 2 it can be observed that six of the columns of the southern flank were found overturned straight to the south, while five of the columns of the northern flank have been toppled to the North. Moreover, two of the columns of the western flank are found overturned to the west and one of the columns of the East flank to the east. Not a single column was found overturned towards the interior of the peristyle. It might be postulated that the superstructure elements and the temple roof might pushed the columns in an outward direction and is responsible for this radial arrangement of the fallen columns. But where are the superstructure elements? The cella wall blocks, as well as almost all of the frieze blocks, were never found on site, which means that either before or after the collapse of the temple the debris have been extensively robbed. A reasonable answer is that the blocks that were fit for second use were removed and used probably for other constructions and only the enormous cylindrical column drums, that was difficult to cut or move, were abandoned on site.

By examining the fallen columns of the temple of Zeus, one can also observe that in 18 from the 34 columns of the peristyle the bottom drum (gray shaded in figure 2) was found in place, and that the crepidoma is also intact. Most drums of the fallen columns are also intact and hence we can safely conclude that the undermining technique was definitely not used in Olympia. The other method to overturn the columns is to pull them down by ropes and pack animals (figure 16). Given the size of the columns of the temple of Zeus at Olympia and their low aspect ratio it would be required a significant effort and resources for such an endeavor. Each column weights approximately 80 tons and with a slenderness ratio of 4.73 a horizontal force of 17 tons would be required under static conditions to overturn them. A single column would require at least 16 of the strongest horses and at least 10 strong oxes to apply such a force. The provision of the animals as well as the necessary ropes for such an operation would require a considerable preparation and organization.

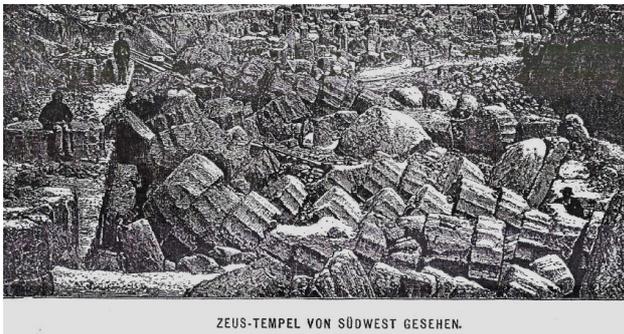
Figure 3 The fallen columns of the temple of Zeus as unearthed during the archaeological excavations of the last quarter of the 19th century (Curtius and Adler 1892).

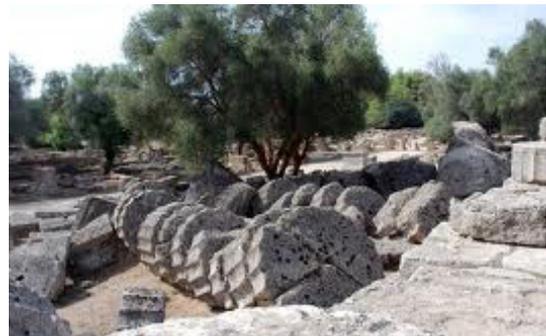
Figure 4 The fallen columns of the temple of Zeus as they are preserved today.

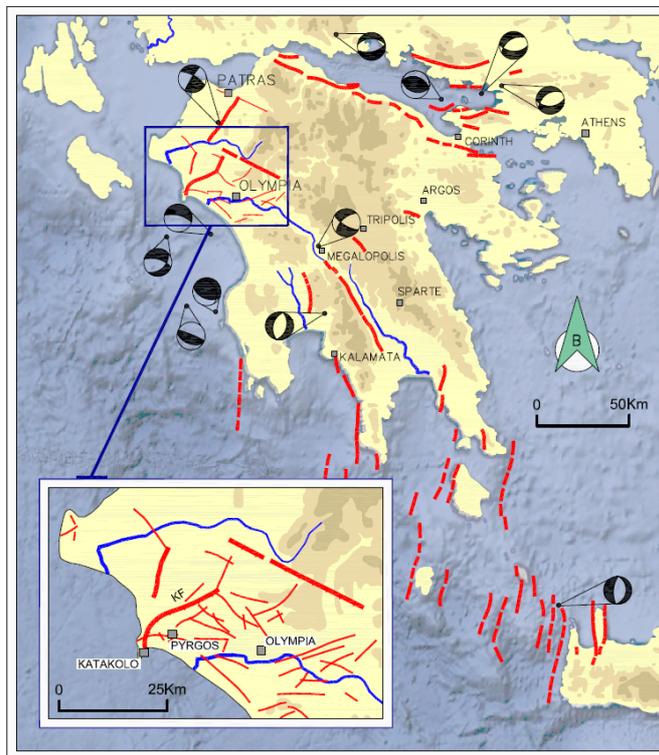
Figure 5. Upper figure: Tectonic setting for the Hellenic subduction zone Thick dark lines with solid bars indicate active trenches, Orange shading indicate the zones of active oblique extension. (Royden and Papanikolaou 2011)

The tectonic activity which controls the seismic hazard in South-Western Greece is dominated by two mechanisms: thrusting along the western part of the Hellenic Arc and extension at the interior of the Arc. The first mechanism is associated with large but infrequent earthquakes, which may have affected the site from a distance, while the latter is associated by more frequent small to medium size events with a potential to affect the site from very short distances. Figure 5 depicts the major tectonic features of the Aegean arc and highlights the regions at the interior of the arc which undergo the most rapid extension, while figure 6 presents the major known active faults of the Peloponnese compiled by Lyon-Caen et al. (1986) and Lekkas et al., (1994). The site of ancient Olympia is situated within the Alphios river tectonic graben, a similar tectonic structure but significantly less active, to the Corinth gulf graben. The Alphios river graben is bounded by E-W and NE-SW trending normal faults. The length of these active faults does not exceed 25-30 km and the expected maximum earthquake magnitudes are limited to 6.0 to 6.4. The inset of figure 6 depicts the location of the Katakolo fault (KF) located at a distance of 12-15 km from the site of ancient Olympia which is the most active tectonic structure at the vicinity of the Olympia site (Lekkas et al., 1993). Offshore to the west lie the Hellenic trench where larger thrust faults are capable of producing stronger earthquakes of magnitude 7.0-7.2. These faults are difficult to map and can only be traced by offshore geophysics and microearthquake surveys. Fault plane solutions of earthquakes along the arc as well as in the back arc area are presented on the map of figure 5. Intermediate depth earthquakes also occur on the subducting slab of the African plate underneath the Peloponnese. The 1962 Corinthos earthquake ($M=6.8$), the 1964 Messenia earthquake ($M=6.0$), as well as the 2006 Kithira island earthquake ($M=6.7$) are good examples of such events. The intermediate depth earthquakes are characterized by an attenuation pattern and strong motion frequency content significantly different to the shallower events.

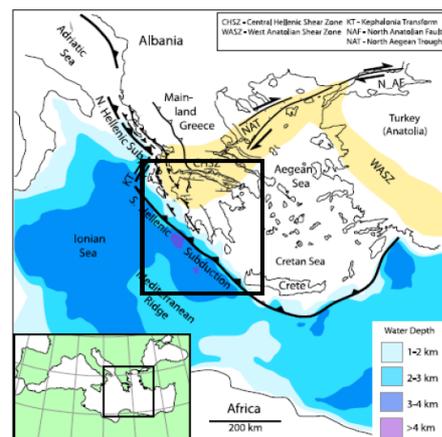
Figure 6. Left figure: Active faults in the Peloponnese. The selected fault plane solutions depicted in the figure indicate the predominant tectonic stress field of the crust.

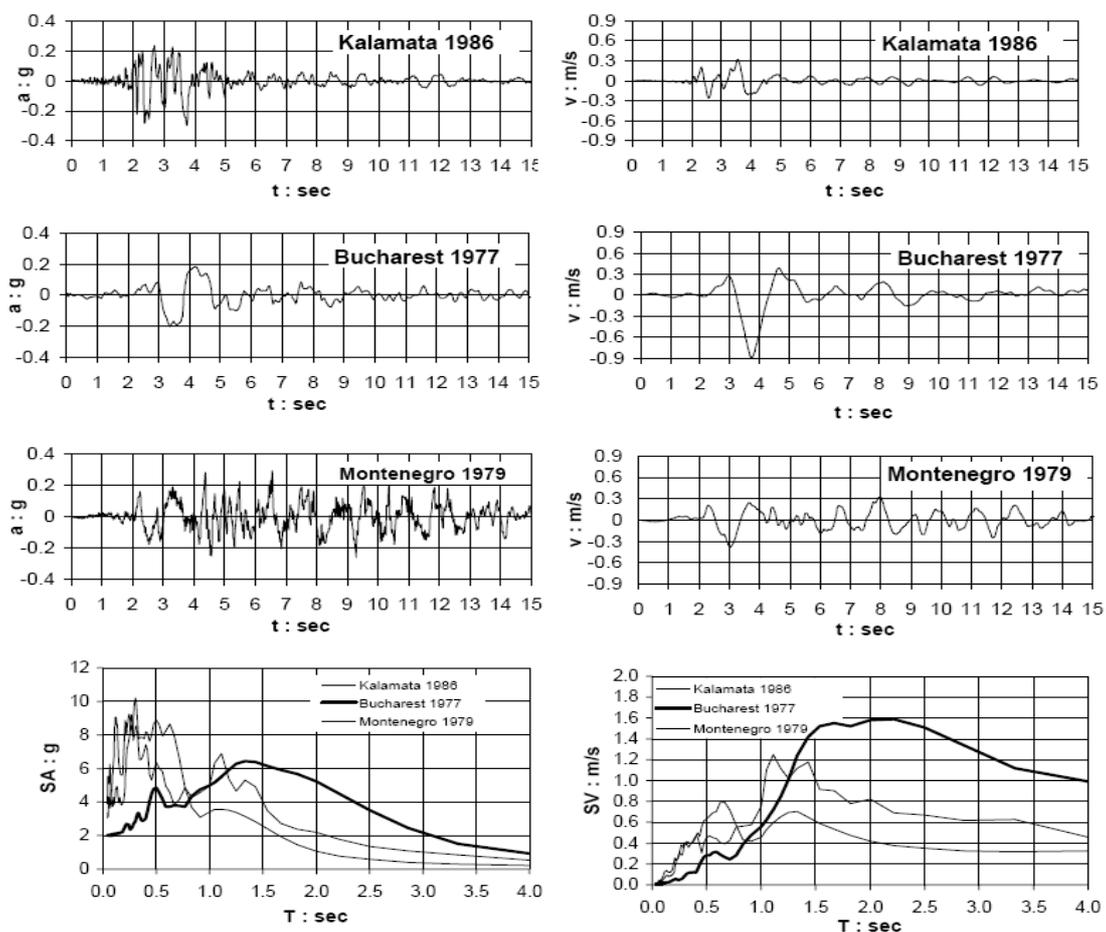
Figure 7. The stronger component of the three records used in the analyses and corresponding response spectra

We deliberately selected records with a strong impulsive character, attributed to directivity effects, because it is well known from previous studies on the seismic response of ancient columns (e.g. Psycharis et al. 2000) that such structural systems are more vulnerable to long period pulses. The acceleration and velocity time histories of the strongest component of the selected records are presented in Figure 7 along with their response spectra. The earthquake records and the relevant metadata were taken by the Ambraseys et al., (2000) strong motion record collection.

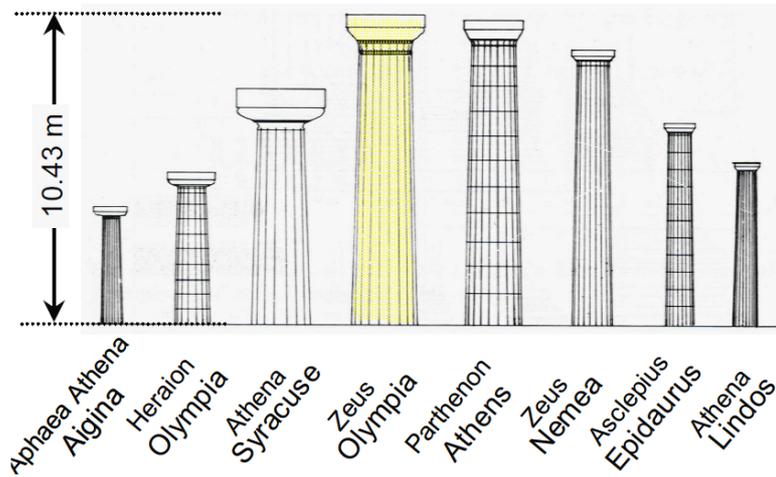
Figure 8. Comparison of a typical column of the temple of Zeus at Olympia with columns from other classical Doric temples (after Müller-Wiener 1988)

In figure 9, on the basis of the safe-unsafe boundaries derived by Jhang and Makris (2001), we compare the safety of the “equivalent single blocks” of all the Doric style columns presented in figure 8, when subjected to a cosine and a sine pulse of $a_g=0.5g$ and $T_p=0.8$ sec and $a_g=0.3g$ and $T_p=1.5$ sec. The first case grossly represent the directivity pulse of a small earthquake at short site to source distances and the latter the directivity pulse of a larger earthquake at larger distances. It is observed that the larger columns (Zeus at Olympia, Zeus at Nemea, Athens Parthenon) are less likely to overturn because of their lower p values (where $p = \sqrt{3g/(4R)}$ and $R = \sqrt{b^2 + h^2}$ = half diagonal of the block-a measure of its size). Moreover, the relatively small aspect ratio of the columns of the temple of Zeus at Olympia classifies them among the most resistant between the columns shown in figure 8. On the basis of this comparison, under single strong motion pulses of duration longer than 1.5 sec and

amplitude higher than 0.3g, most of the columns shown in figure 8 are likely to overturn if they behaved monolithically.

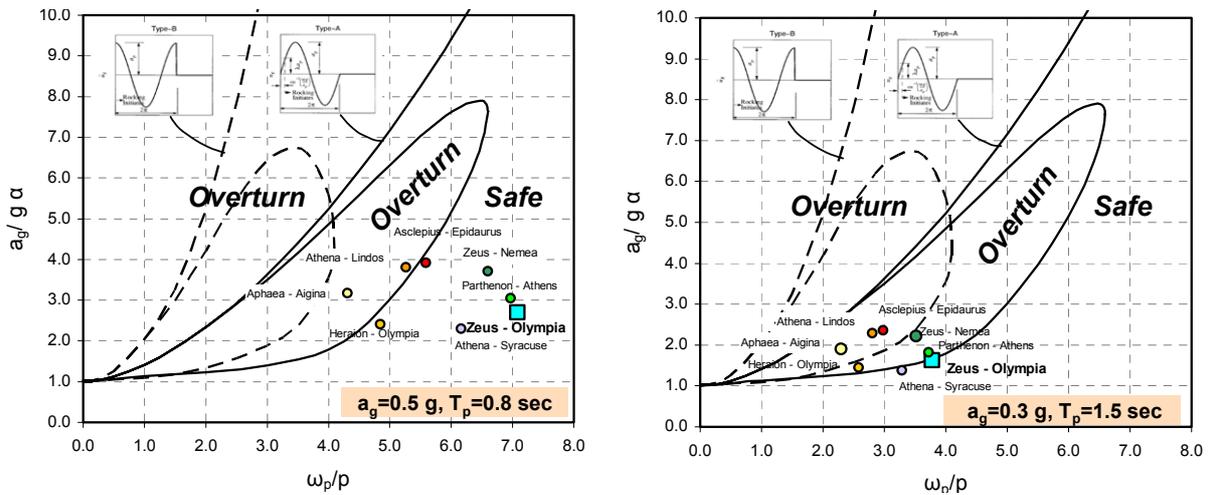
Figure 9. Safety against overturning for cycloidal pulses of single free standing blocks with the aspect ratios of the columns presented in figure 8. **Left chart:** safety margins to a pulse (sine or cosine) with $a_g=0.5g$ and $T_p=0.8$ sec. **Right chart** safety margins to a pulse with $a_g=0.3g$ and $T_p=1.5$ sec. The excitation amplitude of the cycloidal pulse is normalized to the overturning angle of the block under static conditions $\alpha=\tan^{-1}(b/h)$.

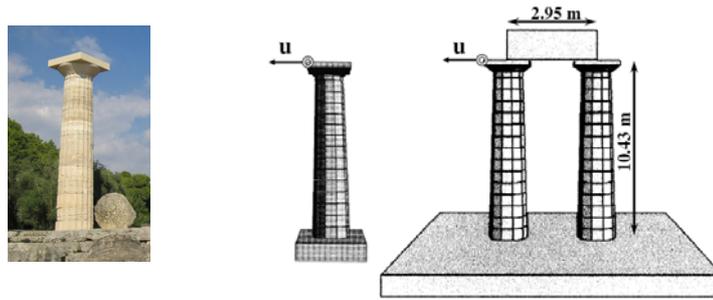
Figure 10. 3DEC single and two-column models used in the analyses. A recently restored column of the temple is shown on the left.

Despite the valuable insight provided by analytical treatment of the rocking response of rigid blocks, numerical analysis of such systems is more flexible and can handle complex 3 dimensional multi-block columns subjected to real earthquake excitations. The distinct element method in particular, which was selected here for our analyses, has been employed in the past (Psycharis et al. 1998, Psycharis et al. 2000, Psycharis 2007, Psycharis et al. 2013), to simulate the dynamic response of multi-drum column assemblies, with satisfactory results. Although the dynamic response of such systems is very sensitive to initial and boundary conditions, it has been acknowledged that distinct element models do capture the most significant aspects of real dynamic behavior, as compared by observed response during shaking table tests (Papantonopoulos et al. 2002, Papantonopoulos et al. 2009) does not suffer from compromises on reproducing the details of a real life multi block assemblies comprising ancient monuments. In the context of the present investigation, models of a single free standing column as well as a pair of columns coupled by an architrave (limestone slabs) were set up and analyzed by the commercially available distinct element code 3DEC (Itasca Consulting Group). The numerical models presented in figure 10 are used not only as a means to constrain the strong motion level necessary to overturn the columns, but also to investigate the mode of collapse and to predict the final location of the fallen column which can be compared directly to their position in the archaeological site. The modeling methodology and the material model parameters are similar to the ones presented by Psycharis (2007).

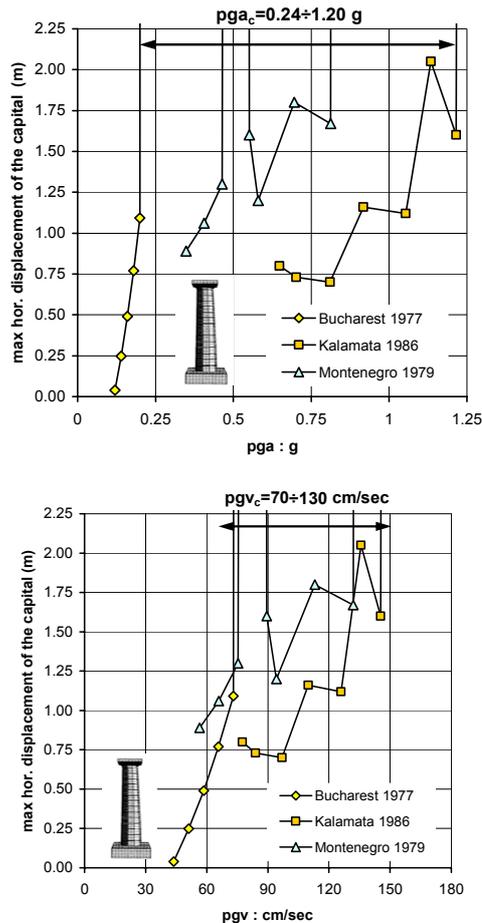
Figure 11. Maximum horizontal displacement registered at the top of a free standing column model versus pga and pgv of the scaled records.

A series of 3-dimensional dynamic analyses of the single column model, subjected to the earthquake records selected in the previous paragraph, was performed by gradually scaling them up until instability of the column is reached in order to bracket the strong motion intensity necessary to overturn the columns and to study the mode of rocking. Figure 11 summarizes the results of these numerical analyses, in the form of maximum response displacement of the capital versus the peak ground acceleration and peak ground velocity of the excitation. The free standing columns of the temple of Zeus overturn for a peak ground acceleration of 0.24 to 1.20 g, depending on the period of the directivity pulse contained in the record and for a peak ground velocity of 70-130 cm/sec. The peak ground velocity is better correlated to the maximum rotation of the column and is a better indicator of the overturning potential of the record as suggested also by other researchers in the field (Makris and Roussos 2000). The strong motion of a small local earthquake, like the Kalamata 1986 earthquake, is unlikely to overturn a free standing column, since the Kalamata record should be scaled up almost by a factor of 4.5(!) to overturn it. Likewise the Montenegro 1979 record should be scaled up by a factor of 1.8 to overturn a free standing column. On the other hand the Bucharest 1973 record represent a more realistic scenario, since it overturns the column almost without scaling. With respect to the mode of rocking, for all the examined records, the column generally rocks vigorously and loses its upper 5 to 10 drums, but with no exception a number of the lower drums remain in place, as shown in figure 12. It is stressed out at this point that in the archaeological site only the first drum was found in place on the temple platform (crepis). All the other column drums lay in a domino-like fashion aside the temple.

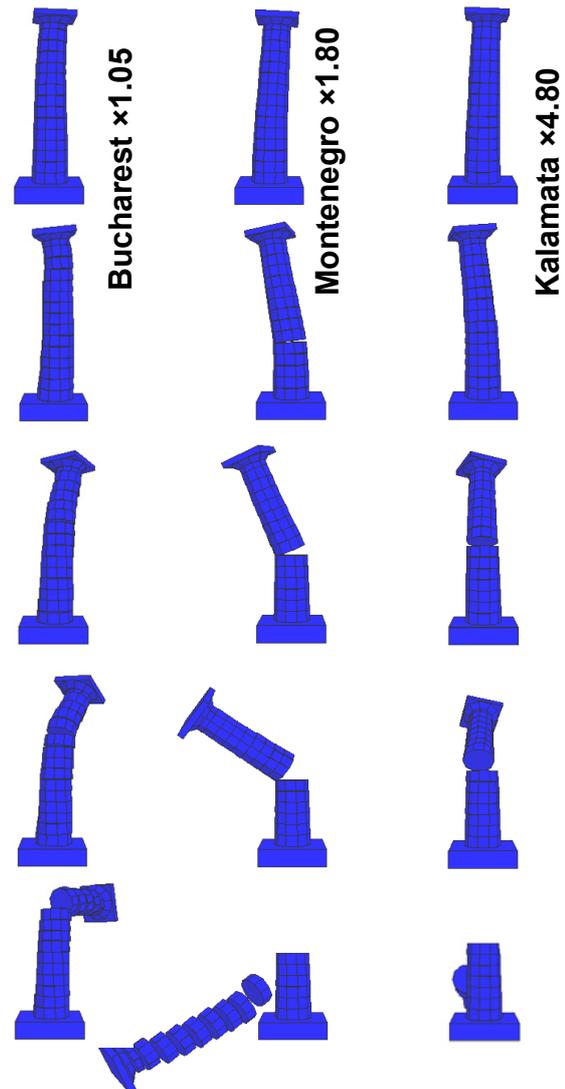
Figure 12. Rocking mode and overturning of a free standing column under the excitation of the three scaled records.

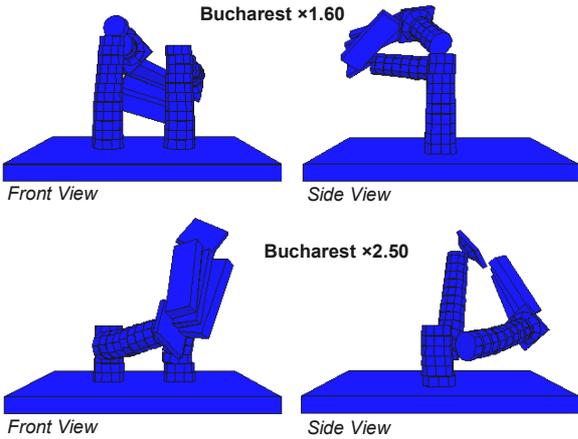
Figure 13. Snapshots of a two-column model subjected to the Bucharest ($\times 1.6$) record. The strongest component of the record is applied normal (left) and along (right) the axis of the colonnade

The mode of rocking of a couple of identical columns linked with rigid slabs (representing the architrave blocks) is more complex. The mode of rocking of the system is altered by the addition of the blocks on top of the columns due to the increased inertia. Analytical work presented by Makris and Vassiliou (2013) for a plane trilith rocking frame, shows that the addition of a beam on top of a couple of slender rigid blocks increases their in plane resistance to overturning. In the three dimensional space the induced asymmetry of the system also contribute to the increased dynamic resistance of the system. The two columns do not rock in phase and consequently the top beam starts to rotate in order to follow the asynchronously rocking columns. This mechanism cancels-out some high and medium frequency pulses and consumes energy by friction between the top beam and the columns. The instability of the system occurs with an out-of-plane overturning of one or both columns. The stability thresholds are for the two column model is significantly higher. The Bucharest 1973 record should be scaled up 1.6 times to overturn the two-column model, the Montenegro 1979 record, 2.0 times and the Kalamata record 6.0(!) times. When the strongest component of the accelerogram is aligned to the colonnade axis the required scaling is even higher. Figures 13 and 14 present the mode of rocking of a two-column model subjected to the Bucharest 1973 and the Montenegro 1979 record. The mode of collapse does not change significantly when we rotate the two components of the record to align the stronger or the weaker one with the colonnade axis. However the stability is found to be significantly higher when the stronger component is parallel to the colonnade axis. In these figures it is also observed that only the upper drums of the columns and the capital fall over while a number of the lower drums remain in place. Figure 14 presents in plan view the likely location of the fallen debris of the two-column model. It is observed that due to the top beam rotation it is more likely the columns to reach the ground at an angle to the colonnade axis and less likely to overturn in a perpendicular direction. However the fallen drum patterns are different to the ones unearthed by the archaeologists during the excavations of the site (compare figure 2 to figure 15).

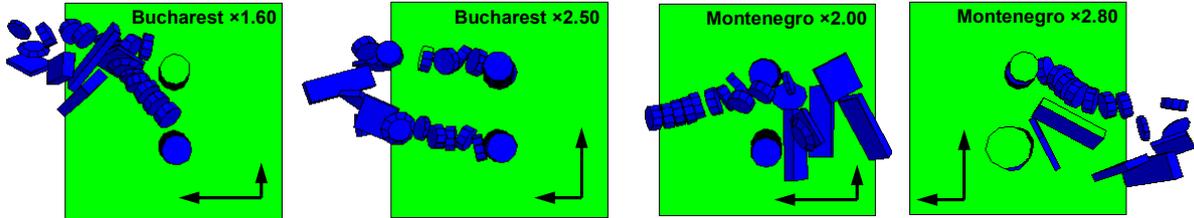
Figure 15. Final position of the collapsed columns for the Bucharest (left) and the Montenegro (right) records (from figures 13 and 14). The long arrow indicates the direction of the strongest component of the record

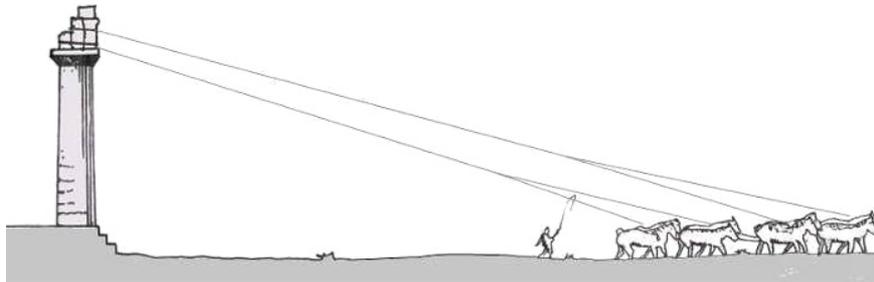
Figure 16. A possible method to pull down the columns using pack animals and ropes.

But if it is not an earthquake that destroyed the temple what were the means and the methods that were used during the early Byzantine period to demolish such structures? Prof. S. Miller, who describes the gradual demolition of the temple of Zeus at Nemea (Miller S. 1986), notices that a simple method to topple the slender (but massive) columns of this temple, was to undermine them either by removing the stylobate blocks or by breaking the bottom drum. A seriously undermined surviving column is a living proof of this practice, also referred as tree-felling technique. A lively description of the methods used for the destruction of ancient temples in the late 4th century A.D. is also provided by Theodoret in his “Ecclesiastical History” (see also Talloen and Vercauteren 2011) where he describes the destruction of the Temple of Zeus at Apamea in Syria by Cynegius, the praetorian prefect of emperor Theodosius I in the East. “An initial attempt was made to pull down the temple but the stone was so hard and the columns so massive, and held together with iron and clamps, that the prefect despaired of pulling them down. Praying for divine assistance, he was visited the next morning by a simple laborer, who suggested that the foundation of three of the columns be undermined and replaced by timber beams, to which he then set fire. When their support had vanished
