STRUCTURAL IDENTIFICATION OF A BYZANTINE CATHEDRAL IN VEROIA TOWN, GREECE

ABSTRACT

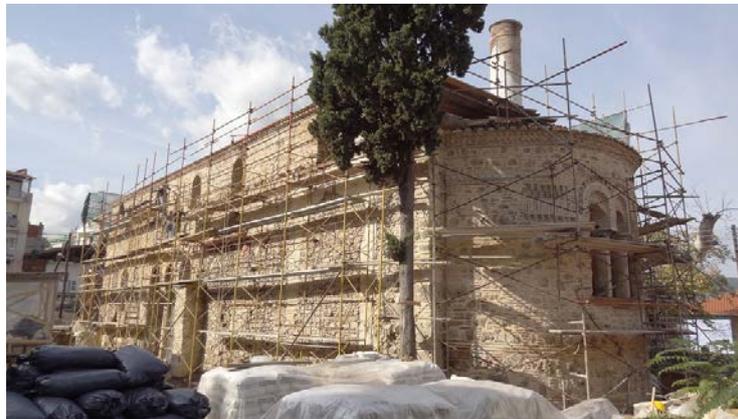
Figure 1. The Veroia Cathedral (view from southeast)

The Cathedral is a partially destroyed 11th century Orthodox Christian basilica (Figure 1). It follows the typical architectural form of a three-aisle stone masonry basilica with wooden roofs. However, the southernmost secondary aisle was destroyed in the past, resulting in two-nave structure (Figure 2). On the eastern end of the central aisle, lies the typical hemi-cylindrical sanctuary topped by a half-dome. The original half-dome was also destroyed and replaced by a reinforced concrete one. The interior walls of the existing structure are covered by religious frescoes, the majority of which dates back to the 13th century. During the Ottoman period, the basilica was used as a Muslim mosque, and a minaret was constructed in contact with the northern wall. At the same time, all exterior and interior walls were plastered, covering the existing frescoes. A later addition is also a low shed built in contact to the northernmost wall, next to the minaret (Figure 2).

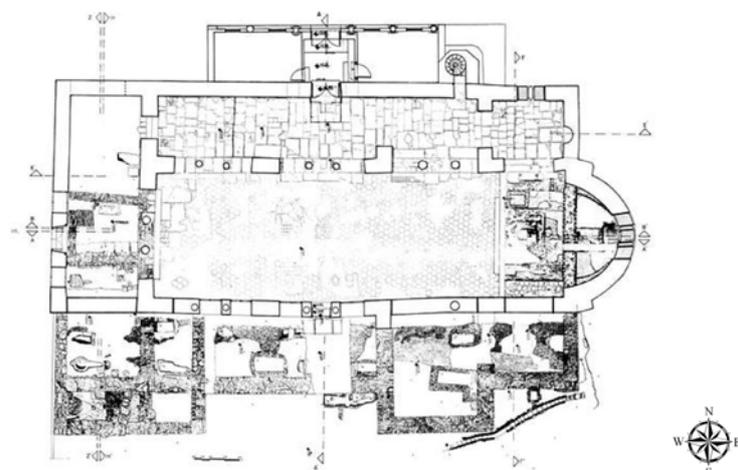
Figure 2. Plan of the Veroia Byzantine Cathedral

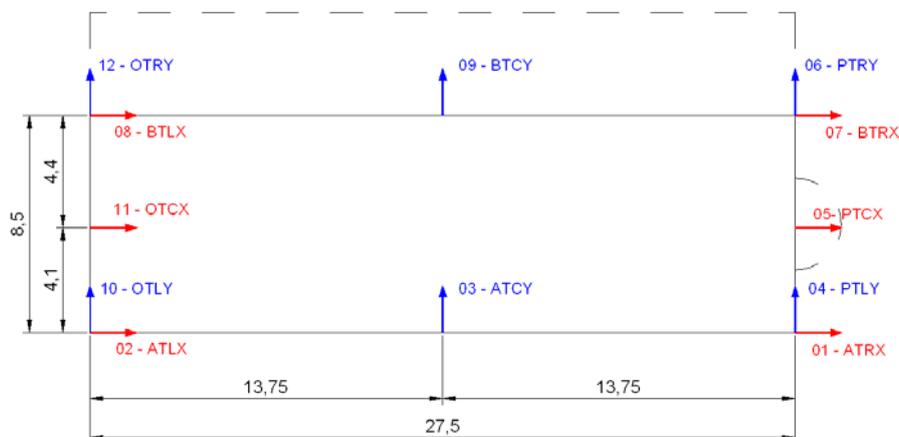
Figure 3. Instrumentation layout at the top of the central aisle walls. Dashed lines denote the northern aisle (top) and the sanctuary (right)

All these factors, in combination with a limited budget, led the research team to finally decide on the instrumentation of the topmost end of the masonry walls of the central aisle, where the wooden roof also sits (Figure 3). A special structural array was deployed consisting of 12 uniaxial accelerometers (*Kinematics Inc.* Uniaxial Force balance sensors *ES-U2*[®] and *FBA-11*[®]), together with a *Kinematics Inc. Aitna*[®] high-resolution (19 bit) recording unit. The technical specifications of the recording system are presented in Table 1.

The mode is related mainly to out-of-plane vibration of the longitudinal walls of the central nave (Figure 7). The similar spectral amplitude at the wall midpoints (Fig. 3, sensors 03-ATCY and 09-BTCY) indicates their potential coupling in the vibration direction (Y-axis) through the wooden roof. The mode corresponds to the high value at 2Hz of the Power Spectral Density diagram of sensor ATCY presented at Figure 6. The corresponding damping ratio for this mode was found to be 3.2%.

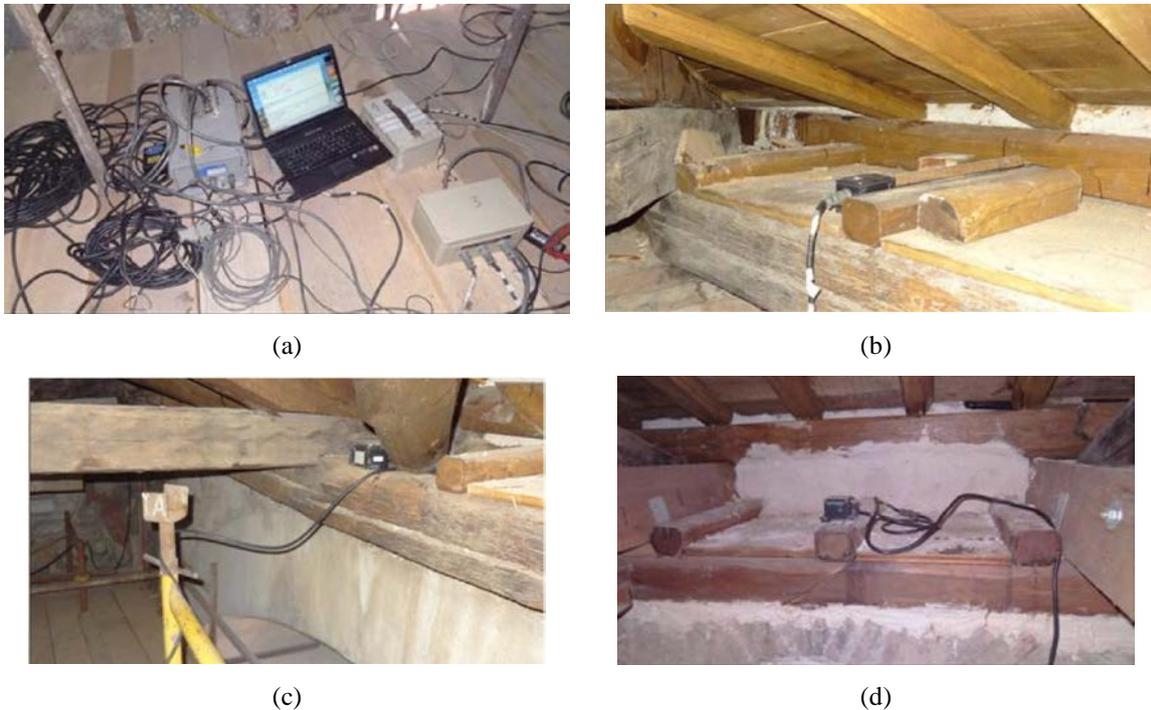
Figure 4. (a) Central recording unit (b), (c), (d) sensors at top walls of central nave

The 12 sensors are connected through cables to the central recording unit, which, in turn, is connected to a PC for setting the system parameters and data acquisition (Figure 4). The sensors were bolted on a wooden beam that runs along the top of the masonry walls, which serves as a base for the wooden roof beams, and which is firmly attached to underlying walls with bolts and mortar, following their response. In this way, drilling of the walls was avoided, especially since at several places frescoes reached their top.

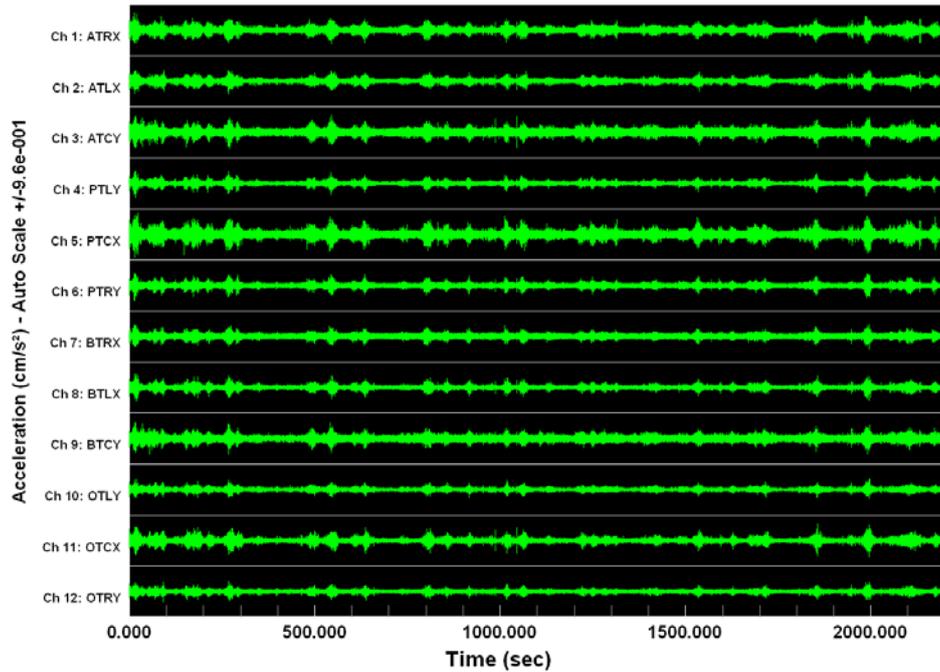
Figure 5. Recordings of the Cathedral response to ambient vibration excitations

Long duration (30 min) recordings were made of the structure’s response to a low-level ambient-type excitation from the motor of a JCB excavator running at low revs and standing near the NE corner of the complex. The recorded response (Figure 5) was used to obtain estimates of excited modes of the central nave, as it is described later herein.

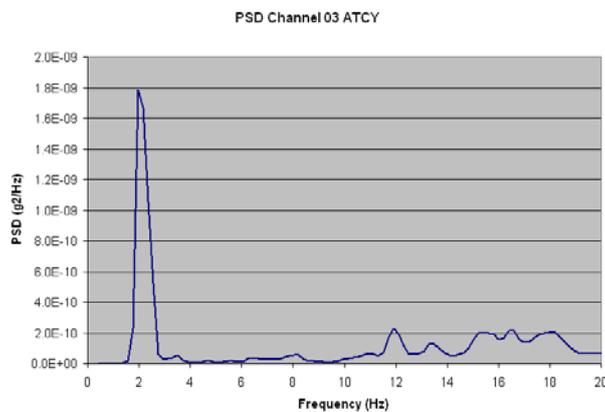
Figure 6. Power Spectral Density - sensor ATCY

In Figure 6, the Power Spectral Density at sensor ATCY is presented, which will be commented on later in the paper.

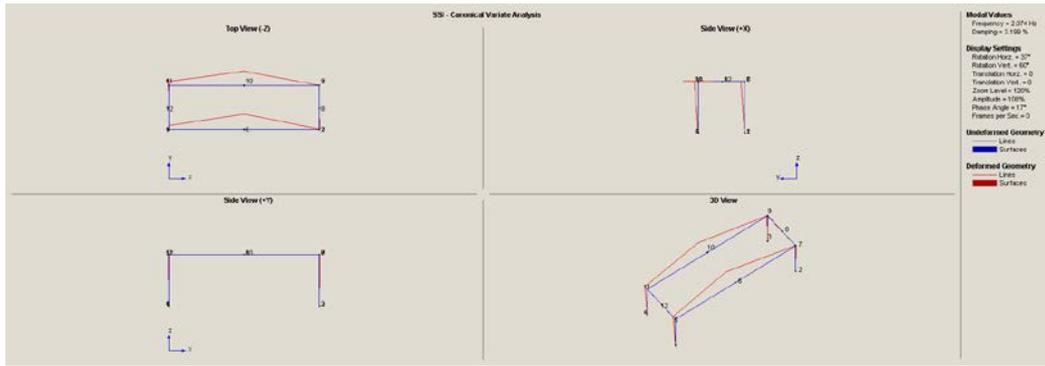
Figure 7. CVA technique – eigenvalue at 2.074 Hz

Eigenvalue at 2.07 Hz (T= 0.48 sec)

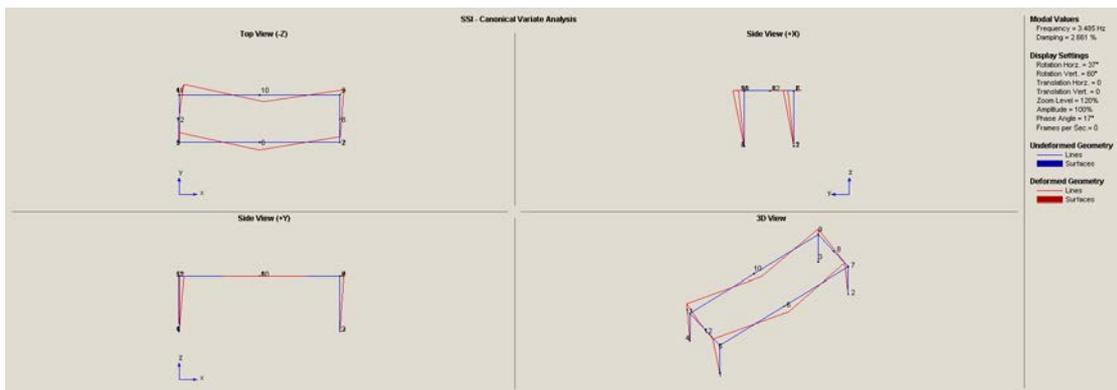
Figure 8. CVA technique – eigenvalue at 3.485 Hz

Eigenvalue at 3.49 Hz (T=0.30 sec)

The eigenmode is coupled in both (X and Y) horizontal directions (Figure 8). It is noted that, as before, the spectral amplitudes are similar in the Y-direction, however it is obvious that the wooden roof does not enforce a diaphragmatic behaviour of the perimeter walls. The corresponding damping ratio for this mode was found to be 2.7%.

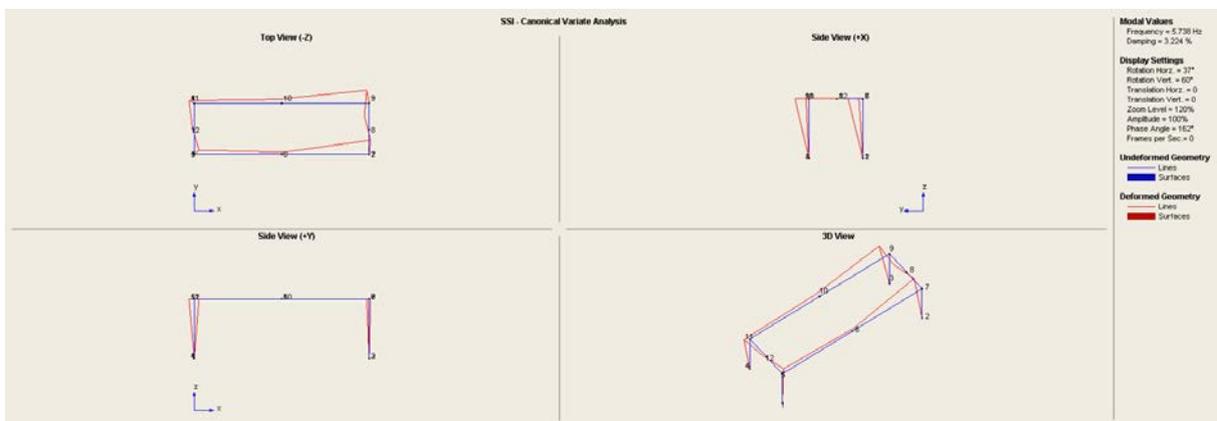
Figure 9. CVA technique – eigenvalue at 5.738 Hz

Eigenvalue at 5.74 Hz (T= 0.17 sec)

A higher-order eigenmode, also coupled in both horizontal directions (Figure 9) with a corresponding damping ratio of 3.2%.
