## ASSESSMENT AND PERFORMANCE BASED STRENGTHENING OF AN ORIGINAL COMPOSITE MATERIAL DESIGNED BUILDING

### ABSTRACT

A 100 years old historical building constructed with an original composite material was assessed. Even though the compressive strength of the material was found to be relatively high, the structure was found weak for carrying the static and lateral loads. Performance – based seismic retrofitting was carried out. A solution was proposed to strengthen the structure in order to withstand the level of hazard 2% in 50 years. The structure was modeled before and after the strengthening using inelastic dynamic time history analysis, and inelastic static pushover analysis. Results and comparisons of modeling are given before and after strengthening.

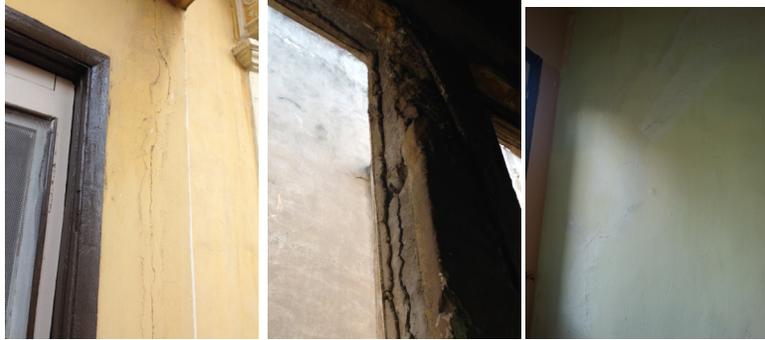
Figure 2. The photos of the building elements showing some bending and shear cracks.

The following deficiencies were discovered: Many shear and bending cracks were noticed in structural and in non – structural elements; columns, beams, walls, stair case, Fig.2. Moreover some cracks were noticed on the roof of the building. Many walls have rotten and humidity layers, due to the establishment of a recent, unprofessional rainfall drainage system. As per the reinforcement procedures of the early 20<sup>th</sup> century in Lebanon, the columns were poor in steel; we have noticed that round steel bars of 14mm diameter were used. Many non – structural elements such as the stair grill already failed. Therefore, by visual inspection, we were able to note that the building was deficient and it needs to be strengthened.
