## SEISMIC ISOLATION OF 200 YEAR OLD HERITAGE CATHEDRALS IN HAITI

H.Kit Miyamoto<sup>1</sup>, Amir S.J. Gilani<sup>2</sup>, Davis Sonda<sup>3</sup>, Y.Zahit Gündoğdu<sup>4</sup>, Akira Wada<sup>5</sup>

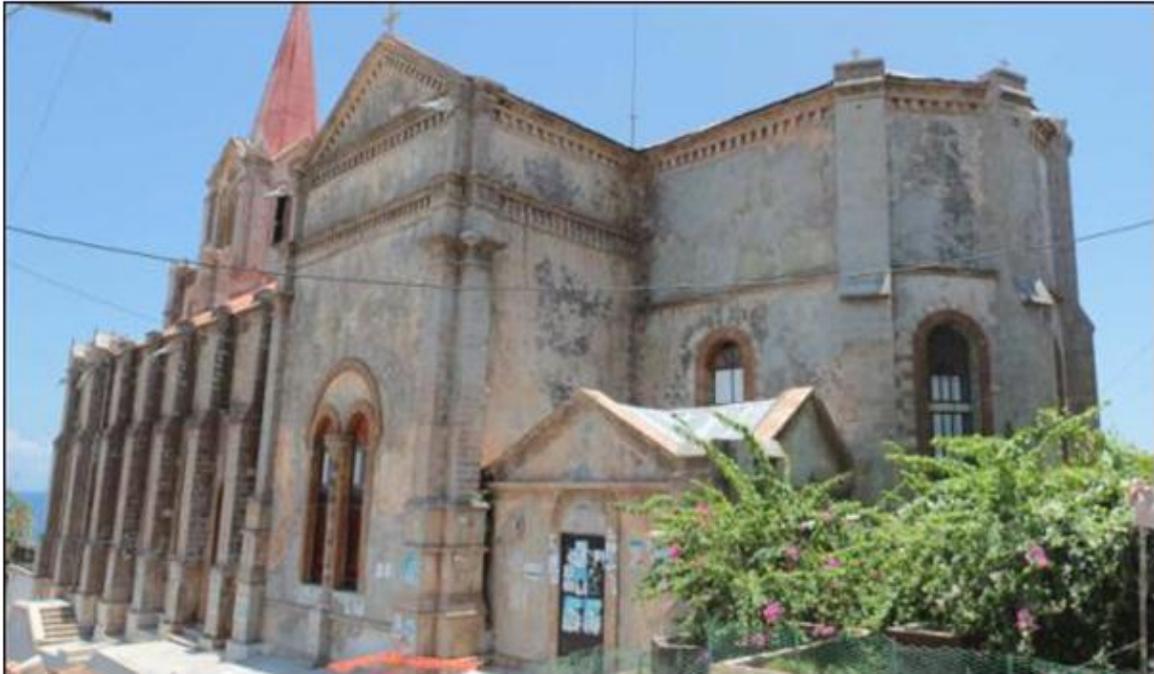
Figure 1. Photograph of the Cathedral, looking east

Saint John Baptist Cathedral of Miragoane (hereafter referred to as the Cathedral) was originally constructed in 1880 and is one of the oldest Cathedrals in Miragoane— a coastal town approximately 80 km west of Port-au-Prince, the capital of Haiti. Figure 1 shows a photograph of the building looking east. The building has an area of approximately 580 m<sup>2</sup> and is nearly rectangular shape. The building is constructed using concrete floors with an unreinforced masonry and stone walls over stone masonry foundations. There is a ground floor, and a mezzanine with access to the upper tower that houses the bell. The roof structure is assembled with trusses that combine both wood and steel and is approximately 13.9 m tall at its peak. The roof is supported by the walls on the exterior and by uniformly placed columns along the interior. The front entrance of the cathedral has a bell tower that stands approximately 30.5 m high. The tower is constructed with steel frames above the walls. There is a concrete mezzanine that sits about 7m above the finished floor of the cathedral. The walls along the perimeter vary from 500 mm to 750 mm in thickness and are the primary gravity and lateral load resisting members. Figure 2 presents elevation and plan views of the building.

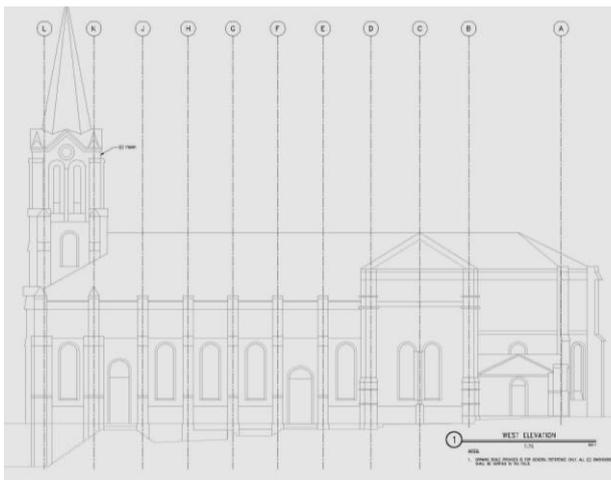
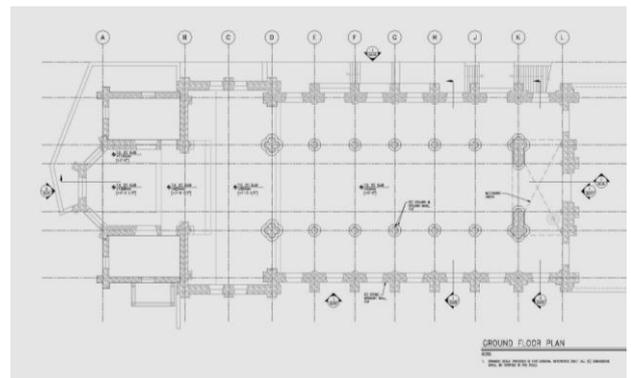
Figure 2. Architectural drawings of the Cathedral

Front elevation

Plan view

Table 4 presents the computed story drift ratios above the isolation plane refer to Figure 2 for the location and elevations (m) of the stories listed in the table. The maximum story drift ratios are 0.42% and 0.49% at the DE and MCE levels, respectively.

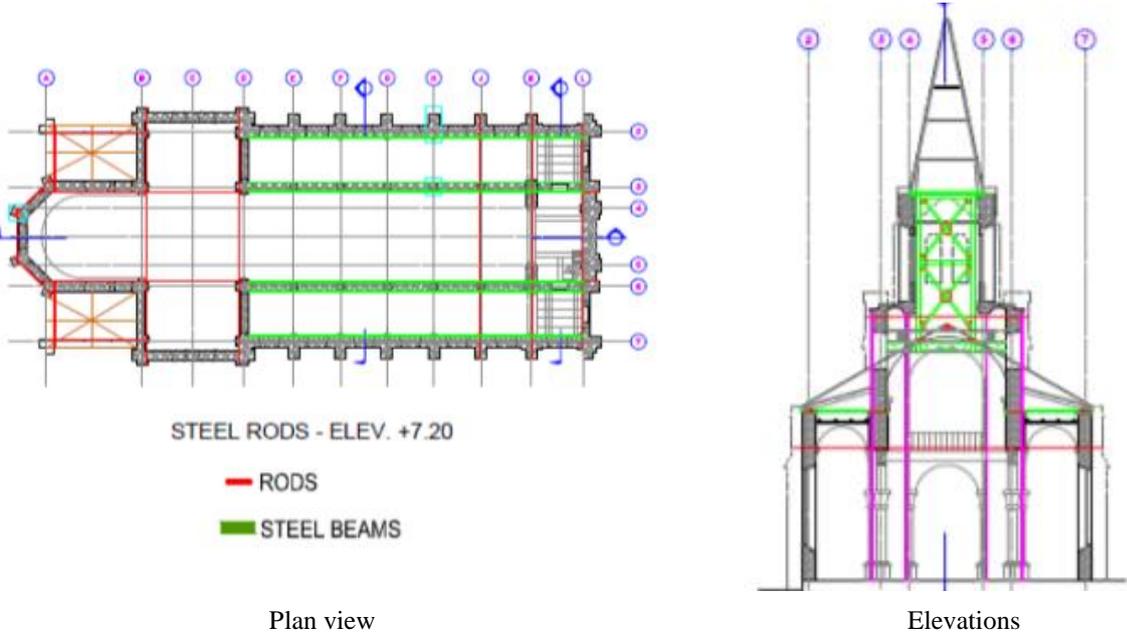
For the seismic isolation system to be effective, this type of failure need to be precluded, as such, it is important to connect structural elements and provide a robust path for the transfer of seismic forces. In the United States, this type of failure is mitigated and the seismic load path is developed by addition of either wood or concrete diaphragms to the existing buildings. Since such approach was not feasible in Haiti, the strengthening was provided by a series of steel rods and beams (channels and angles) serve to connect the wall elements and provide horizontal bracing (diaphragm) and vertical bracing. The horizontal bracing prevent out of plane mechanisms and connect the internal columns to the external walls. Such approach has been used extensively in Europe and especially in Italy and Greece [10] for retrofit of historic buildings. Figure 3 presents the plan and elevation view of the Cathedral showing the added steel members. As shown in the figures steel members are added: a) Horizontal tie-down steel rods are added to the building to connect the perimeter walls in both directions, b) System of steel truss works is added to provide diaphragm action in plane and vertical bracing, c) Bracing is added to reinforce the tower and to connect this segment to the rest of the Cathedral, d) Vertical tie-down rods are added to reinforce the walls at tower base and to improve its flexural capacity, and e) Steel longitudinal reinforcement is added to the tower walls

Figure 3. Typical structural intervention details

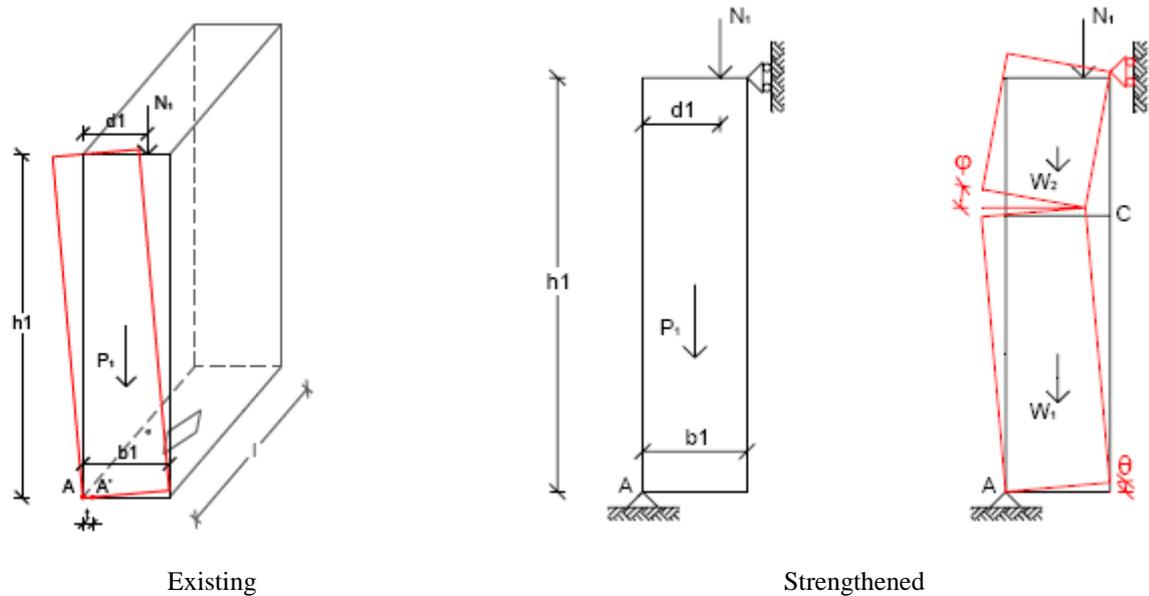
The wall failure in the original configuration will be comprised of the rigid motion (rocking) of the wall about its base; see Figure 4. This kinematic condition is possible since the top of the wall is not attached to a diaphragm. The lateral load (acceleration) required to initiate failure is resisted by the vertical load acting on the wall. Once the steel members are added, the diaphragm action excludes this mode of failure. Instead, the failure mechanism will include formation of a hinge along the height of the wall (see Figure 4). A larger lateral force (acceleration) will be required to initiate this higher mode failure. In addition, the tie-down rods provide additional resistance to overturning and thus serve to increase the lateral load required to initiate out-of-plane failure of walls [8]. The key parameter for development of the out-of-plane strength is the lateral acceleration at the base of the wall and perpendicular to its plane that initiates failure. This is because, the seismic load is considered as static force (wall mass times spectral acceleration at the base of the wall), and acceleration is assumed to be constant along the height of the wall ( $a_o$ ). The computed capacities are further adjusted by two factors: a) Knowledge factor  $\kappa$  to account for uncertainties in material properties, construction details, and geometric characteristics, and b) Behavior factor  $q$  to account that the limited ductility of the walls and constraint by adjacent elements to provide restraint to the out-of-plane rotation of the wall segment under consideration. At the time of analysis, no field test data was available, a  $\kappa$  factor of 0.75 (1/1.35) was used as prescribed in the Italian seismic code [9]. Similarly, the Italian code recommends using a value of 2.0 for  $q$  when a simplified linear procedure is utilized.

Figure 4. Out-of-plane failure modes for a typical wall segment

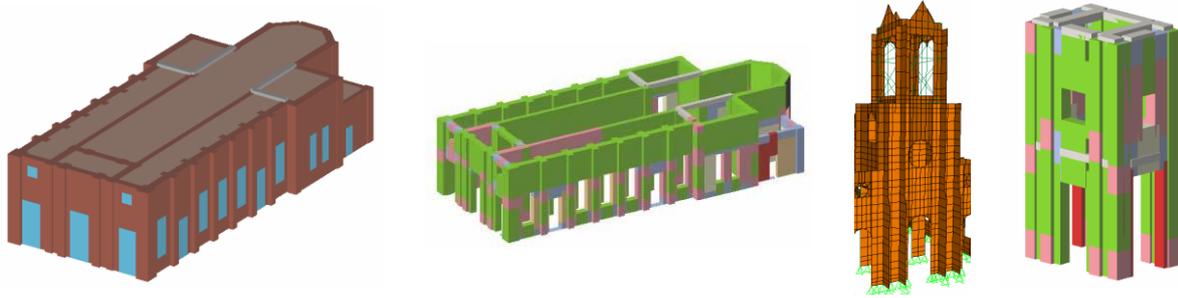
Shown in Figure 5 is the state of the main cathedral and bell tower at the limit state. In this figure:: a) Green denote wall segments that remain elastic, b) Pink corresponds to flexural yielding, c) Red

designates flexural failure, d) Ivory indicates shear yielding , and e) Light blue represents traction failure Note that no shear failure was developed and limit state is reached when walls reach their ductile flexural capacity. The progression of the nonlinear response in the bell tower is listed in Table 3.

Figure 5. Mathematical model, and failure mode for main cathedral and bell tower

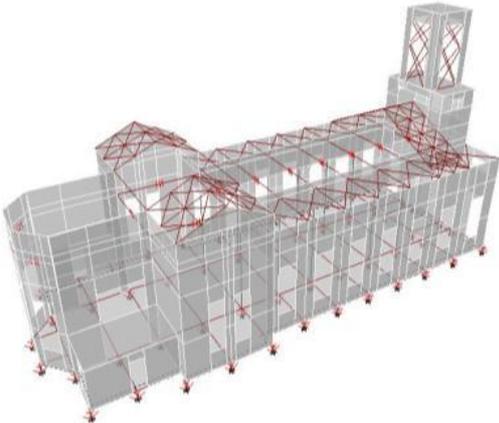
A three-dimensional analytical model of the building was prepared using the program ETABS [2] see Figure 6. The inertial mass of the structure is estimated at 2,800 Mg. The individual isolators were model as bilinear link elements using the friction and curvature properties provided by the TP bearing manufacturer. All calculations were performed using nominal values (no upper- and lower-bound analyses were conducted.)

Figure 6. Analytical model of the building

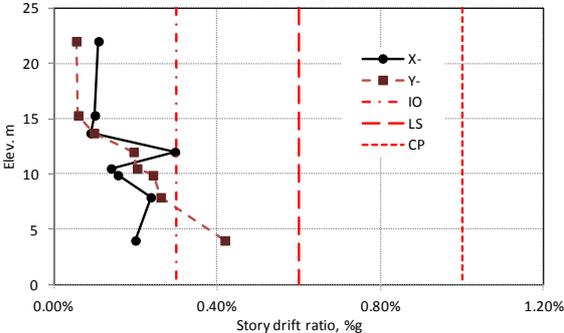
or permanent value of 1.0%. Therefore, for the retrofitted structure, at both DE and MCE levels, performance of between IO and LS are obtained; see Figure 7 and thus the enhanced performance criteria are satisfied for drift response.

Figure 7. Story drift ratios (DE) and performance limits

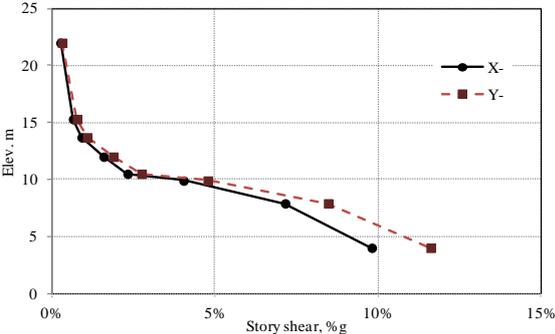
Figure 8 presents the distribution of shear force (normalized with respect to the building seismic mass) along the height of the structure. The effective base shear for this building is approximately 12%g at the DE intensity. The addition of the isolation system has served to significantly reduce the demand on the structure. This can be further seen in Figure 9 showing that maximum total acceleration of 0.5g is reduced to 0.18g as it travels (and thus filtered) through the isolation plane.

Figure 8. Distribution of story shear along building height

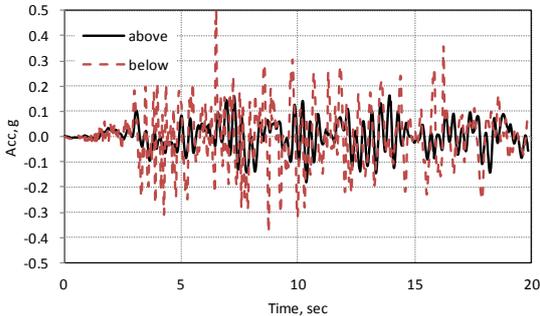
Figure 9. Computed lateral accelerations above and below isolation plane, DE, X direction

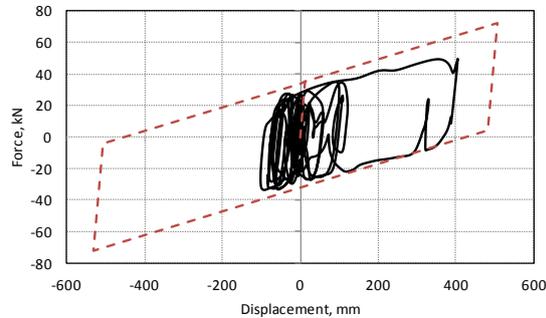
Figure 10 presents the force-deformation response of a typical isolator from MCE analysis. Also shown in the figure is the nominal bi-linear backbone curve of the isolator obtained from the

Figure 10. Typical isolator response

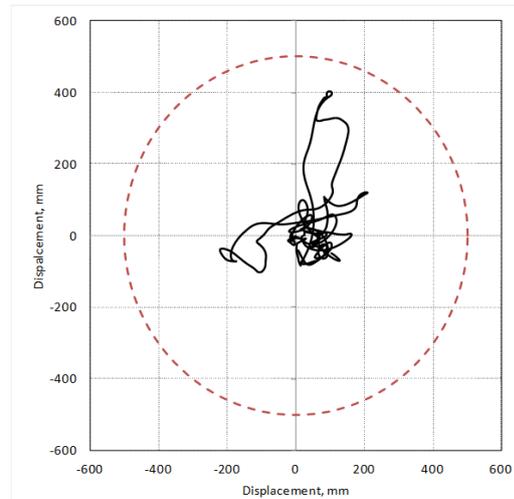
manufacturer data. Figure 11 presents the bi-direction MCE displacement response of a typical isolator. Also shown in the figure is the displacement limit (500 mm) as specified by the manufacturer. As seen, the isolator MCE displacements in any direction are less than its allowed maximum motion.

Figure 11. Bi-directional response of an isolator
