## SEISMIC VULNERABILITY AND SEISMIC RESISTANCE OF YEREVAN ZVARTNOTS INTERNATIONAL AIRPORT'S DEPARTURE HALL

Main purpose of this paper is estimation of seismic vulnerability and resistance of Yerevan Zvartnots International Airport's old terminal's departure hall. It was constructed in 1980-s and had a cultural significance for the Republic of Armenia.

This research aims to discuss and give proposal about rehabilitation possibility of Departure Hall (structure in form of an open ring). Analytical design model and seismic calculation were done due to requirements of Armenian Earthquake Resistant Construction Design Codes (RABC II-6.02-2006), employing LIRA 9.6 software.

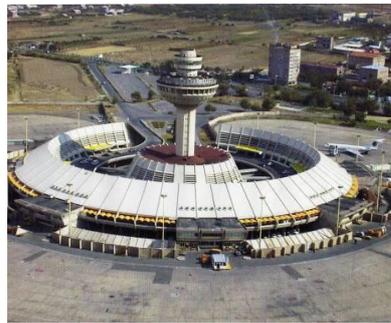
Terminal 1 of the Yerevan “Zvartnots” international airport consists of three structures: Departure hall (a building in form of an open ring, with two levels and an open ground floor, used as a parking), Control tower with a lower building of 10m, 5 floors and 2 underground levels and Passageway for the vehicles access, connecting the lower level of the parking to the higher level of the principal building. It was constructed in 1980-es and has cultural significance for RA (see fig. 1).

Figure 1. “Zvartnots” International Airport of RA

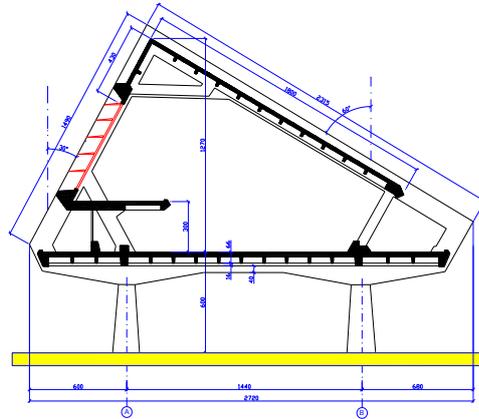
Figure 2. Cross section of the building in form of an open ring

A building in form of an open ring is a structure standing on two columns, it is broadened in two sides with consoles, with double sloping cover, under which is a parking lot for movable transport. The waiting hall which ground on the columns has 24.4m broadness, is nearly 6.0m height from the ground (-1.65-4.50m ) and also has half storey on +7.50m level. The vertex is on 12.5m height from ground.

The constructive scheme of the building presents from itself arranged 1-56 digital axes, frames of combined elements, which are connected with combined bundles in the ring-shaped direction. The columns of frames of combined elements according to the height, have changeable cut  $0.4 \times 1.4m$  below,  $0.4 \times 1.0m$  above. On the +4.15m level columns are united with shutters having changeable cut which on the heads of the columns have  $0.4 \times 1.85m$ , in the middle of flight and in the ends of consoles  $0.4 \times 1.05m$  sectors. On the +4.40m level the shutters are united with sloping columns and sloping shutters, which have  $0.4 \times 0.6m$  sectors. The marked elements are done from 300 grade of concrete and reinforced with reinforcements of AII class. The combined slabs of the cover have 0.45m height (see fig.2).

The structure is divided into 7 sectors. On above mentioned axes combined shutters also on the haunches of the solid ring-shaped beams, metallic insertions are anticipated which let one cover of the ring lean against the one, securing also their free sliding in the ring-shaped direction softening stretches arising from seismic and thermal vibrations.

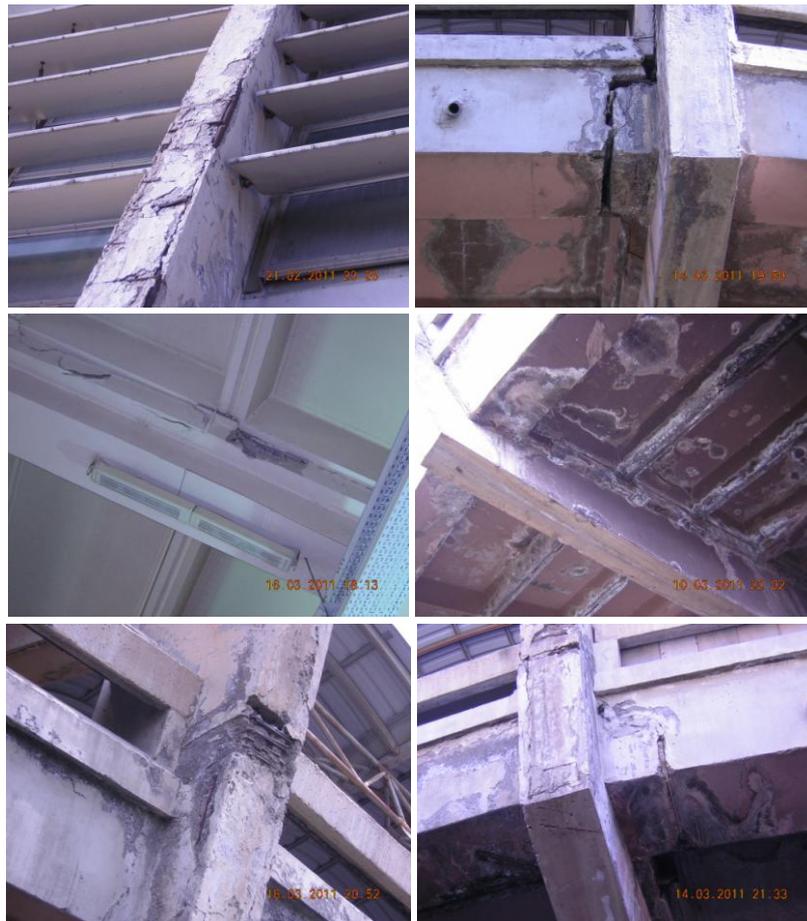
Figure 3. Damages of the reinforced concrete members

There are damages of different degrees in the reinforced concrete constructions of different sections of the open ring building. Mainly the concrete protective layer of the steel framework of the reinforced concrete constructions have corroded, the steel framework has been laid bare and has been subjected to corrosion of different degrees, the metal supplementary elements do not have an anti-corrosion protective layer and have also been subjected to corrosion of different degrees (see fig.3).

- There are damages of different degrees in the reinforced concrete constructions of different sections of the open ring building (frames, beams connecting frames to each other, inserted floor and roof slabs, cantilever constructions, reinforced concrete handrails, and etc.). Mainly the concrete protective layer of the steel framework of the reinforced concrete constructions have corroded, the steel framework has been laid bare and has been subjected to corrosion of different degrees, the metal supplementary elements do not have an anti-corrosion protective layer and have also been subjected to corrosion of different degrees (see fig. The damages have occurred because of during the exploitation of the building (about 30 years) the reinforced concrete constructions have been periodically subjected to humidity which has brought to the freezing-melting process in case of negative temperature during winter resulting in corrosion of concrete.

- Water removal from atmospheric precipitations is not organized in a proper way in the building.
- The construction works have not been carried out with sufficient quality.

- The concrete protective layer of the steel framework doesn't have enough thickness.
- Longitudinal steel framework is placed with large distance- with a 35-40cm step.

- In separate reinforced concrete constructions the concrete doesn't have a satisfactory grade of solidity.

It should be noted that the strong and considerable damages in reinforced concrete constructions (the decomposition of the concrete protective layer of the steel framework, the general proportionate and local disproportionate corrosion of steel framework and supplementary metal elements, and etc.) have occurred mainly on the first floor and on the level of the roof of the first floor.

- The zone of thermal-movement joints has been subjected to considerable damage.
- The functional importance of thermal-movement joints has been violated in the factual constructive solutions of the building.
- In the assembly junctions of sloping supports of reinforced concrete frames, the concrete protective layer of the steel framework has decomposed, the steel framework has been laid bare and has been subjected to general strong corrosion.

Add the seismic capability through building rigidity increase. It is proposed to complement the spetial frame of the building with reinforced-concrete rigid diaphragms or steel bonds as shown in proposed scheme (see the proposed installation dots of rigid diaphragms).

The rehabilitation of the building may include employing of special systems of seismic protection, such as interactive ties and structures that can increase damping factor of structure (For example SISTEM DC90). It is neseccary to increase natural periods of structure more then 2.0 sec. To reach this aim is proposed to apply seismic isolation system with the laminated rubber bearings on the level +3.5m.

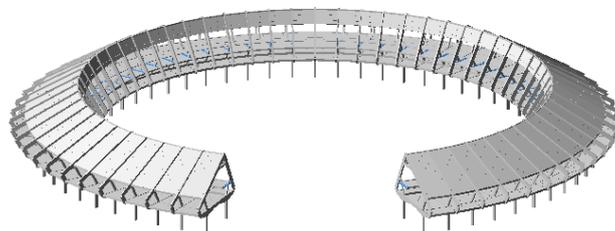
Figure 4. Special design model

Building is modelled as special frame. Columns and beams are modelled as linear elements, walls and floors slabs as shell elements (see fig.4).

Seismic calculation of the building has been performed by LIRA version 9.6.

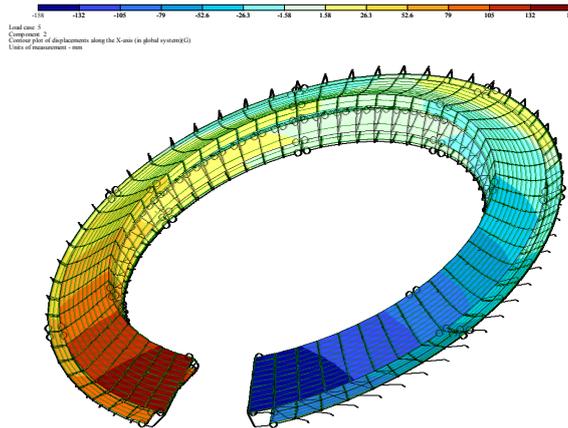
Figure 5. Displacements along X direction

It should be noticed that according to RABC II-6.02-2006 codes for the displacement calculation the  $k_1 = 1.0$ . On the fig. 5 is shown displacements along X direction.

Maximum displacement along X direction in level +3.5m,  $\Delta = 7.965\text{sm}$ , in level +8.1m,  $\Delta = 4.585\text{sm}$ , In level +17.1m,  $\Delta = 6.012\text{sm}$ .

The presented values show that along X, Y directions the drift values are greater than 1/200 accepted value. It should be noticed that large displacements and forces arise on the edge flights which means that open ring could be closed as a retrofitting type.

The results of seismic calculations are shown, that reinforcement of the columns is not enough about 2.2-4.1 times and for the beams - 2.1-2.4 times. The presented values show that along X, Y directions the story drift values are greater than accepted 1/200 value. It should be noticed that large displacements and forces arise on the edge flights. This means that open ring could be closed as a retrofitting solution.

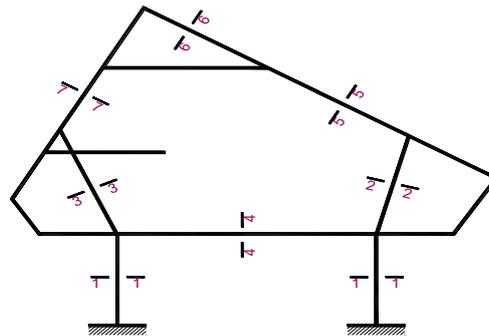
Figure 6. Schematic section of structure

In the table 2 are presented the analyses of the frame reinforcement according to designed and needed calculation shown on the fig 6.

The results of table 2 are shown, that reinforcement is not enough for the columns about 2.2-4.1 times and for the beams – 2.1-2.4 times.
