DYNAMIC BEHAVIOUR OF SRC BUILDINGS DAMAGED BY THE 2011 GREAT EAST JAPAN EARTHQUAKE BASED ON STRONG MOTION RECORDS

Toshihide KASHIMA¹

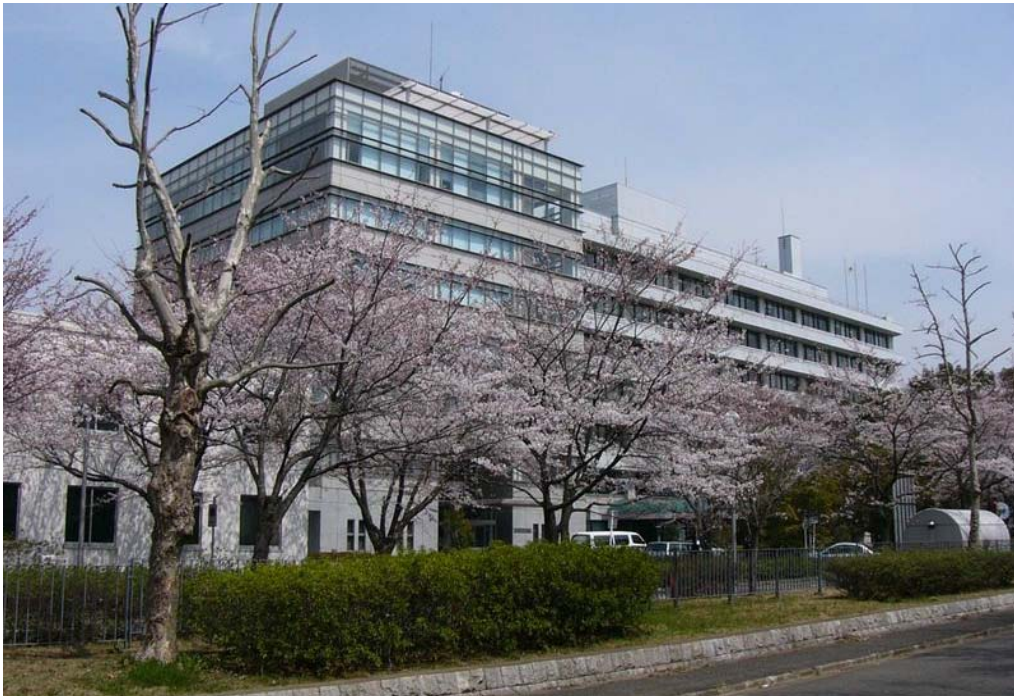
Figure 1. BRI main building (right) and annex building (left)

The Building Research Institute (BRI) is located in Tsukuba City, approximately 60 km north-northwest of Tokyo. The BRI has two office buildings consisting of the main building, a 7-storey steel-framed reinforced concrete (SRC) structure completed in 1979, and the annex building, an 8-storey SRC structure built in 1998 that is connected to the main building by a passageway having expansion joints. Both buildings are supported by a spread foundation at a depth of about 8 m. The building features are summarised in Table 1 and the exterior of the buildings is shown in Fig. 1.

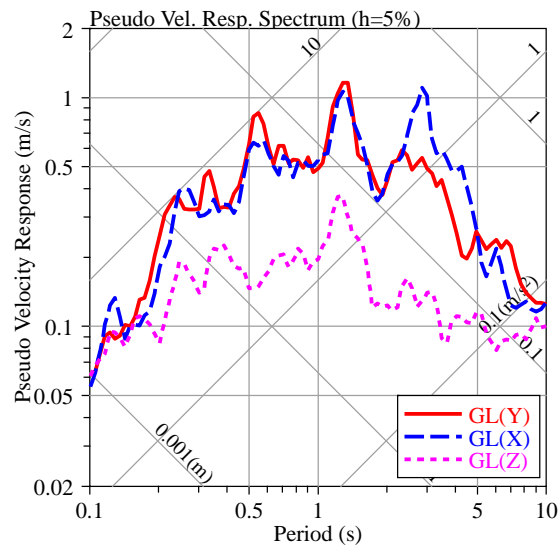
Figure 4. Pseudo-velocity response spectra of acceleration records on the ground (GL) during the Great East Japan Earthquake

The pseudo-velocity response spectra of the strong motion data at GL are plotted in Fig. 4. The damping ratio of the response spectra is 5%. The response spectra show a wavy shape with peaks at the periods of 0.5, 1.3 and 2.8 s. The pseudo-velocity response spectra in the horizontal directions exceeded 1 m/s at the periods of 1.3 and 2.8 s, which would be very severe ground motion for building structures.

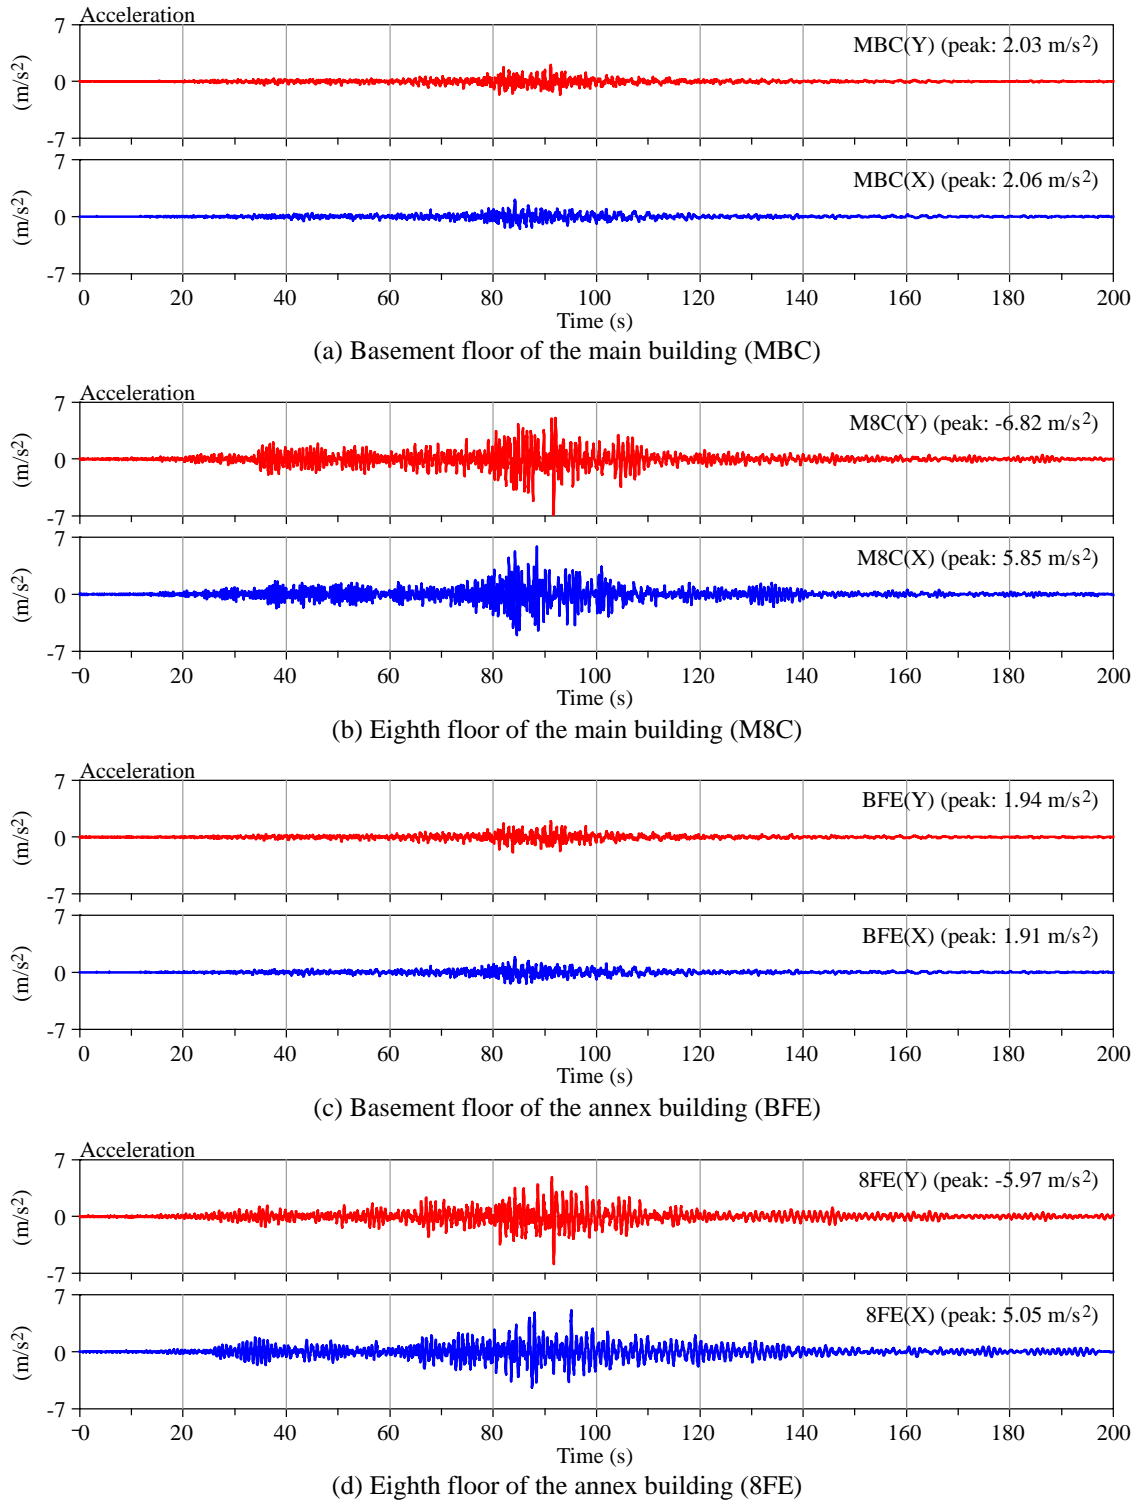
Figure 5. Acceleration waveforms recorded in the BRI buildings during the Great East Japan Earthquake

Figure 5 shows the acceleration waveforms in the horizontal directions recorded at the basement and eighth floors in the main and annex buildings. Destructive shaking arrived at the time of 80 s and continued for nearly 30 s. The responses of the buildings were already large at the time of 35 s. The quake lasted for almost 3 min.

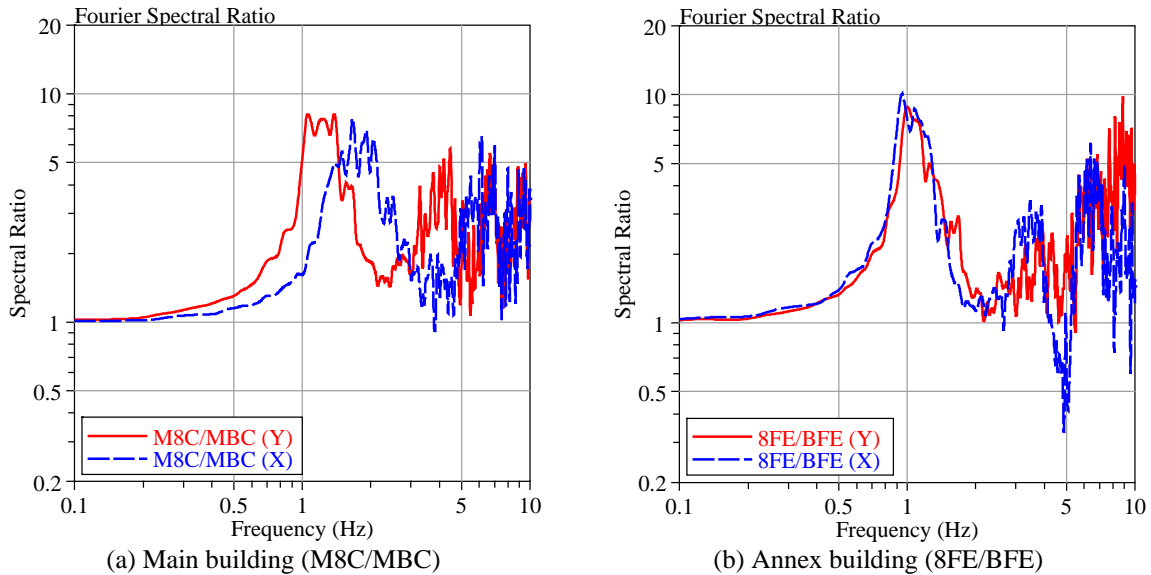
Figure 6. Fourier spectrum ratios of 8F/B1F of the acceleration records in the main and annex buildings during the Great East Japan Earthquake

Fourier spectrum ratios of the acceleration data at the eighth floor to the basement floor in the horizontal directions of both buildings are plotted in Fig. 6. The spectra are smoothed using the Parzen

window having a width of 0.1 Hz. Looking at Fig. 6(a), peaks corresponding to the fundamental natural frequencies can be found at frequencies of about 1.3 and 1.7 Hz in the Y- and X-directions of the main building, respectively. The natural frequencies of the annex building can be inferred as about 1 Hz in both horizontal directions, as shown in Fig. 6(b). Nevertheless, the spectrum ratios have wide and complicated shapes in the frequency range near the first natural frequencies; therefore, detailed investigation on nonlinear behaviour of the buildings is needed.

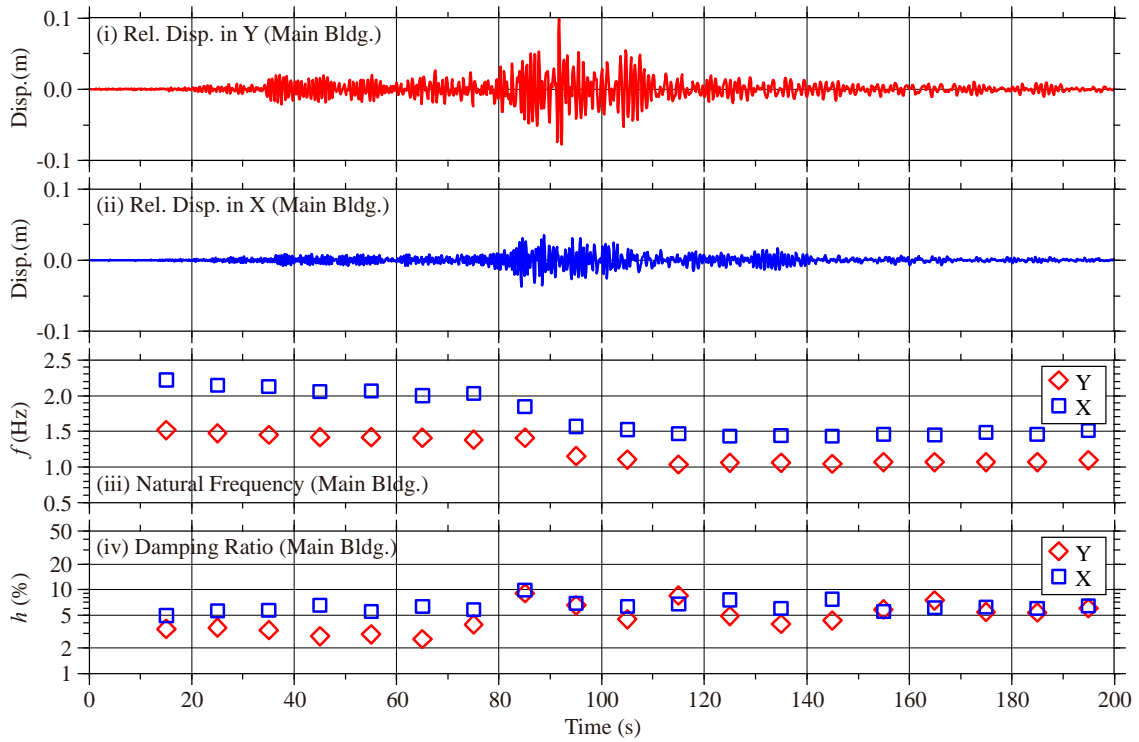
(a) Main building

Change in the dynamic characteristics of the buildings during the severe shaking is discussed in this section. Figure 7 indicates the time histories of the building displacement, and the fundamental natural frequencies and damping ratios of the buildings. Building displacement means the relative displacement of the eighth floor to the basement floor. The fundamental natural frequencies and damping ratios were estimated for every 10 s using the acceleration data. As the fundamental frequency and damping ratio, a frequency period and a damping ratio of a single-degree-of-freedom system that can simulate an actual response having the best fitness were determined using the grid search method (Kashima et al., 2006a). The relative displacement of the eighth to the basement floor was selected as the response to be fitted. Red diamonds (\blacklozenge) and blue squares (\blacksquare) represent the values in the Y- and X-directions, respectively.

Looking at Fig. 7(a), the maximum building displacement in the Y-direction of the main building reached nearly 0.1 m. The natural frequency in the Y-direction was initially about 1.5 Hz, and started to drop from the time of 80 s. Finally, the natural frequency fell to 1.1 Hz. The maximum displacement in the X-direction was less than 0.04 m, but the natural frequency decreased from 2.2 to 1.5 Hz as well. The damping ratio of the main building was 2% to 5% in the initial part, and seemed to increase during the intense shaking.

Figure 7. Building displacement, transition of natural frequencies and damping ratios of the BRI buildings during the Great East Japan Earthquake

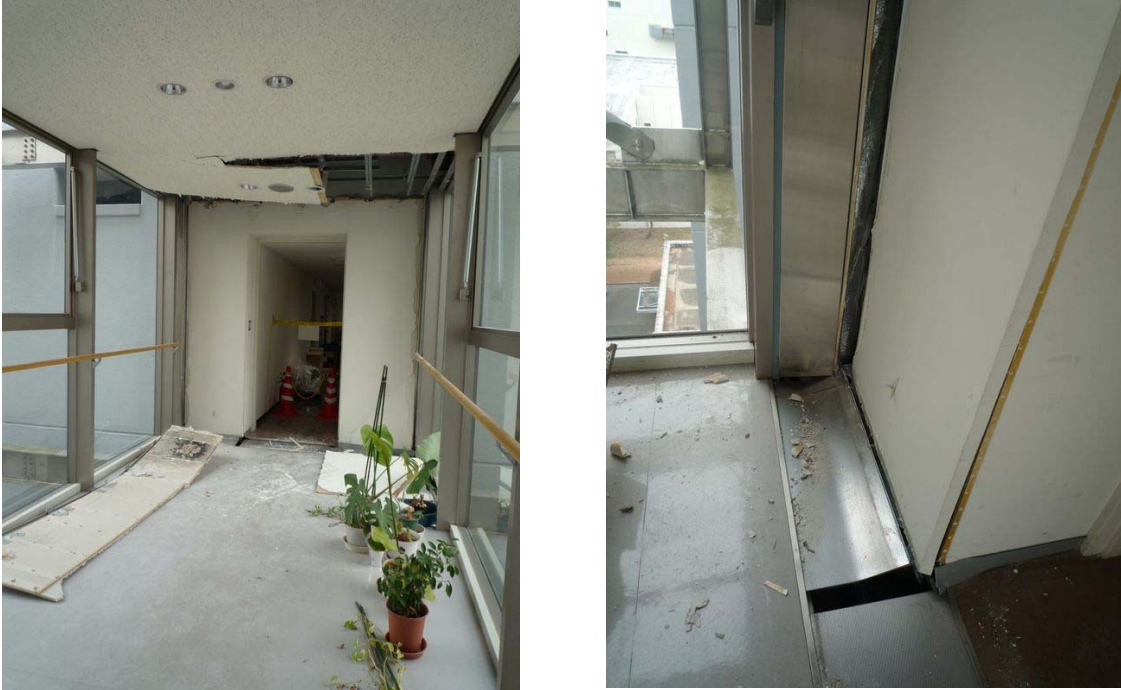
Figure 8. Damage to the expansion joint and passageway at the eighth floor

The damage to the expansion joint of the passageway between the two buildings was significant, as shown in Fig. 8; therefore, the dynamic behaviour of the expansion joint is investigated in this chapter.

Figures 10 (c) and (d) indicate the deformation of the expansion joint at the eighth floor in the Y- and X-directions, respectively. The deformation of the expansion joint represents the difference between the building displacement at the position of the expansion joint of the main and annex buildings. The maximum deformation in the X-direction exceeded the 0.1 m clearance of the expansion joint. The analytical results of the strong motion data suggest that the lack of clearance of the expansion joint caused its damage.

Deformation of the expansion joint between the two buildings during the Great East Japan Earthquake was estimated using strong motion data. The deformation of the expansion joint at the eighth floor exceeded 0.1 m. It can be inferred that a lack of clearance of the joint caused the damage to the passageway and expansion joint.

Restoration work on the buildings was carried out in 2012. Cracks on the concrete walls were filled with epoxy resin and splits on the partitioned walls were repaired. However, the work did not recover the stiffness of the buildings.
