SEISMIC ENGINEERING INVESTIGATION OF HYDROPOWER STATION DAMS

This paper presents new methods of seismic monitoring hydropower station's dams on two experimental examples. The first one is an observation of construction characteristic (eigenfrequency) oscillations induced by ever-present background microseisms and by wind pulses. The second one is a seismic scanning of a dam body performed with hydropower machinery vibrations.

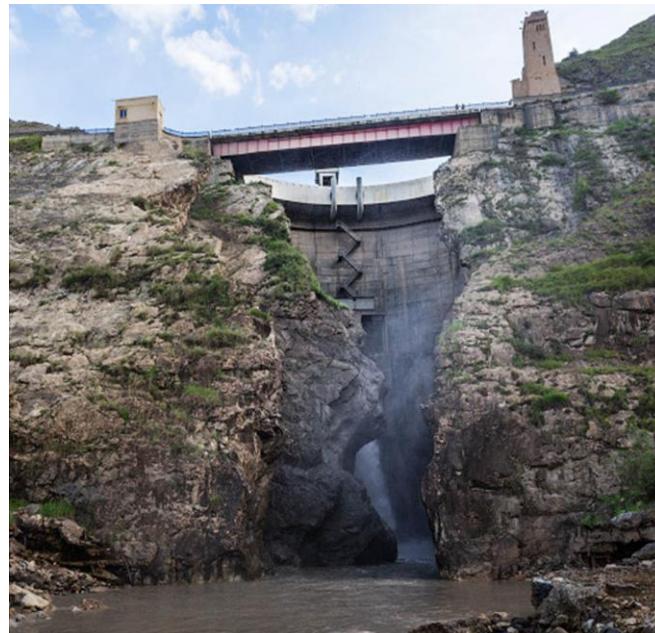
Gunib HPS (Fig.1) is placed on Kara-Koisu river in a complicated topographic and geologic situation. The narrow canyon, the bedrock in canyon sides and large amount of silt in the river were all the premises to the arc concrete solution of the dam body. The length along the ridge is 58.74 m, height – 73.70 m and the width across the ridge is 4.5 m. The transport bridge is connected with the dam.

Figure 1. Gunib HPS, Dagestan, Russia

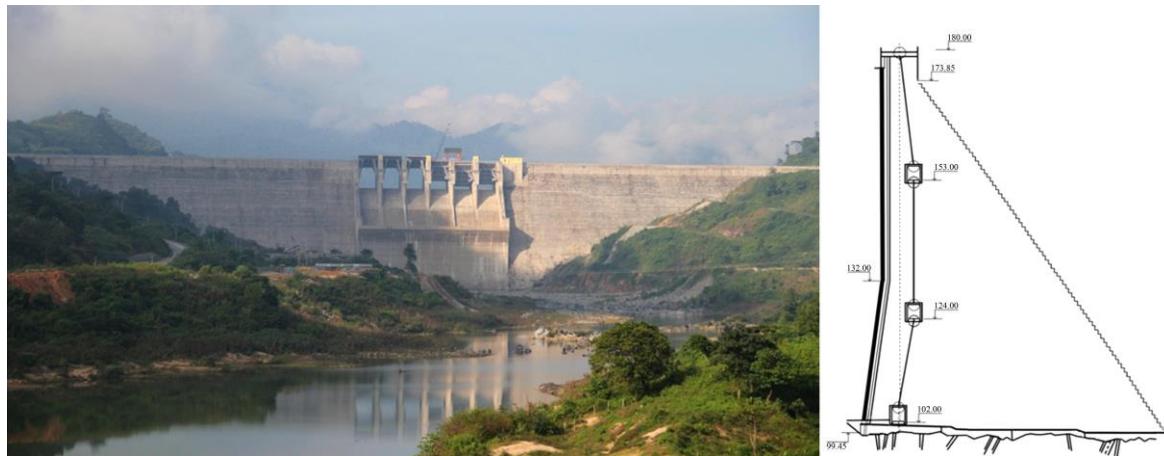
2. Another possibility to survey a dam is a combination of a scanning with technogenic vibrations and a study of its base soils by microseisms registration and surface waves analysis. An example is given by an investigation performed for the concrete gravitational dam Song Tranh-2 (Vietnam) – Fig.8. The base of the dam is granite-gneiss with cracks. The dam is designed to withstand earthquakes with M=5.5 (Ngô Thị Lu, Rogozhin, 2008).

Figure 8. The Song Tranh-2 HPS (Vietnam) view from the lower afterbay and a cross-section of the dam

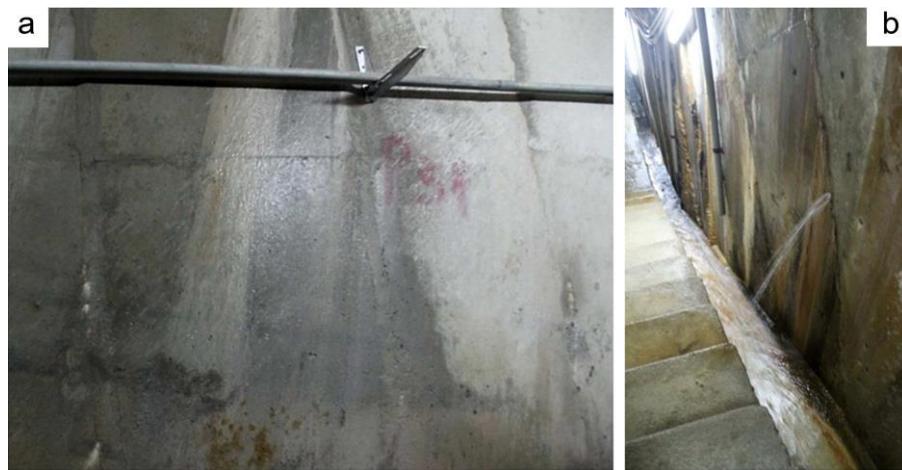
Figure 11. Photos of visual inspection inside the dam (3rd floor, N-E direction) in 2012 (a) and 2013 (b)

Fig.10 shows the spatial distributions of relative amplitudes at 3.125 Hz frequency. The wave types of the technogenic vibrations that were used for the scanning were not studied thoroughly and it is hard to relate the displacement velocities values in the dam body with deformations. Nevertheless, a homogeneous spatial picture corresponds to a homogeneously durable material and anomalies correspond to zones with material properties altered. A bright anomaly in the left part of the dam (Fig.10a, 2012) was proved to coincide with a visually found (Fig.11a) wet area with lowered durability. Some few zones seem to appear in the central part of the dam (blue spots in Fig.10a). Results of the study in 2013 (Fig.10b) confirm previous findings with a bright anomaly in left part – an inspection of the dam reveals the corresponding zone with lower durability. Additionally, the whole body of the dam exhibits a general loss in durability. The filtration level has raised resulting in visible water currents (Fig.11b).
