NEW SEISMIC METHODS FOR THE HISTORICAL CONSTRUCTIONS DIAGNOSTICS

ABSTRACT

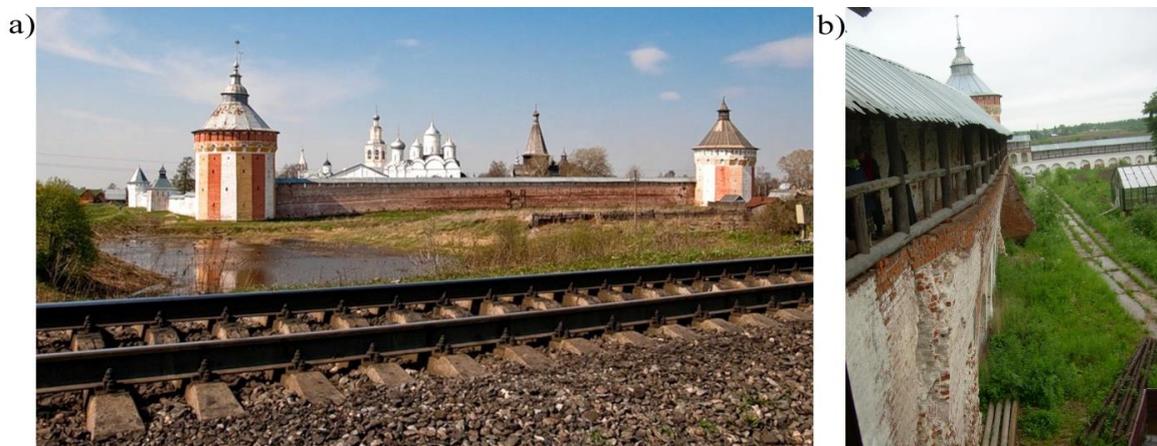
2. Another example of the seismometric technique in use is an investigation of the **southern wall of Spaso-Prilutskij monastery (Vologda, Russia)** – Fig. 8a. The purpose of the study was to estimate the impact of vibrations caused on the wall by the neighbouring railway and to find the cause of its damages.

The monastery was found in 1371 and in the current state the southern wall is damaged and is careened inside along visible cracks, which are close to towers (Fig.8b). Five controforces present to support the wall and are in poor condition too. 170 m separate the southern wall from the Northern Railway and Vologda river flows across the western wall. The vibrations caused by passing trains are tangible without any devices and are especially strong near the southern wall.

Figure 8. The southern wall of Spaso-Prilutskij monastery as observed from a) the railway side and b) from monastery courtyard

The wall is in unsatisfactory construction state and needs urgent repairs. The main source of cracks, horizontal shift and careen are caused by the founding soils. Thus, the fundament should be studied in detail and fortified. Additionally a soil fortification is recommended. The vibrations generated by the railway are found to be not responsible for the damages even if the long-time exposure takes place. Hence, the vibration isolation is not necessary.
