A NEW DETERMINATION OF FORBIDDEN DISTANCE FOR HOUSE CONSTRUCTION DUE TO A LARGE-SCALE EARTHQUAKE

Shoko KOMAI¹, Yoshiya HATA² and Ken-ichi TOKIDA³

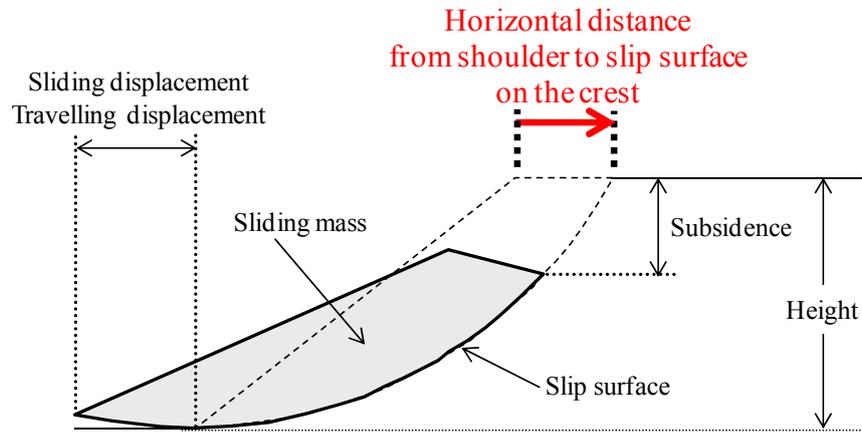
Figure 1. The importance of evaluation of slope failure range

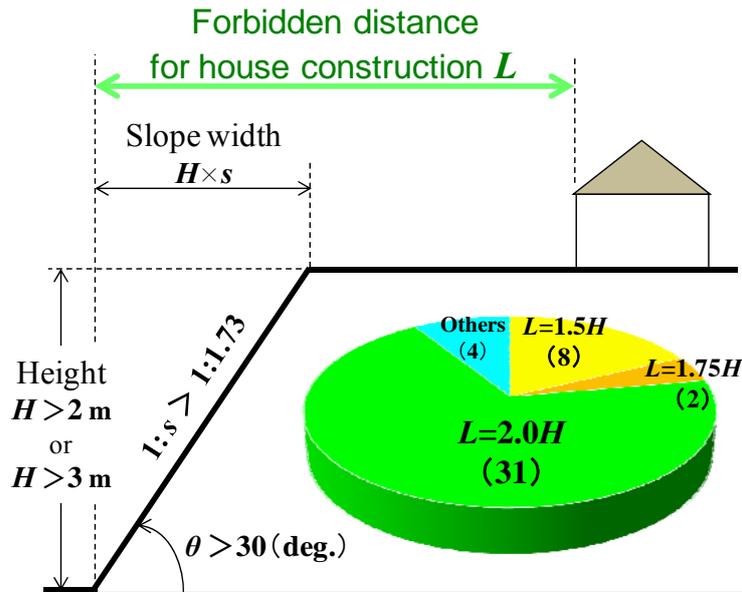
Figure 3. Present tendency of Ordinance Concerning Cliff in Japan with forbidden distance for house construction

regulations on forbidden distance for house construction close to a slope (e.g., Hirade and Tamura, 2006). In Japan, we call this enforcement ‘Ordinance Concerning Cliff’. The cliff ordinance is various by each 45 prefectures except Osaka and Nagano Prefectures. Fig.3 arranged the contents of Ordinance Concerning Cliff of 45 prefectures. The most popular Ordinance Concerning Cliff at a slope of interest is defined by the following equation.

Where, L is horizontal distance from toe of the slope crest to slip surface on the crest and H is slope height which means vertical distance from toe to shoulder of the slope (see Fig. 3). The guideline by the equation (1) is adopted in Fukushima (Asahidai Case), Miyagi (Seikaen Case and Taiyo New Town Case), Iwate (Tate New Town Case), Niigata (Takamachi Case) and Hokkaido (Midorigaoka Case) Prefectures. The other Ordinance Concerning Cliff in Hiroshima Prefecture is restricted the forbidden distance for house construction by the following equation.

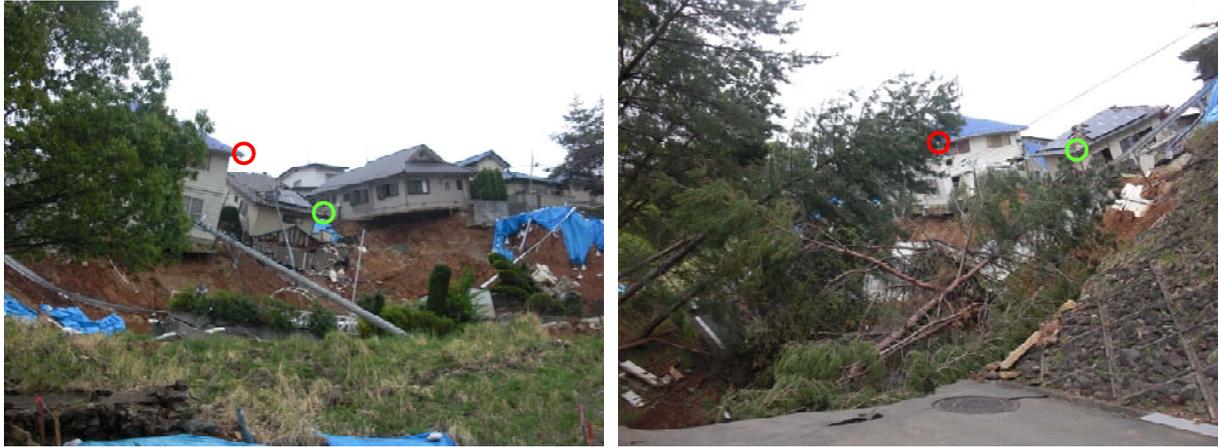
Photograph 1. Damage condition at the slope site of interest based on the author's reconnaissance results

A bird's-eye view with the condition of slope failure is shown in Fig. 4. Here, we have also added the main landslide direction (N100°W) to Fig. 4. Furthermore, Fig. 5 shows two-dimensional model of the slope of interest in the N100°W direction. In Fig.5, the height is 30 m and the gradient is 1:1.7 and 1:2.0, the slope of interest is without regulation of Ordinance Concerning Cliff in Fukushima Prefecture. However, the failure range from toe of the slope is 70.2 m (Trace of western slip surface) and 85.9 m (Trace of eastern slip surface). Moreover, the slope failure range reached to the foundation of the houses, and serious damage of some houses collapsing occurred (see Photograph 1).

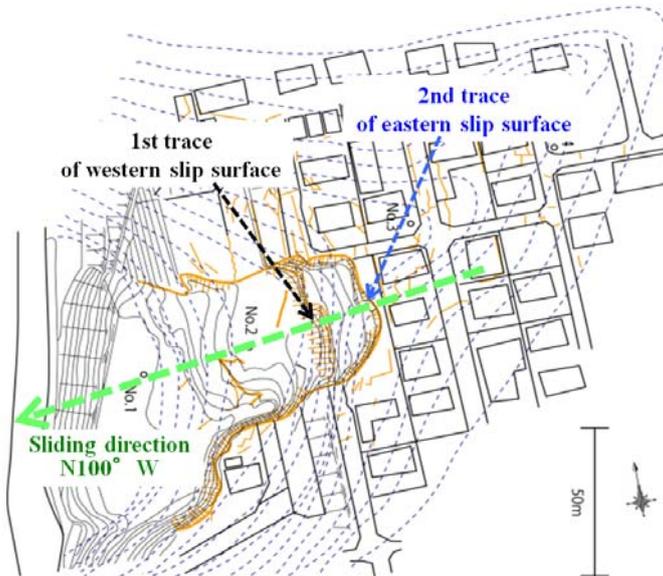
Figure 4. Bird's-eye view with the damage condition of the slope failure

In Fig.6, the estimated slope failure range is 79.7 m considering “Firstly Slip”. The estimated range is not similar with the observed slope failure range of 85.9 m. However, as shown in Fig. 4, we can observe the trace of the slope failure at not only the west side but the east side. In addition, we carried out the hearing to some residents who lived near the slope of interest. As the hearing results, they said that the failure range had not reached to the foundation of the houses immediately after the 2011 main shock. We have confirmed that the above-mentioned results coincidence with the actual results based on the resident hearing.

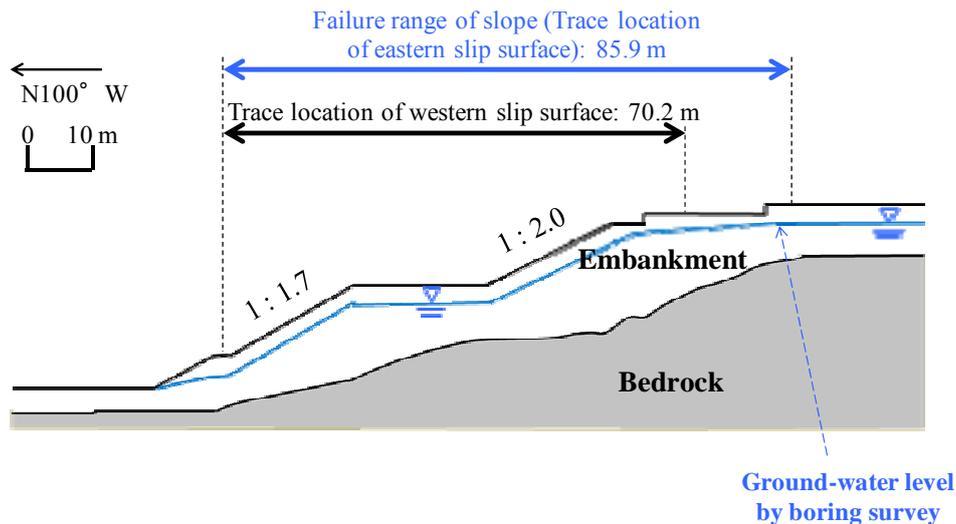
Figure 5. Two-dimensional model of the slope of interest

In Asahidai Case, the horizontal seismic coefficient k_H is 0.292. Moreover, in this fill slope, the unit weight γ is 16.87 kN/m³ based on the previous study (Ono and Nakamura, 2013), and the cohesion c is 29 kPa, internal frictional angle ϕ is 14.8 deg based on the result of CD test (Nakamura et al., 2012). The groundwater level (see Fig. 5) was based on the past ground investigation test at the site of interest (Nakamura et al., 2012).

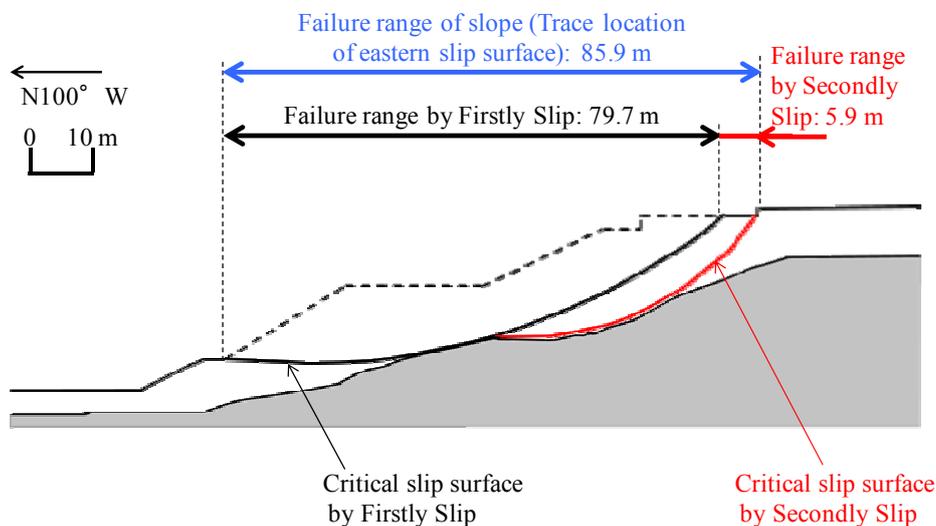
Figure 6. The results of failure range in the slope of interest

Fig. 6 shows the result of stability analysis for the slope of interest. The process of estimating the slope failure range consists of the following 3 simple steps. First, we investigate a critical slide circle to a residential fill slope based on the modified Fellenius Method (Fellenius, 1936). Here, applying the empirical equation (Noda et al. 1975) to the peak ground acceleration of a presumed earthquake motion at the slope site of interest (Hata et al., 2012b) estimated the horizontal seismic coefficient k_H . Next, we remove the sliding soil block by the critical slide circle from the above-mentioned initial slope model. We call this process the slope failure range by "Firstly Slip". Finally, based on the slope model which removed the sliding soil block by Firstly Slip, we also investigated the critical slide circle using the modified Fellenius Method without the horizontal seismic coefficient ($k_H=0.0$). We call this process the slope failure range by "Secondly Slip". We defined horizontal distance from toe of the slope to not only Firstly Slip but also Secondly Slip on the crest as the slope failure range in this study.

In this study, therefore, we carried out slope stability analysis considering “Secondly Slip”. In Fig.6, the observed slope failure range is 85.9 m, the estimated slope failure range considering not only “Firstly Slip” but also “Secondly Slip” is 85.6 m (=79.7 m + 5.9 m). The difference between the observed range and the estimated range is very small. It suggests that application for the proposed method to estimate the failure range of an embankment in this study is high comparatively.

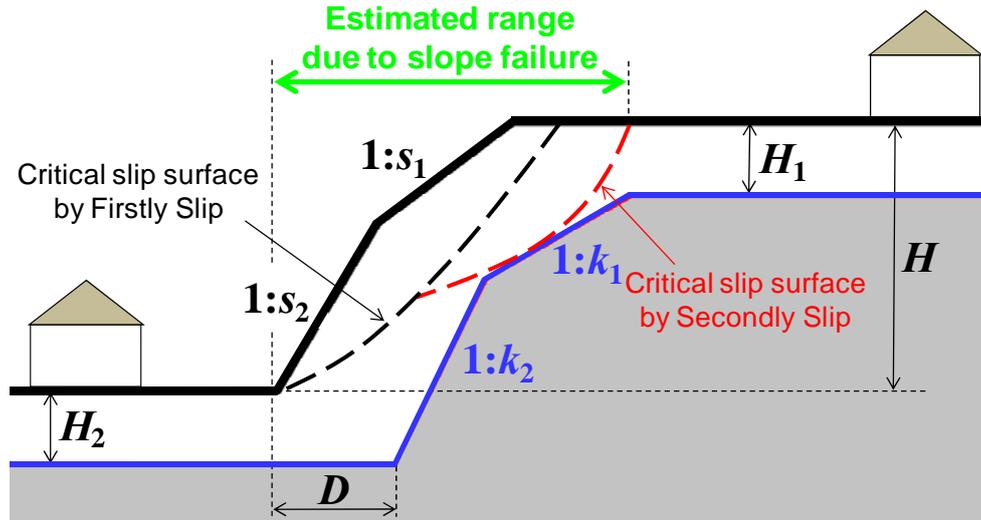
Figure 7. Some parameters which were expected to have an influence on failure range of slopes

Based on the findings obtained from the result of analysis of the 7 previously mentioned case histories, we examined the determination of the numerical calculation condition. First, as some parameters which were expected to have an influence on failure range of slope, as shown in Fig. 7, we choose 11 parameters (Slope height H , ground layer thickness from engineering bedrock to surface H_1 , H_2 , the horizontal shortest distance between embankment and inclined bedrock D , gradient of embankment slope $1:s$ (s_1 :top, s_2 :bottom), gradient of inclined bedrock $1:k$ (k_1 :top, k_2 :bottom), unit weight of embankment γ (kN/m^3), cohesion of embankment c , internal frictional angle of embankment ϕ , and horizontal seismic coefficient k_H (k_{H1} : “Firstly Slip”, k_{H2} : “Secondly Slip”).

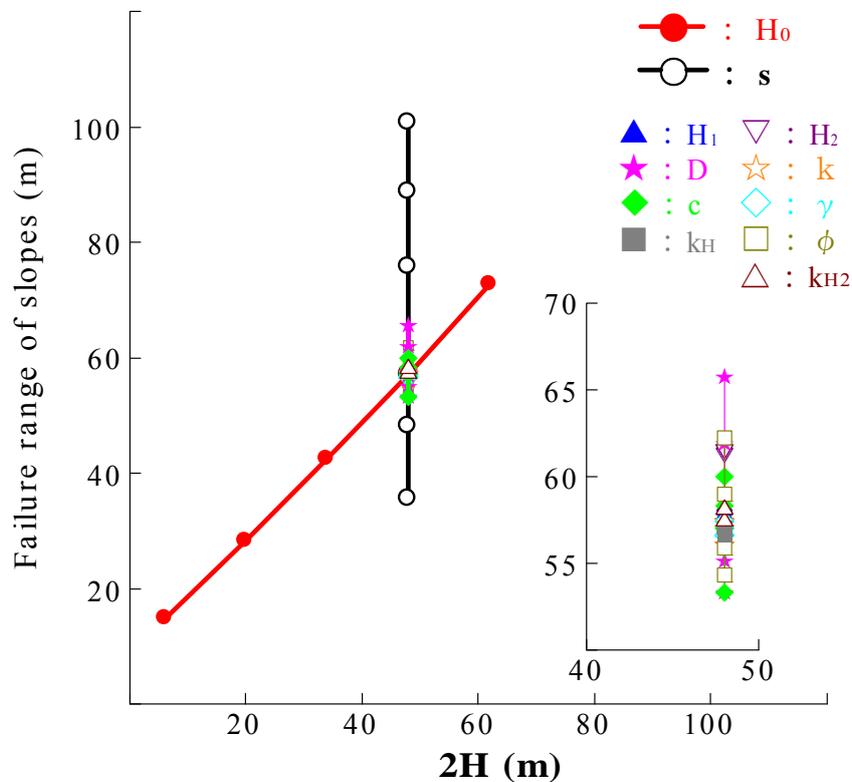
Figure 8. The results of the sensitivity analysis with the most popular Ordinance Concerning Cliff

Finally, we carried out the evaluation of failure range of slopes for all 48 cases. The evaluation method for the slope failure range is investigating critical slide circle for not only Firstly Slip but also Secondly Slip. The result of the sensitivity analysis on the reference of the most popular Ordinance Concerning Cliff by Equation (1) is shown in Fig. 8. In Fig. 8, the selected parameters to have a large influence on the slope failure range are the slope height H and the slope gradient $1:s$. In the parametric

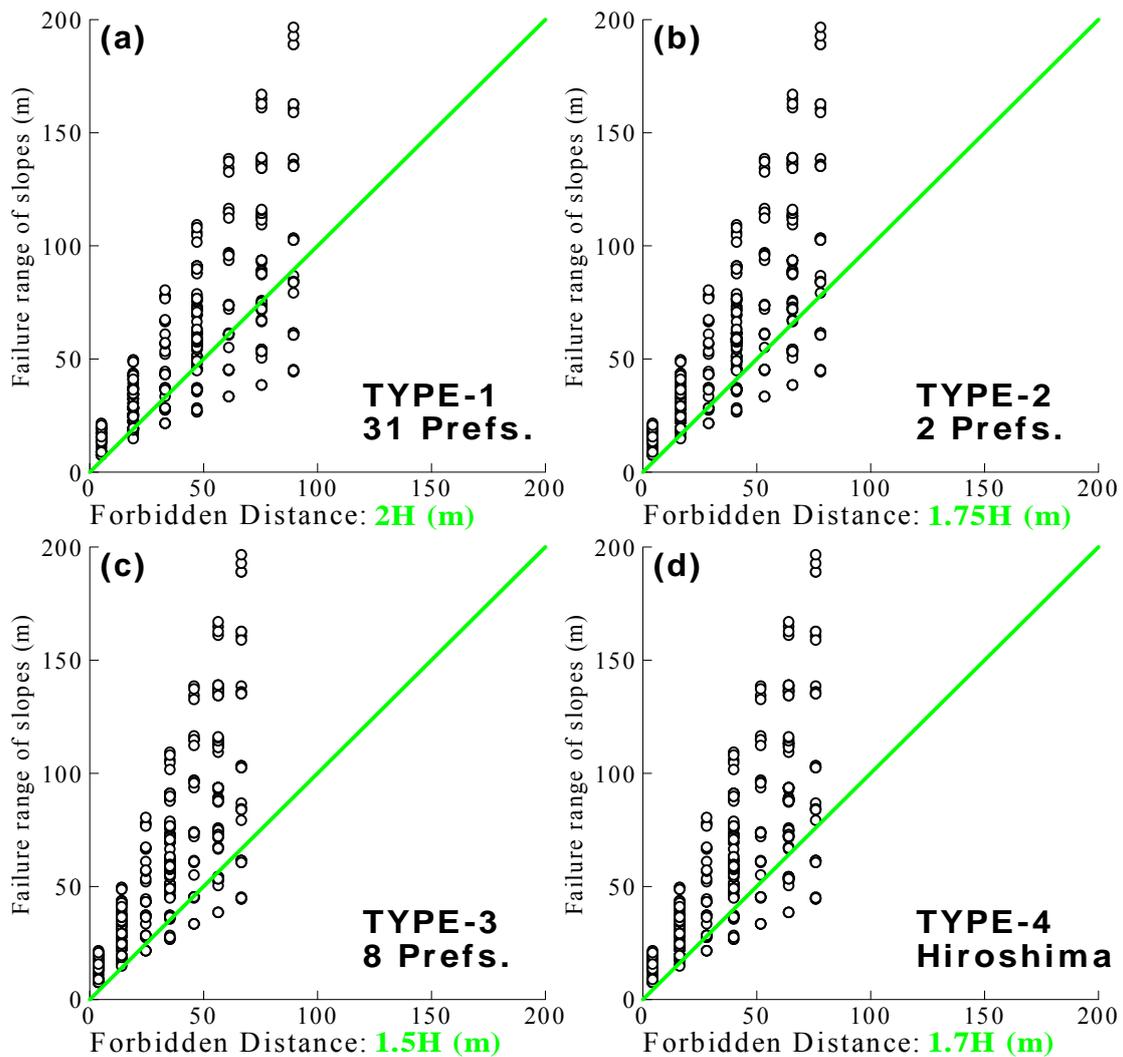
Figure 9. The estimated failure range against forbidden distance for house construction by the present Ordinance Concerning Cliff (TYPE-1~TYPE-4)

Figs. 9 and 10(a), (b), (c) indicates the special issue of the present Ordinance Concerning Cliff to examine relationships between the present regulation range and estimated slope failure range. In Fig. 9, the estimated failure range of the artificial slope of all 510 cases were distributed against forbidden distance for house construction by the present Ordinance Concerning Cliff (TYPE 1: Fig. 9(a), TYPE 2: Fig. 9(b), TYPE 3: Fig. 9(c), TYPE 4: Fig. 9(d)). As shown in Fig. 10, we also indicated the standard straight line which has an angle of 45 degrees (calling “45 deg. Line”).

If the estimated slope failure ranges plotted in “Safe Area” which located the bottom of “45 deg. Line”, we can confirm that the present forbidden distance for house construction was satisfied. If the estimated slope failure ranges plotted in “Dangerous Area” which located the top of “45 deg. Line”, we can confirm that the present forbidden distance for house construction was not satisfied.

In Fig. 9, in the present forbidden distance for house construction (TYPE 1-4), a lot of plots are distributed over Dangerous Area. Since the present forbidden distance for house construction (TYPE

1-4) are without the influence of gradient of embankment slope 1:s, it is necessary to take the influence of the gradient into consideration in the estimation equation for the failure range.

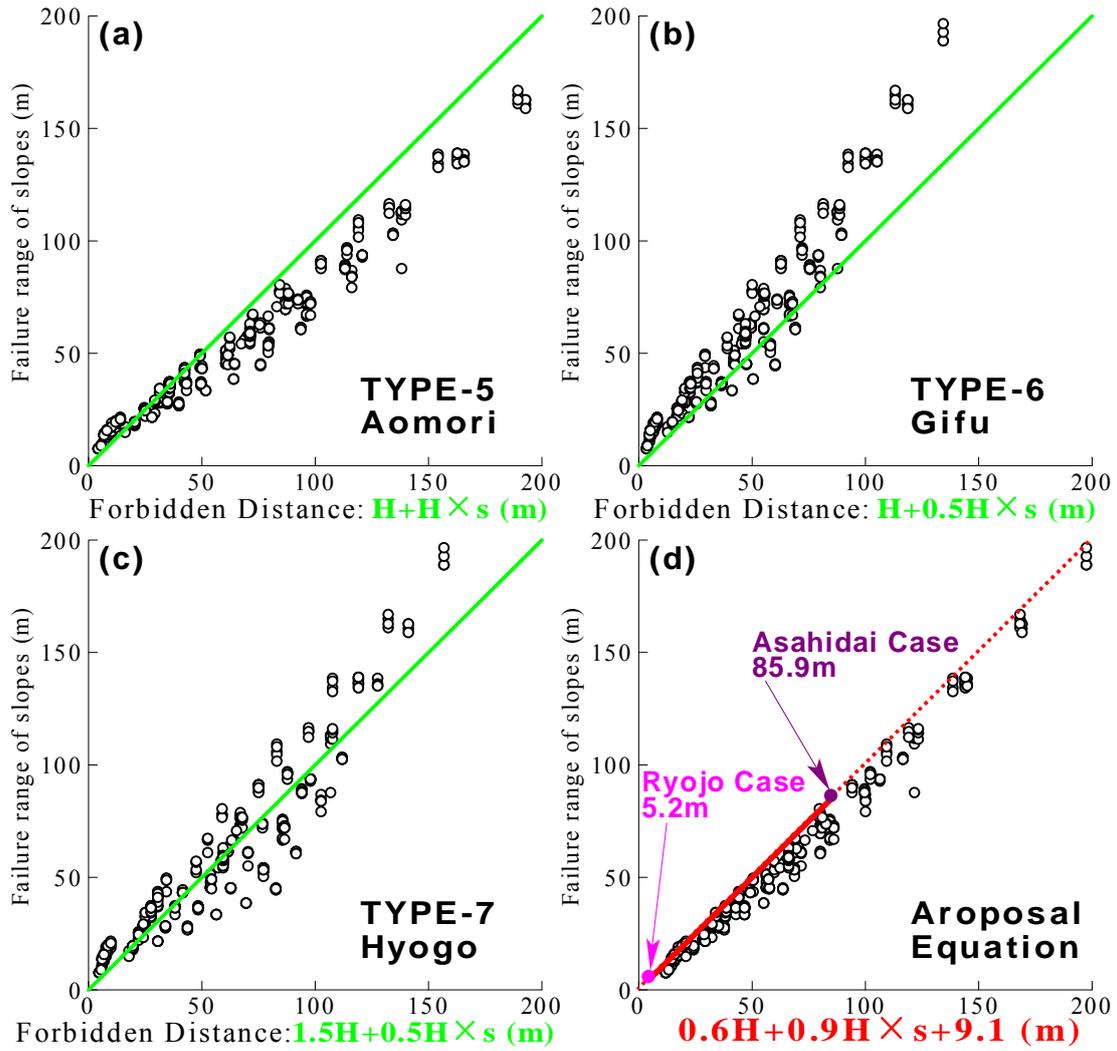
Figure 10. The estimated failure range against forbidden distance for house construction by the present Ordinance Concerning Cliff (TYPE 5~TYPE 7), and the proposed equation considering special issue in this study

Fig. 10(a), (b), (c) indicates the distribution of the estimated failure range of the artificial slope of all 510 cases against forbidden distance for house construction by the present Ordinance Concerning Cliff (TYPE 5: Fig. 10(a), TYPE 6: Fig. 10(b), TYPE 7: Fig. 10(c)) with “45 deg. Line”. In Fig. 10(a), (b), (c), a lot of plots are distributed around 45 deg. Line. Based on the comparison between Fig. 9 and Fig. 10(a), (b), (c), the estimated accuracy of the slope failure range using the equations is improved by consideration of gradient of embankment slope 1:s.

However, a tendency to evaluate the slope failure range in “Safe Area” is strong comparatively with the present regulation of TYPE 5 by following equation (see Fig. 10(a)).

In addition, a tendency to evaluate the slope failure range in “Dangerous Area” is strong comparatively with the present regulation of TYPE 6 by following equation (see Fig. 10(b)).

Moreover, in Fig. 10(c), the estimated slope failure range distributed in not only “Safe Area” but also “Dangerous Area” with the present regulation of TYPE 7 by following equation.

In Figs. 9 and 10(a), (b), (c), use of the present forbidden distance for construction of houses by Ordinance Concerning Cliff cannot estimate the slope failure range of a residential fill slope with sufficient accuracy.

Therefore, based on the findings acquired from the above-mentioned analyses, we proposed the new determination of the forbidden distance for house construction by Ordinance Concerning Cliff. Fig. 10(d) shows the estimated the failure range of the 510 artificial slopes were plotted with the new regulation of forbidden distance for house construction by following equation.

$$L=0.6 \times H+0.9 \times H \times s+0.91 \quad (6)$$
