VULNERABILITY ASSESSMENT OF CLASSICAL COLUMNS WITH DISLOCATED DRUMS

Ioannis STEFANO¹, Michalis FRAGIADAKIS² and Ioannis N. PSYCHARIS³

ABSTRACT

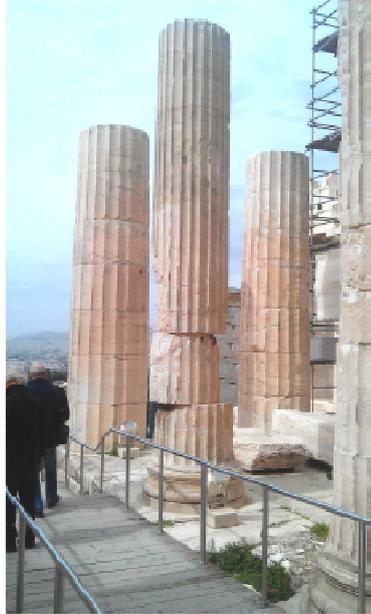
Figure 1. A column at Propylaia of Acropolis hill in Athens, Greece. Drum dislocation is observed above the first drum.

Classical monuments are particular masonry structures made of discrete bulgy stone blocks. A common structural element of these ancient structures is the multidrum column (Figure 1), which consists of bulgy discrete drums stacked one on top of the other without mortar. During earthquakes, the columns respond with intense rocking, wobbling and, depending on the incipient ground motion, with sliding of the drums. In some cases, steel connections (dowels) are provided at the joints, which restrict, up to their failure, sliding but do not affect, in general, rocking.

In order to explore the effect of drums’ dislocations on the seismic performance of the column, two different configurations of the same column were considered. The “intact” column (Figure 2a) is made of seven drums of diameter equal to 1.00 m, and height equal to 0.85 m. The “damaged” column has the same size and number of drums with the intact one, but above the first drum there is a dislocation of 15% of the drum’s diameter, i.e. 0.15 m (Figure 2b). This dislocation may be attributed to previous earthquake events or to human activity (e.g. an explosion as in the case of the Propylaia column of Figure 1).
