PIPELINE DAMAGE ASSESMENT USING HORIZONTAL DISPLACEMENTS FROM AIR PHOTO AND LiDAR MEASUREMENTS IN AVONSIDE AREA, CHRISTCHURCH, NZ

ABSTRACT

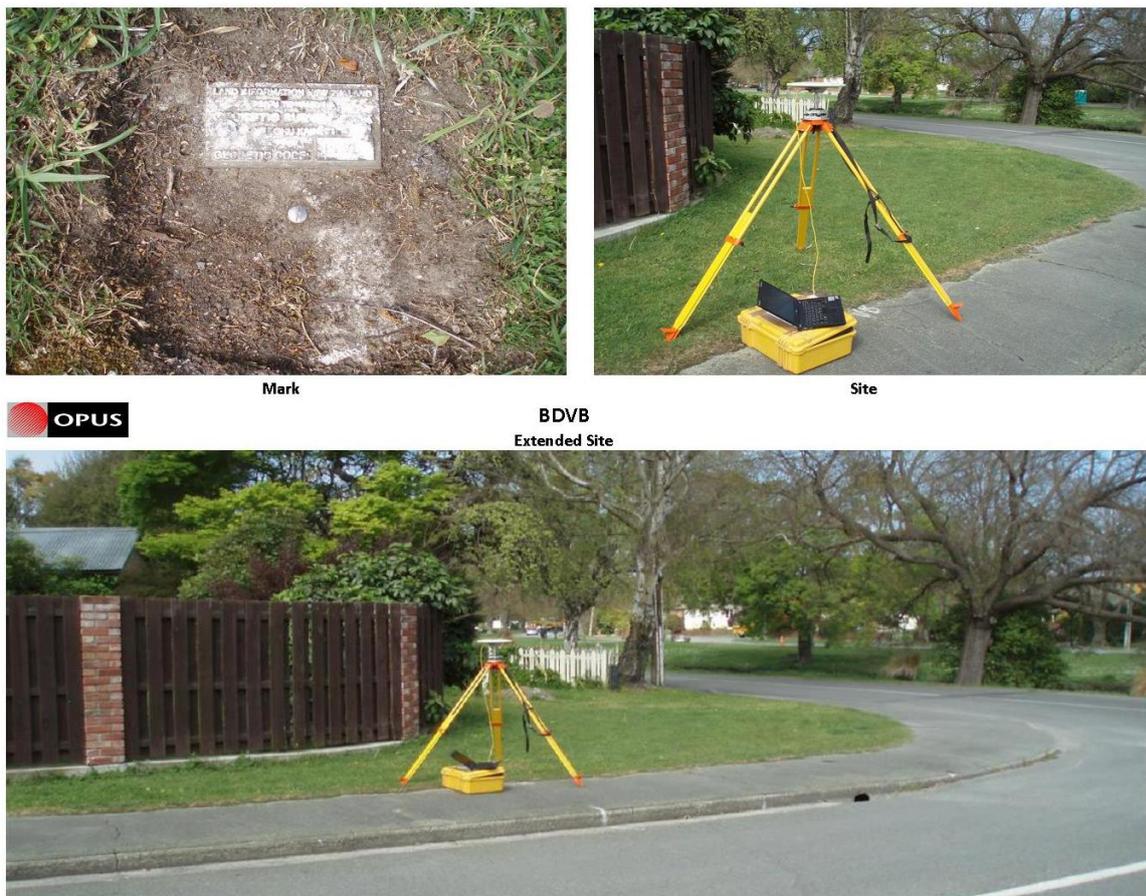
Figure 2. Benchmark measurements (from http://apps.linz.govt.nz/gdb/index.aspx?nextform=image&image_id=108377&mode=&sessionid=11555239158881397733794&code=BDVB)

There exist some benchmark displacement measurements in Christchurch area after the Canterbury earthquake sequence. Canterbury Geotechnical Database (CGD) provides about 403 benchmarks and their movement relative to earliest survey values after three big earthquakes. These data consist of information from Land Information New Zealand (LINZ), Christchurch City Council, The Earthquake Commission (EQC) and CERA. Figure 2 (LINZ 2014) shows how benchmark looks like and how land movements are measured. There are 25 benchmarks from 403 benchmarks in Avonside area which are used in comparisons with LiDAR and air photos displacements.
