BEHAVIOR OF TWO EARTH-FILL DAMS DURING THE 11 AUGUST 2012 ARASBARAN, IRAN PAIR EARTHQUAKES

ABSTRACT

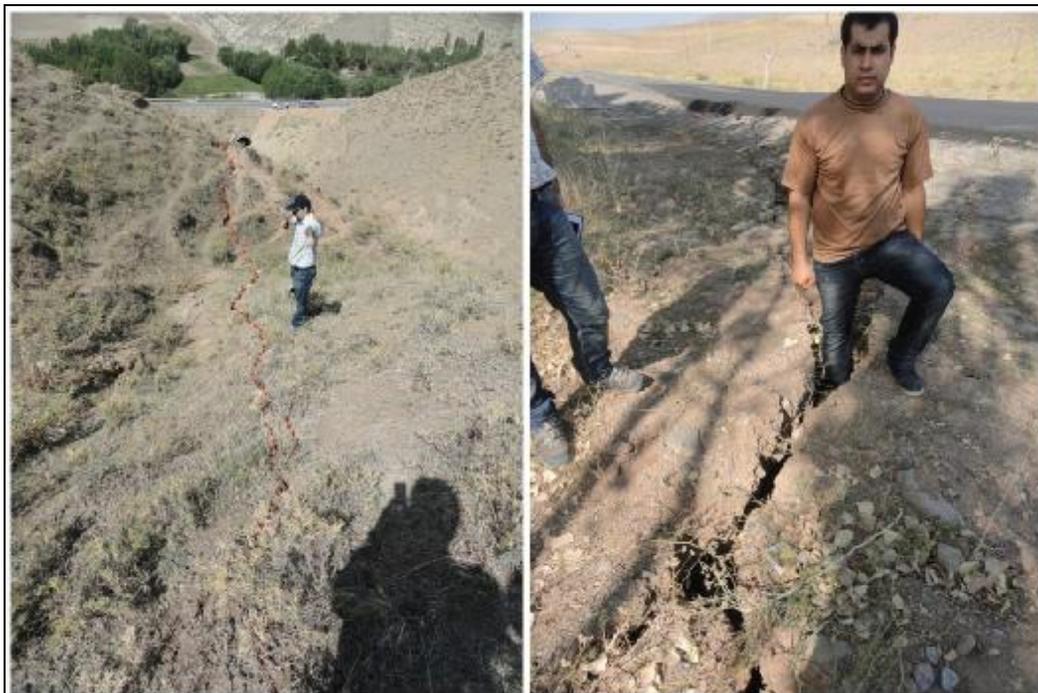
Figure 5. A surface displacement due to lateral spreading near a gully close to the south Varzeghan fault (left) and the maximum measured displacement observed in the field (right).

In the field visit that took place following the occurrence of the pair earthquakes, the seismic source was recognized (Figures 4 and 5) and the Sattar-Khan and Nahand Dams responses to the quakes were investigated. The evidences showed that co-seismic surface deformation of the 11 August 2012 Arasbaran earthquakes consisted of surface tensional features with various, but an east-west dominant trends. With regard to their trend dispersions, they cannot definitely be related to a distinct seismic source. On the Tabriz-Varzeghan road, about 5 Km to Zaghan-Abad Village the maximum co-seismic horizontal and vertical displacements were measured 50 and 30 cm, respectively. Some of these types of failures were resulted on the ground lateral spreading near to gullies. Another surface deformation feature due to these earthquakes was planar landslides occurrence in foothills. Thus, it can be implied that the seismic surface deformation belongs to a secondary co-seismic surface rupture type rather than a primary type.

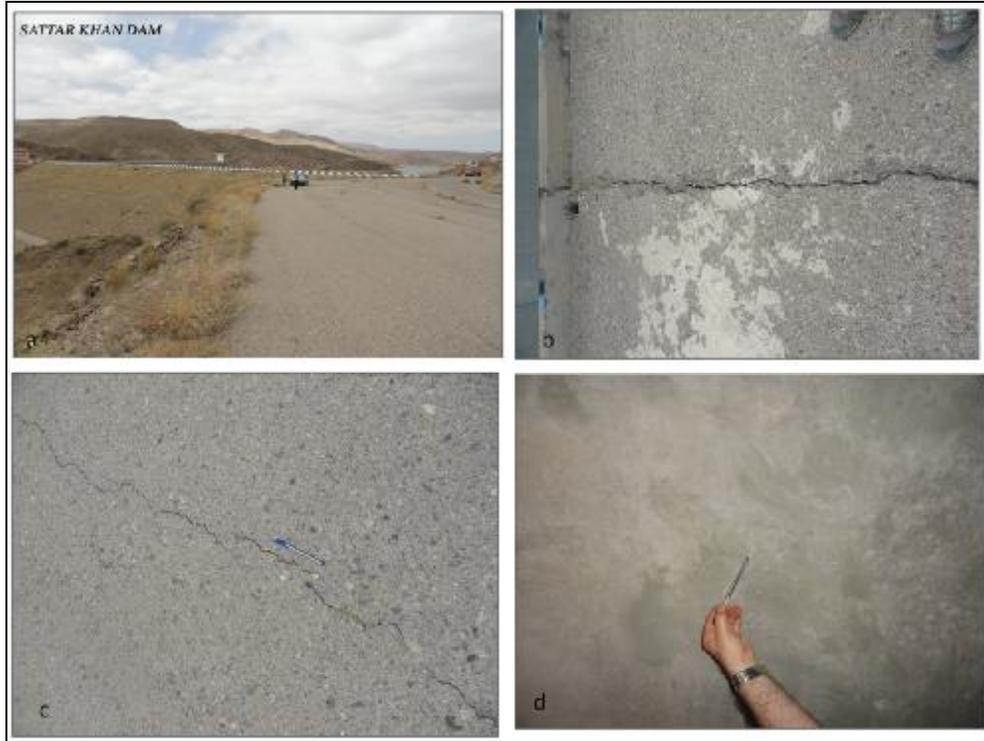
Immediately after the earthquake, a special committee of the dam stability based at the East Azarbaijan Regional Water Organization observed the Sattar-Khan dam and did not report any special case of damage on the dam. However, some longitudinal cracks, sliding and siphon blocks was reported at the vicinity of the downstream irrigation network. During the visit, equipment operation buildings, drainage gallery under the dam body and the dam body were observed. No special sign of damage was observed on the dam body. Some transversal cracks (Figure 6b, 6c) on the asphalt on the crest near the left abutment were very shallow and because of growing of vegetations in them, were not related to the earthquakes.

Drainage gallery under the dam body was also visited. Other than hairy cracks (Figure 6d) in the gallery lining which was not clear whether or not were related to the earthquakes, no specific feature was observed. No water leakage was observed through the cracks. Debit of the drainage gallery at the grouting curtain had no change with the debit before the earthquakes

Figure 6. a) Downstream face of Sattar-Khan dam, b and c) Some old tension cracks on the crest of dam, growing the vegetation are seen in trace of cracks, d) Hairy cracks in the drainage gallery under the dam body.

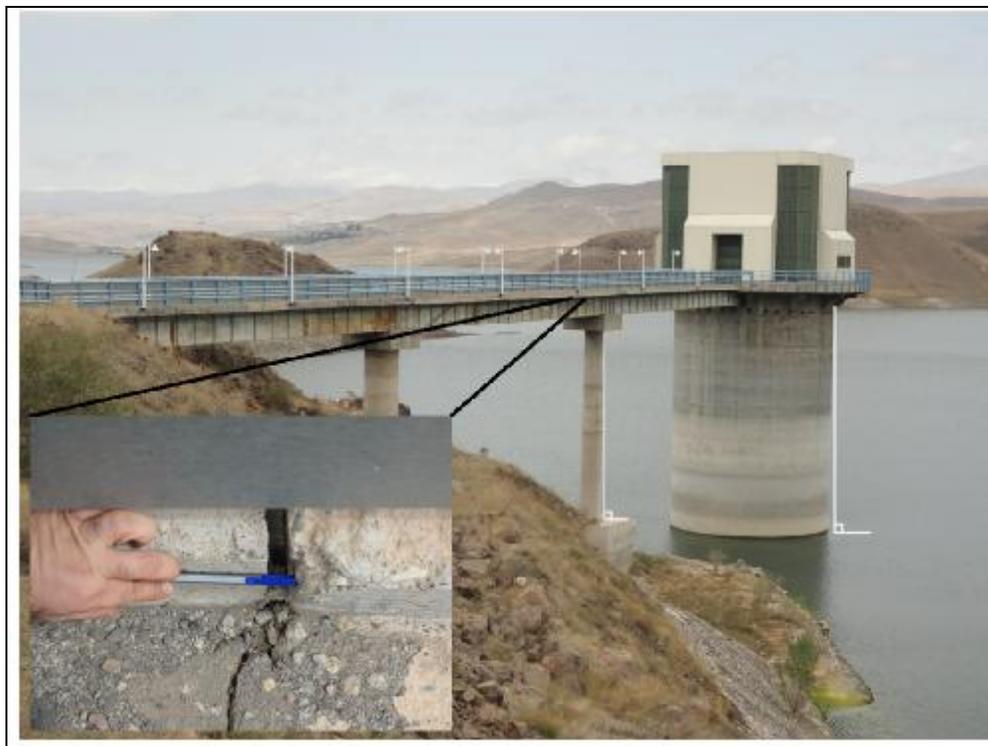
A doubt on a small creation of inclination in the middle column of the bridge between the dam intake tower and the dam body could be observed (Figure 7). The middle column of the intake tower connecting bridge toward the reservoir's right bank which has a higher height and narrower diameter has likely presented a different response to the earthquakes and seems that has inclined a little bit. Getting closer to the bridge, a continuous transversal crack on the access bridge to the intake tower was observed exactly on the middle column which a 4 cm right lateral displacement was observed along this crack (Figure 7). Taking into consideration that the dam intake tower has shown a different response to earthquake compared to the dam body, entrance control gates of the intake shaft needed to be controlled. The authorities of the East Azarbaijan regional water stability committee and the operator of the dam assured that this problem was controlled immediately after the earthquake and were sure of its safe operation. After impounding two steps micro-geodesy monitoring were performed. A strict proposal was made to the authorities of the dam operation to start a new monitoring process.

Figure 7. Sattar-Khan dam intake tower. There is a doubt in development of a small inclination in the middle column of the bridge between the intake tower and the dam. The observed crack on the middle column is shown in the lower left corner.

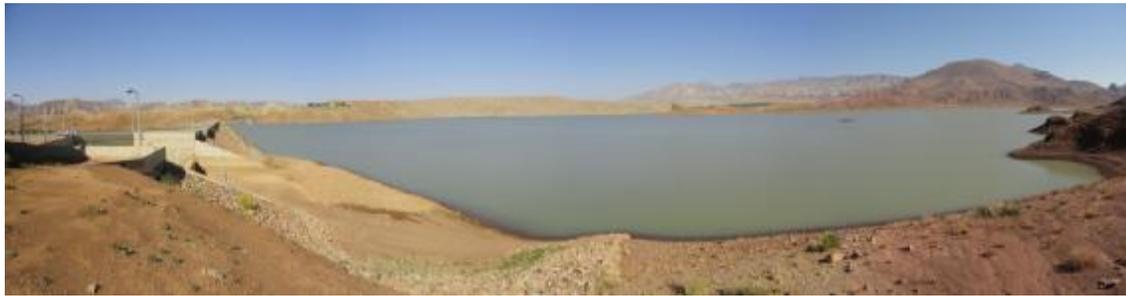
The Nahand earth-fill dam with clayey core (Figure 8) is located 43 km to the northeast of Tabriz City, the capital of the East Azarbaijan province. This dam was built to regulate about 32 million cubic meters of water annually to partially supply the drinking water mid-term supply of Tabriz City. The height of the dam from the river bed is 35 m, the length and the width of the crest are 730 m and 8 m, respectively, and the total reservoir volume is 24 million cubic meters. The length of the non-gated spillway is 30 m. The intake tower is reinforced concrete which two gates with maximum capacity of 5 cubic meters per second discharges the water.

Figure 8. Nahand dam and its reservoir.
