## EVALUATION OF SEISMIC RISK OF INDUSTRIAL FACILITIES

### ABSTRACT

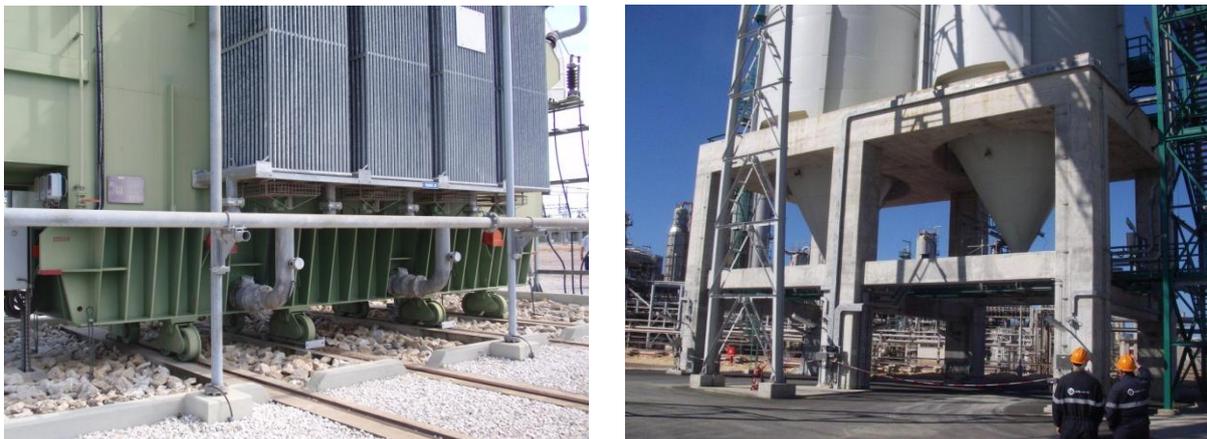
Figure 2 – Examples of analysed structures and equipments

The first phase of the project comprised technical meetings with the main stakeholders and visits and inspections to the respective facilities. The choice of the equipments to be analysed was based on two criteria: the importance of the equipment/facility, measured by the impact of disruption on the facility, and its apparent seismic vulnerability. Figure 2 shows some structures/equipments that were analysed.

It is expected that several suggestions to prevent damage or to repair structures can be offered to the stakeholders as a result of the REAKT project. For instances the following suggestions can be offered regarding the cases shown in figure 2. In the case of power transformers, the solution is simple and straightforward: to fix them to the foundation, for instances as shown in figure 11. In the case of the pipes, the first step is to assess if the potential transversal movements are large enough to cause damage, and if yes, to improve the transversal supports to prevent the movement, and if necessary to strengthen the support columns and foundations. The floatation of the containers cannot be avoided, but eventually it may be worth to try to prevent them from reaching other facilities. The problem of the water main can also be solved by burying it and/or creating redundancies (another water main in a different path) of similar capacity. In the three first cases the solutions are extremely cost effective, as the potential benefits are much higher than the respective costs.

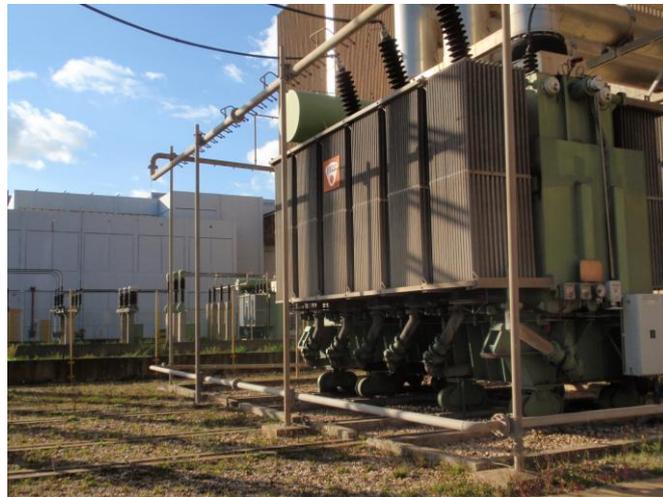
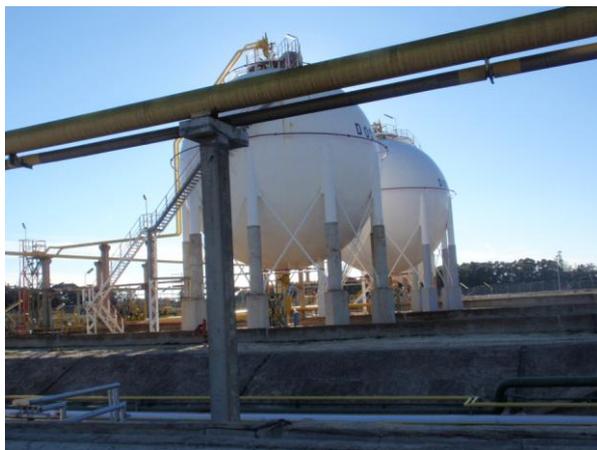
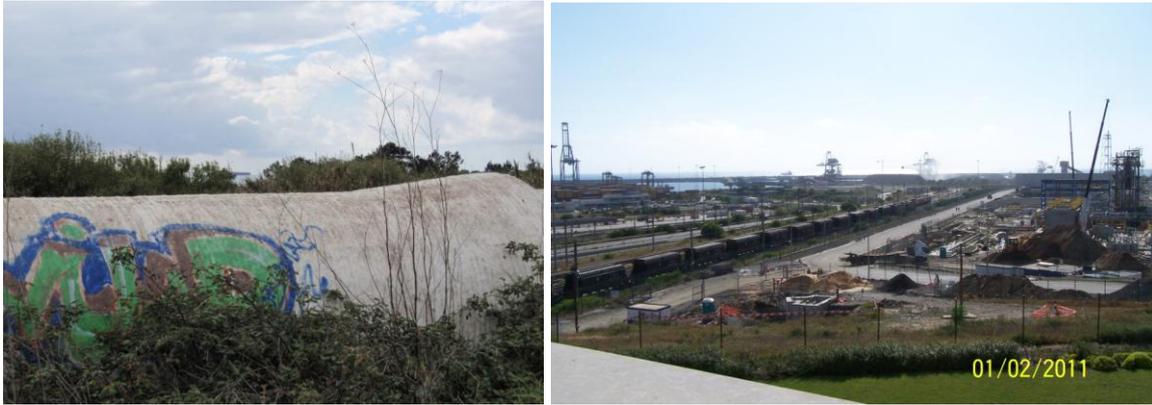
Figure 3 – Equipments with some vulnerabilities

The contact with each stakeholder started with a meeting in the respective facilities, where these were described in general, essentially from a functional point of view. Since some facilities are near the sea, during the inspections the tsunami risk was also considered, even though it was not part of the REAKT proposal. As a result of the inspections several weaknesses were identified. Figure 3 show some examples: a) power transformers: lack of anchorage, that allows horizontal displacements and possible damage in the connection to other equipments; b) and c) lack of transversal connections in pipes, allowing the pipes to fall from the supports or hit each other due to transversal movements; d) water main near and parallel to the coast, exposed to tsunami wave; e) containers that can float to other facilities if there is a tsunami.

a) Transformers

b) Pipes

c) Water main parallel to the coast                      d) Containers (left) and other facilities behind

Some of these weaknesses derive from a fact, that is thought to be common in Europe, that many industrial equipments are not designed, built and mounted with the concern of providing seismic resistance. This is due to two reasons: i) seismicity and seismic risk is not part of the curricula of university courses of mechanical and electrical engineering, and other engineering courses, and ii) lack of technical codes, (Lopes and Oliveira, 2001). The second reason is a consequence of the first one and both are related with the priorities at the early stages of modern earthquake engineering. At those times, several decades ago, the priority was the safeguard of the human life, therefore avoiding the collapse of civil engineering structures. Besides, the industry and the lifelines were less important than they are today, especially in developed societies. Therefore much more attention was paid to buildings, bridges and other structures, than to electromechanical and other equipments. However it was noticed in the meetings and inspections that more recent facilities were design and built according to more stringent requirements, including very demanding specifications for seismic design. A very clear example were the technical specifications for the Gas Terminal, built between 2001 and 2004, that prescribed a  $PGA=0.5g$  (Tractebel et al, 2001) for ultimate limit state design of the most important equipments, approximately the double of the value prescribed in the code in force at the time for current buildings. Another example was the Artland factory of pta (a plastic product used for several purposes), where the inspections revealed almost no weaknesses, which obviously does not mean they don't exist as the inspections were not detailed and exhaustive, but indicates that are probably much less in number and importance than in older facilities. Therefore the main source of information and parameter used to the general assessment of facilities and equipments that were not analysed with detail (all but a few exceptions) were the general perception that resulted from the inspections, coupled with the date of design and construction obtained in the meetings and inquiries.
