Turkish Earthquake Foundation - Earthquake Engineering Committee
Prime Ministry, Disaster And Emergency Management Presidency

SEISMIC RETROFITTING OF DEFICIENT RC BUILDINGS WITH POST-TENSIONED METAL STRIPS: FULL-SCALE SHAKE-TABLE TESTS

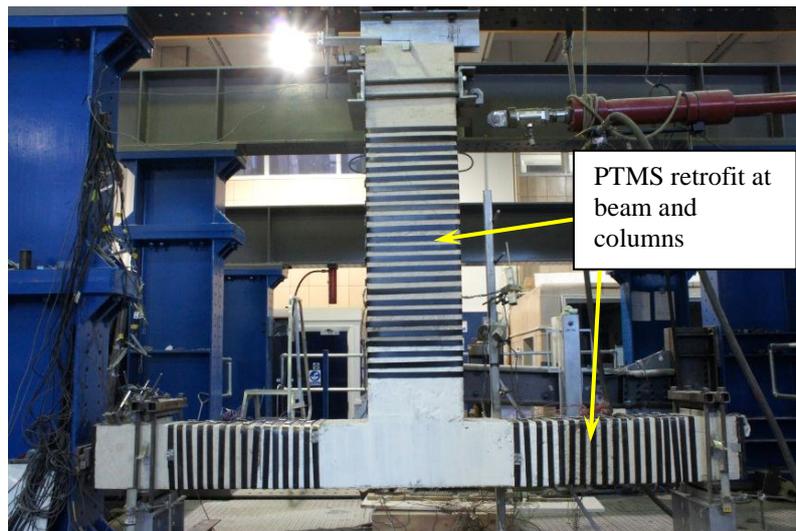
Figure 1. Retrofitting of beam and column of RC joint using the PTMS technique (column shown horizontally)

An economical, faster and less intrusive retrofitting technique using Post-Tensioned Metal Strips (PTMS) was developed at the University of Sheffield (Frangou et al., 1995; Frangou, 1996). The PTMS technique involves the post-tensioning of high-strength high-ductility steel strips (“banding”) around concrete members using hydraulically-powered standard strapping tensioning tools as those used in the packaging industry. To maintain the post-tensioning force, the strips are mechanically-fastened with push type metal clips clamped using a pneumatic sealer (jaws). As a result, active confinement is provided to the strengthened component even before applying load. Recent research (Helal, 2012) demonstrated the effectiveness of the PTMS technique at enhancing the shear capacity of deficient joints by up to 95%. The technique can be also used to strengthen beams and columns of joint specimens (see Figure 1 taken from Garcia 2013). However, to date the effectiveness of the PTMS technique at enhancing the behaviour of a real full-scale RC structure has not been verified.

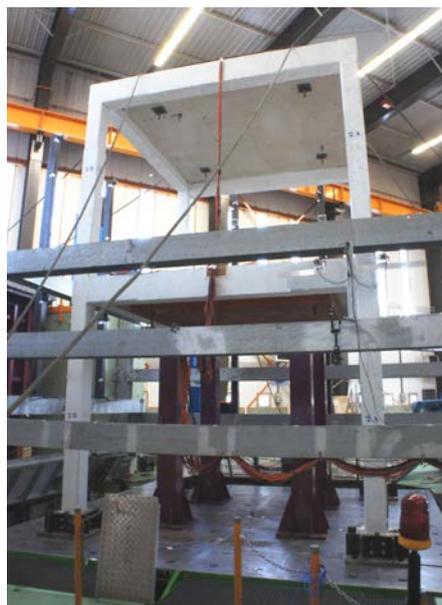
Figure 2. View of BANDIT building prior to tests and PTMS retrofitting

This paper examines the effectiveness of the PTMS technique at improving the performance of a full-scale RC building with poorly detailed beam-column joints. The structure was tested on the AZALEE shake table of the CEA/EMSI laboratory in Saclay, France, as part of the multi-phase EU-funded BANDIT project within the FP7 SERIES programme (Seismic Engineering Research Infrastructures for European Synergies). Figure 2 shows a general view of the BANDIT building.
