ON THE COLLAPSE OF BRIDGE FOUNDATIONS IN LIQUEFIABLE SOILS DURING EARTHQUAKES

Subhamoy BHATTACHARYA¹ and Andreas KAPPOS²

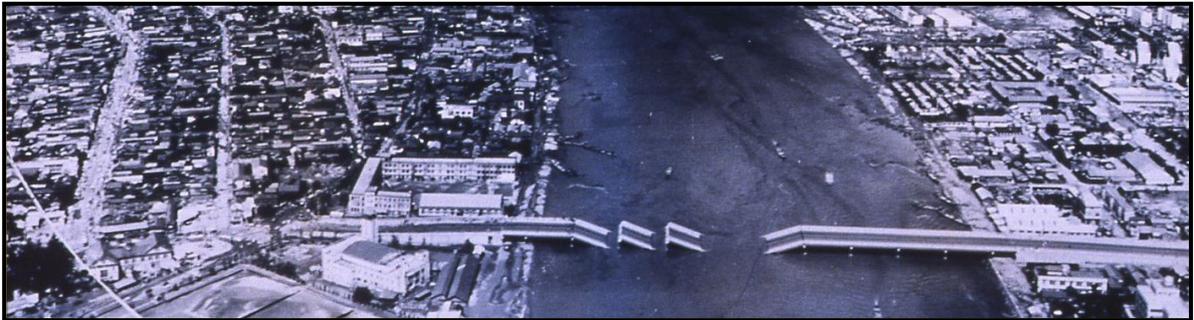
Figure 1: Showa Bridge collapse during 1964 Niigata Earthquake

In the context of bridge foundations, it is a common observation in liquefaction-related bridge failure that piers (intermediate supports) collapse, whilst the abutments (end supports) remain stable, see for example Figures 1,2 and 3. Figure 1 shows the collapse of the Showa bridge after the 1964 Niigata earthquake which will be discussed in details in this paper. Figures 2 and 3, on the other hand shows the collapse of the Million Dollar bridge after the 1964 Alaska earthquake and the collapse of Nakatsuno bridge following the 1948 Fukui earthquake. Similar observations were also observed in other earthquakes, see for example 1990 Luzon earthquake (Philippine), 2010 Chile earthquake.

Showa Bridge, a simple steel girder bridge supported on piled foundations, were one of the many bridges that collapsed during the 14th June 1964 Niigata earthquake, see Figure 1. The total length of the bridge was about 307m. The bridge had 12 composite girders and its breadth was about 24m. The main span length was about 28m and side span length was about 15m (Fukuoka 1966), see Figure 6. The collapsed view from the southwest of the Showa Bridge is shown in Figure 1.

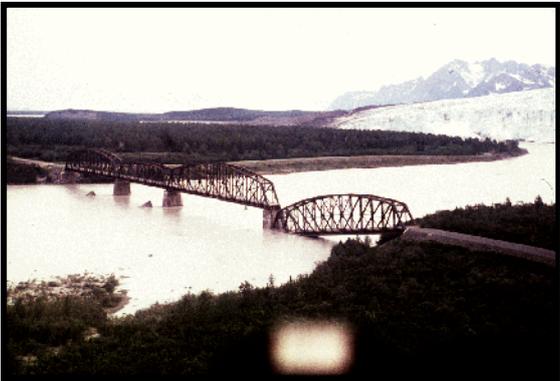
Figure 2: Million Dollar Bridge collapse during 1964 Alaska Earthquake

Typically, the lateral load carrying capacity of a pile is 10 to 20% of the axial load capacity. Therefore, for a typical multiple span bridge having similar span lengths, the number of piles supporting an abutment is larger than the number of piles supporting a pier. As it can be observed from Fig 1 and 2, collapse of pile-supported bridges in seismically liquefied soils is often characterised by tilting or failure of pier(s) and the subsequent collapse of the bridge deck(s). It is worthwhile to note that in these examples bridge piers collapsed whilst the abutments remained stable.

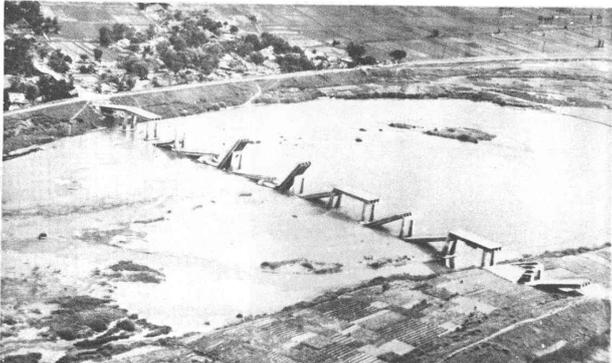
Figure 3: Nakatsuno Bridge collapse during 1948 Fukui earthquake (Japan)

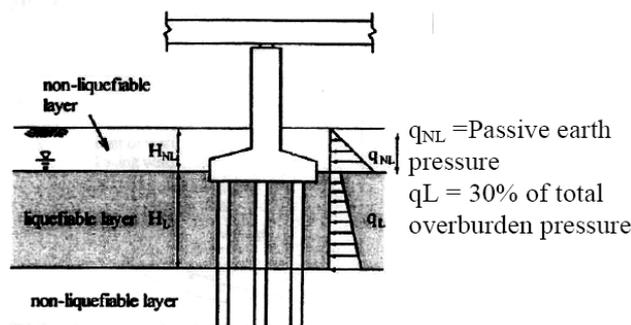
The Japanese Code of Practice (JRA 2002) has incorporated this understanding of pile failure and as shown in Figure 4. The code advises practicing engineers to design piles against bending failure assuming that the non-liquefied crust offers passive earth pressure to the pile and the liquefied soil offers 30% of the total overburden pressure. Other codes such as the USA code (NEHRP 2000) and Eurocode 8, part 5 (1998) also focus on the bending strength of the pile. This simply treats piles as beam elements and assumes that inertial lateral loads and lateral spreading cause the bending failure of the pile. A good discussion can be found in Bhattacharya and Madabhushi (2008).

Figure 4: JRA (1996 or 2002) code of practice showing the idealization for seismic design of bridge foundation.

Therefore, two separate calculations are necessary considering two different loading conditions based on Japanese Highway Code of practice JRA (JRA, 2002): (a) kinematic loading exerted by the lateral pressure of the liquefied layer and any non-liquefied crust resting on the top of the liquefied deposit - see Figure 4; (b) inertial force due to the oscillation of the superstructure. The code recommends engineers to check against bending failure considering inertia and kinematic forces separately.

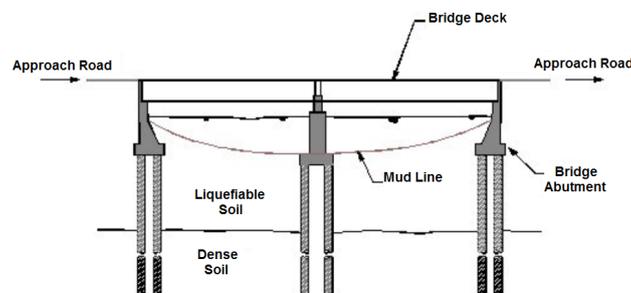
In bridge design, the number of piles required to support an abutment is governed by lateral load considerations since the abutment has to retain earth and fills of the approach roads. It is also noted that abutment piles carry the vertical load of the deck. On the other hand pile foundations supporting bridge piers are predominantly designed to support the vertical loads only. Figure 5 presents the schematic diagram of a typical two span bridge showing the abutment and pier foundations. From static equilibrium, for a multiple span bridge having similar span lengths, abutments support a vertical load equal to one-half of the vertical load supported by a pier.

Figure 5: Schematic diagram of a typical two span bridge showing the abutment and pier foundations.

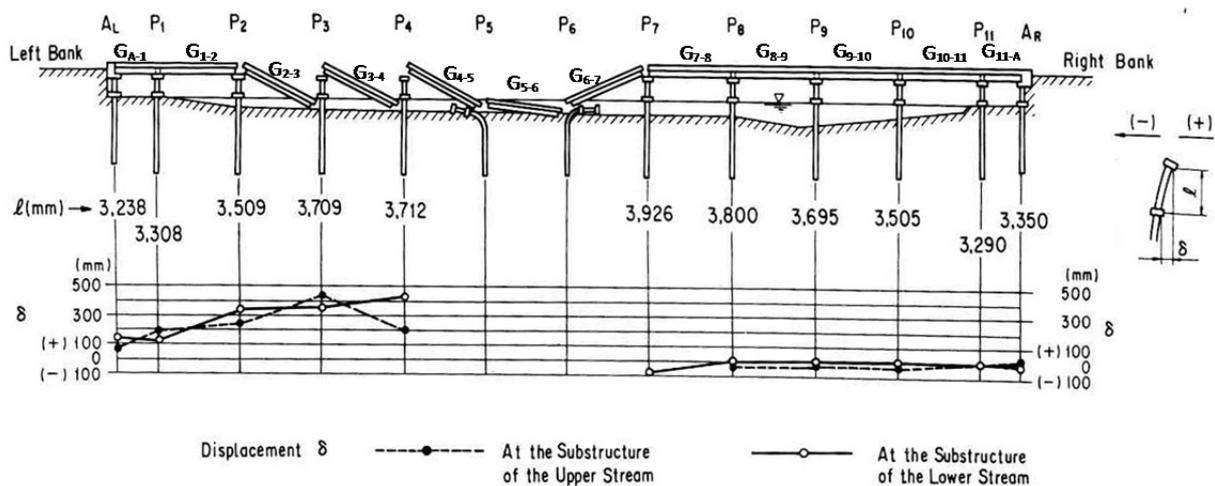
During the 1964 Niigata earthquake, the bridge site was subjected to extensive liquefaction and lateral spreading. Reliable eyewitnesses quoted by Horii (1968) and Hamada and O'Rourke (1992) along with the progressive damage simulation by Kazama et al. (2008) suggest that the bridge collapsed 1-2 minutes after the peak ground acceleration (PGA) had ceased. Yoshida et al. (2007) collated many eye witness statements and established the chronology of the bridge failure. Figure 6 shows a schematic diagram of the collapse of the bridge. The sequential failure initiated when piers P5 and P6 collapsed in opposite directions, accompanied by the fall of girder G5-6 (between P5 & P6) in the river. Immediately afterwards, in a domino effect, girders G6-7, G4-5, G3-4 and G2-3 partially fell in the river. Based on the eye witness reports, Kazama et al. (2008) also reported that the collapse of the bridge girders proceeded as G5-6 → G6-7 → G4-5 → G3-4 → G2-3. As a result, five of the twelve spans fell off the pile heads in the earthquake.

Figure 6: Schematic diagram of the collapse of the bridge along with the deflections of the pile caps (Iwasaki 1986)

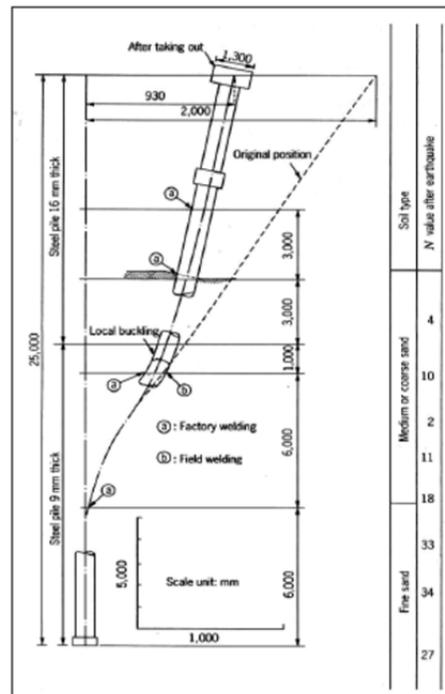
Figure 7 shows the structural details and soil data for a pile of pier P4 after post earthquake recovery. On the other hand, Figure 8 shows the deck-pier support arrangement where there is alternating roller (movable) and pinned (fixed) except for pier P6 where both the supports are roller. Yoshimi (2003) commented on the lack of redundancy in the structural design of the bridge. It may be noted from Figure 6 that relative displacement of more than 30cm at the deck level will lead to unseating of the deck and hence may lead to collapse.

Figure 7: Structural and soil data for a pile of pier P4 (Fukuoka 1966)

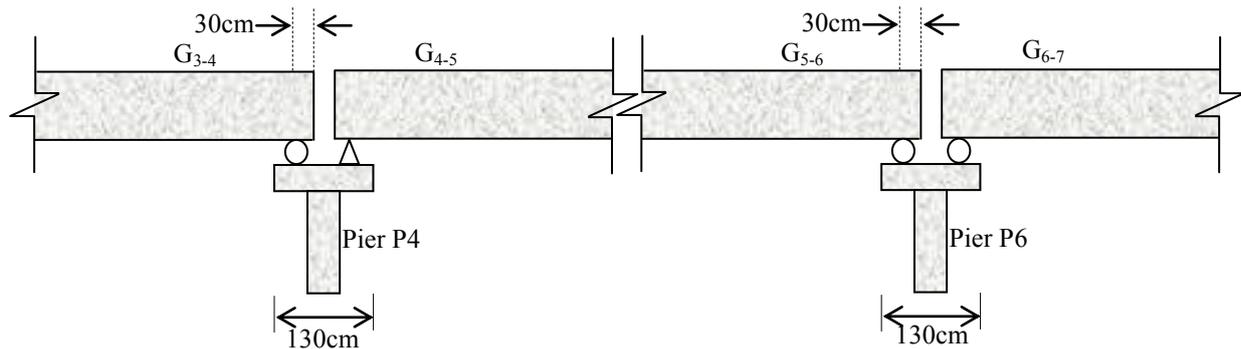
Figure 8: Support condition of the bridge at two piers

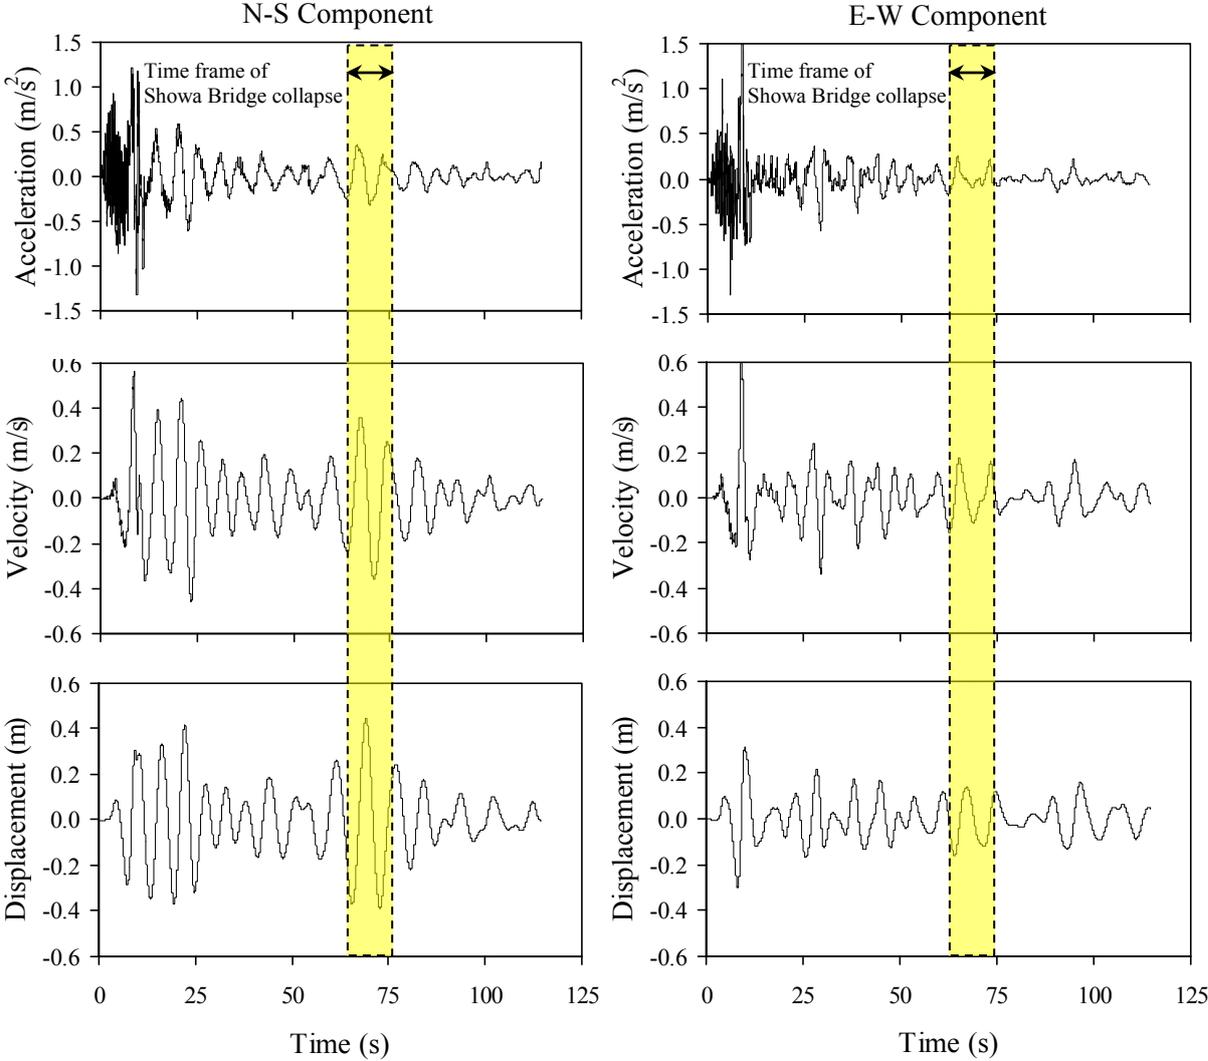
Figure 9 shows the time history of the acceleration, velocity and displacement recorded at the basement of a building (Kawagishi-Cho) at a location 1.25 km from the Showa bridge. It may be mentioned that records at Kawagishi-Cho are the only available strong motion records recovered near Niigata city and the site was fully liquefied. As a result, this ground motion is used to study the feature of earthquake at the time of collapse i.e. at about 70 seconds. Kudo et al. (2000) suggests that the long period ground motion was not produced by liquefaction but it radiated from the same source. They attributed the essential nature of the ground motion to the earthquake source, propagation path and deep sediments of regional scale. The plots on Figure 9 also show the window when the Showa Bridge collapsed. It may be observed that there is slight increase in acceleration i.e. a shock wave or a jolt during the time of collapse. It has been hypothesised (Kudo et al. 2000 and Yoshida et al. 2007) that this long period motion was presumably surface waves from the same earthquake source and travelled the same propagation path. From the ground motion, it is evident that the period of the ground is about 6-7 seconds during the bridge collapse.

Figure 9: Recorded acceleration, velocity and displacement time histories, adapted from Kudo et al. (2000). Also in the diagram the time window (65s - 75s) when it is believed the Showa Bridge collapsed is indicated. (<http://kyoshin.eri.u-tokyo.ac.jp/SMAD>)

Inertial forces during the initial shock (within the first 7 seconds of the earthquake) or lateral spreading of the surrounding ground (which started at 83 seconds after the start of the earthquake) cannot explain the failure of Showa Bridge as the bridge failed at about 70 seconds following the main shock and before the lateral spreading of the ground started. In this study, quantitative analysis is carried out for the various failure mechanisms that may have contributed to the failure. The study

Based on the recorded motion, it can be estimated that the period of ground motion is 6 to 7 sec at about 70 sec after the onset of the earthquake. Assuming 10m of resonant wavelength of liquefied layer, the equivalent shear wave velocity can be estimated to be about 6.7m/s (see equation 1):

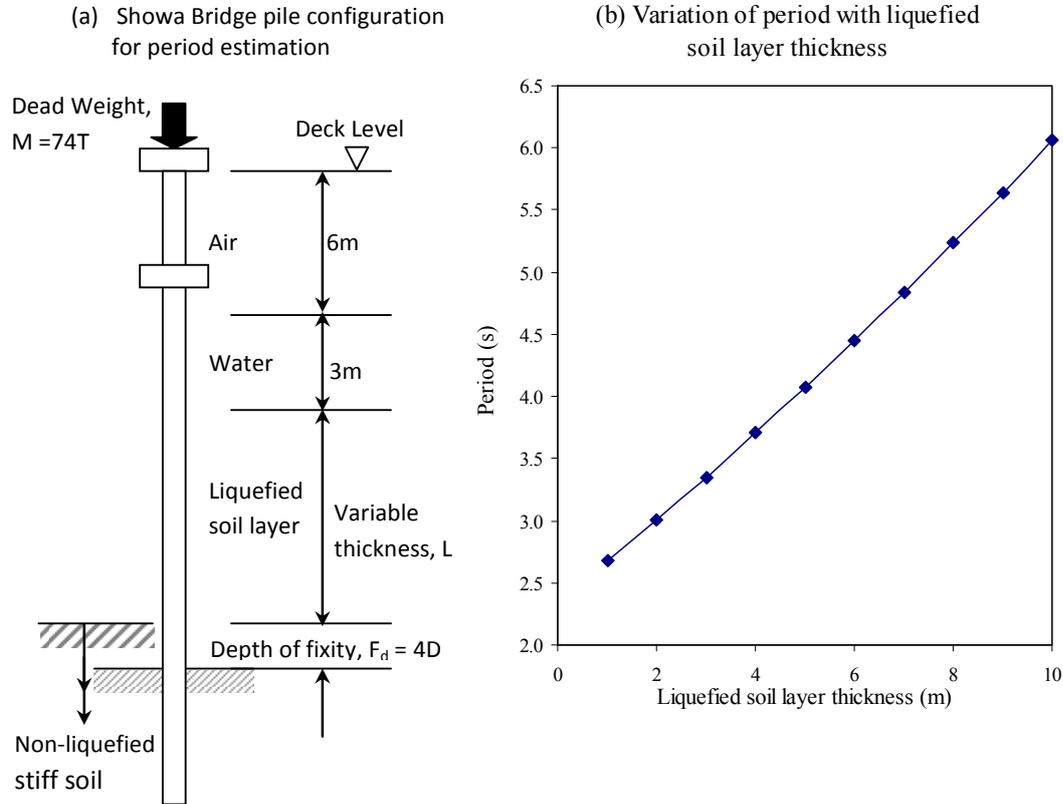
The fundamental period of a bridge deck-pile-soil system will change with the liquefaction-induced-stiffness degradation of the soil surrounding the pile. The fundamental period, in most cases, will lengthen depending on the thickness of the liquefied soil layer. This has been shown through high quality experimental results carried out by Lombardi and Bhattacharya (2014) and analytical work by Bhattacharya et al (2008) and Adhikari and Bhattacharya (2008). To examine the effects of thickness of the liquefied soil layer on the period of pile foundations of the Showa Bridge, an idealised pile configuration has been adopted as shown in Figure 10(a). Further details can be found in Bhattacharya et al (2014).

The pile is assumed to be fixed at a depth of 4D below the liquefied soil layer (for further details see Bhattacharya et al. 2005). Weight from the deck on the pile is applied as mass, M on the free head of the pile. The fundamental period of the pile is then computed by considering the pile to be simple

cantilever for different length of the liquefied soil layer, L , and is shown in Figure 10(b). The simplified assumption is that liquefied soil offers no stiffness to small amplitude vibrations, the discussion of which can be found in Bhattacharya et al. (2009). It may be observed that the period increases with increasing thickness of the liquefied soil layer. For liquefied soil thickness of 10m as in case of pier P4, the fundamental period of the pile system increases from 2seconds before liquefaction to about 6seconds after liquefaction.

Figure 10: Period estimation for Showa Bridge pile: (a) pile configuration for period estimation (b) variation of period with liquefied soil layer thickness

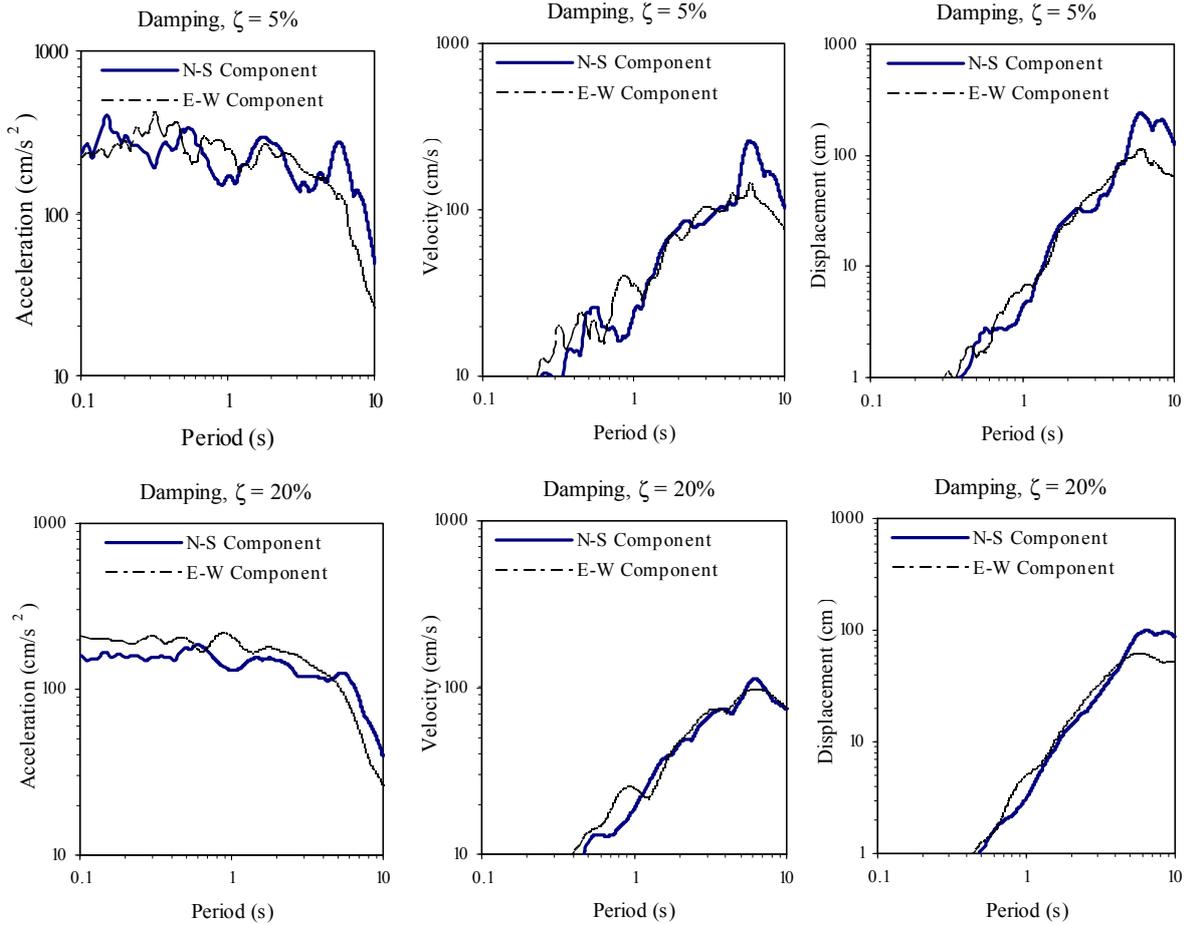
The acceleration, velocity and displacement spectra considering a Single Degree of Freedom (SDOF) system for the base motions as shown in Figure 11(a) are obtained with damping constant of 5% and 20%. The acceleration, velocity and displacement spectra are shown in Figure 11 and it may be observed that the spectral displacement reaches its peak at the period range of 6-7 seconds. An acceleration displacement response spectrum (ADRS) is plotted in Figure 12 for better comparison of the spectral behaviour.

Figure 11: Acceleration, velocity and displacement spectra for a SDOF system for the time histories mentioned in Figure 7 for damping of 5% and 20%

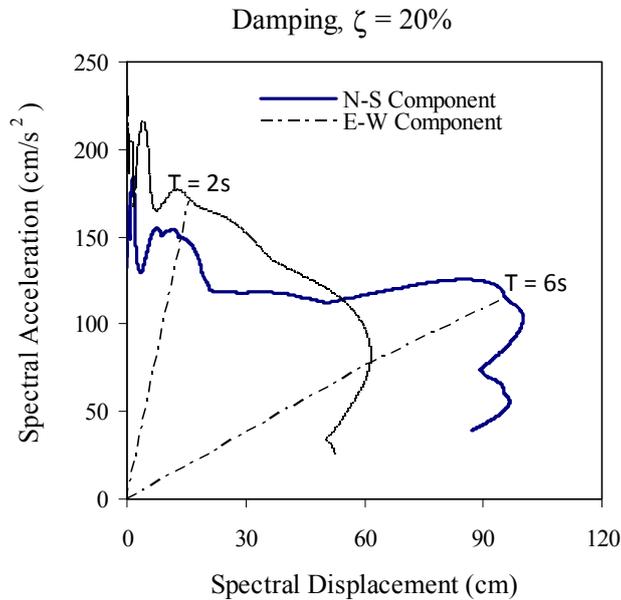
Figure 12: Acceleration-displacement response spectra for a SDOF system for the time histories mentioned in Figure 7 for damping of 20%
