FIRE RESISTANCE OF WALL PANEL SUBJECTED TO SEISMIC LOADING

ABSTRACT

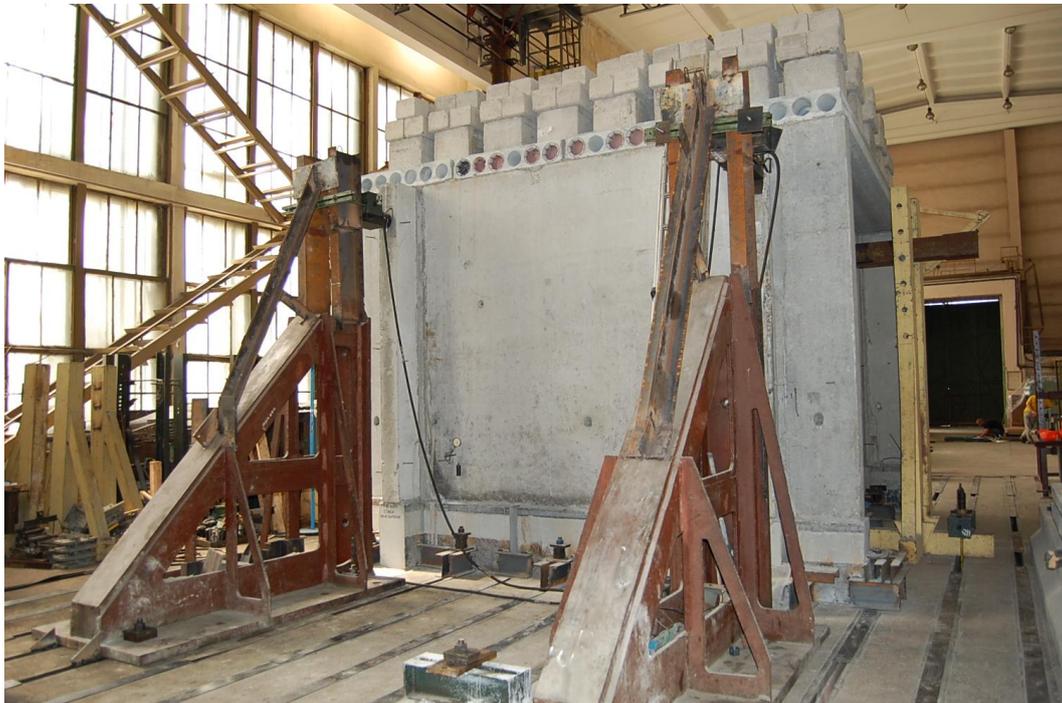
Seismic loading tests of the fragment were performed under the simultaneous action of vertical static load and lateral variable action imposed using hydraulic jacks with automatic pumping stations and simulated the seismic load intensity 7 to 9 points (see Fig.1). Due to imposed action, constructions of experimental fragment were sustained such damages as diagonal cracks in upper corners of the embrasures of wall panels, cracks along the anchor canals etc. Experimental fragment was dismantled after tests.

Figure 1. Loaded experimental fragment

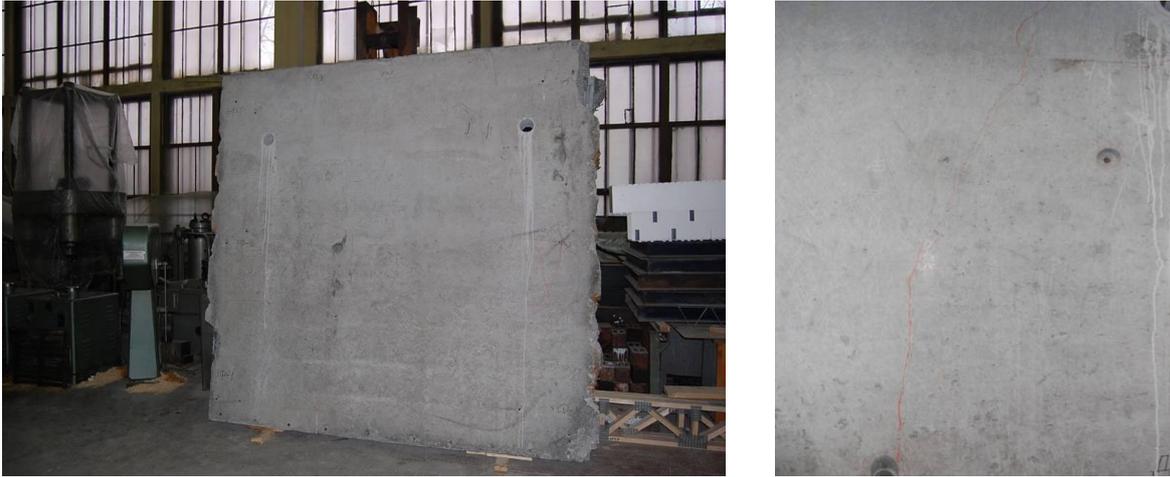
Internal load-bearing blind wall panel BC-111 measuring 3040mm (H) × 3160mm (W) × 200mm (D) had been chosen among the constructions of experimental fragment for the fire test. Strength class for concrete of the wall panel was C16/20. Wall panel had double wire-mesh reinforcement. Required fire resistance of the wall panel was REI 120. Vertical crack had grown from the anchor canal across the wall panel in consequence of seismic loading tests. Width of crack was over the 0.3 mm to 0.45 mm range (see Fig. 2). The choice of this panel was justified as a test specimen shouldn't be made of different types of materials (e.g. block or bricks) except it reproduced real construction (Ukrainian Standard, 2007).

Figure 2. Wall panel BC-111 and vertical crack across the wall panel due to seismic loading test

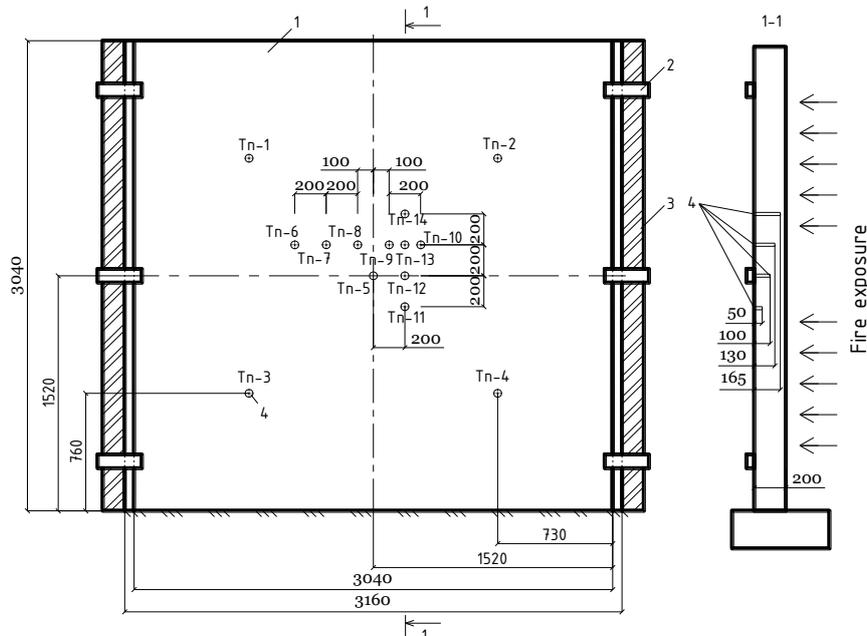
Figure 3. Layout of thermocouples

Temperature of the wall panel was taken by thermocouples situated on the non-exposed surface, through the wall panel cross-section, on the reinforcement near the exposed surface (see Fig.3).

1 – test specimen of the wall panel BC-111; 2 – fixtures; 3 – fire resistance test furnace; 4 – thermocouples: Tn-1 – Tn-5 – situated on the non-exposed surface; Tn-6 – Tn-10 – situated on the reinforcement near the exposed surface; Tn-11 – Tn-14 – situated through the wall panel cross-section

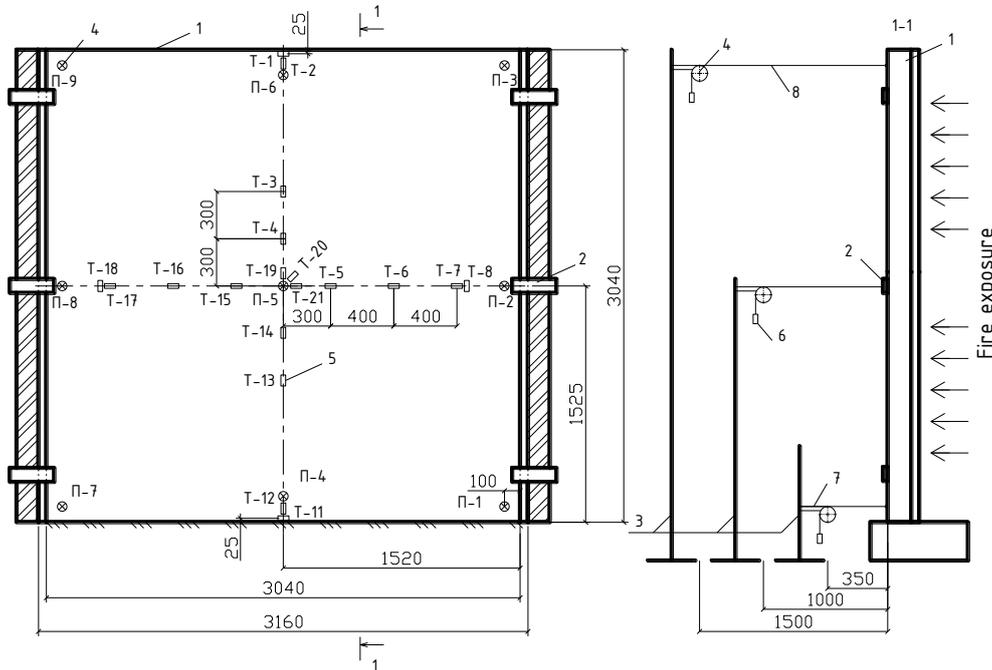
Figure 4. Layout of deflectometers and resistive-strain sensors

Horizontal displacements of the wall panel were measured by remote deflectometers on some tripods that are placed at a distance to test specimen during the fire test. Fiber strains of non-exposed surface were measured by nineteen resistive-strain sensors situated at thirteen points on the non-exposed surface: in the center, along the horizontal and vertical axes of symmetry (see Fig.4).

1 – test specimen of the wall panel BC-111; 2 – fixtures; 3 – tripods; 4 – deflectometers; 5 – resistive-strain sensors; 6 – plumbs; 7 – clamps for mounting of deflectometers; 8 – wire

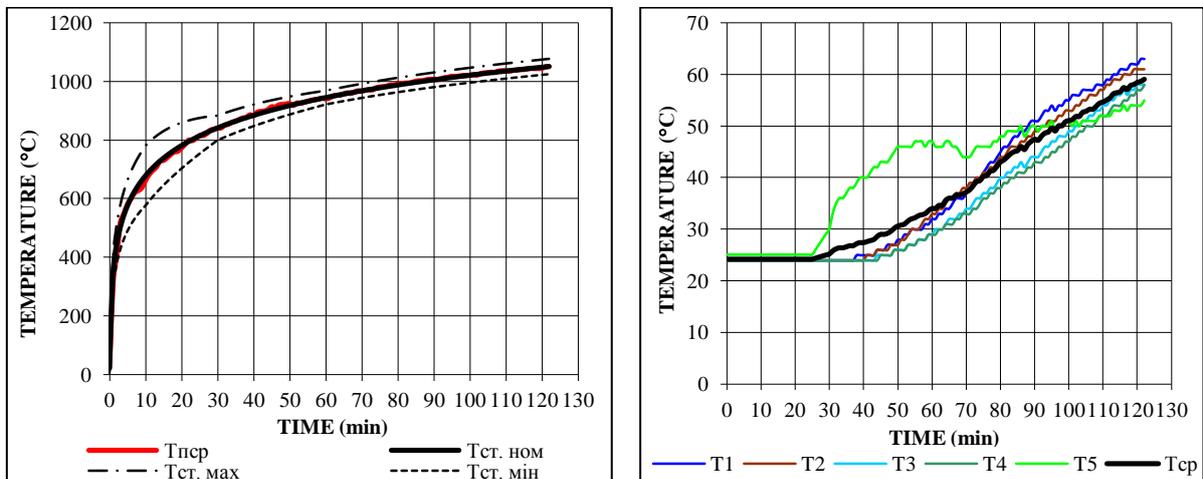
Diagrams of temperature are shown in Fig.5 and Fig.6. The horizontal part of the diagrams indicated the intensive evaporation of moisture at 100 °C. It prevented wall panel warm up to higher temperatures. The average temperature rise was 38 °C over the whole of the non-exposed surface. The maximum temperature rise at any point of that surface was 43 °C. These values didn't exceed 140 °C and 180 °C respectively (Ukrainian Standard, 1998).

Figure 5. Diagrams of temperature in the furnace and on the non-exposed surface of the wall panel

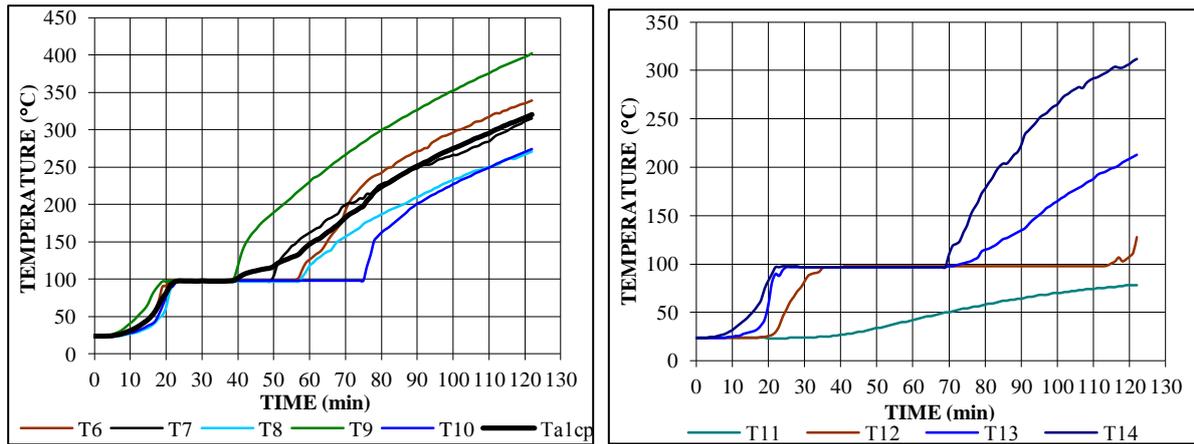
Figure 6. Diagrams of temperature on the reinforcement near the exposed surface and through the wall panel cross-section

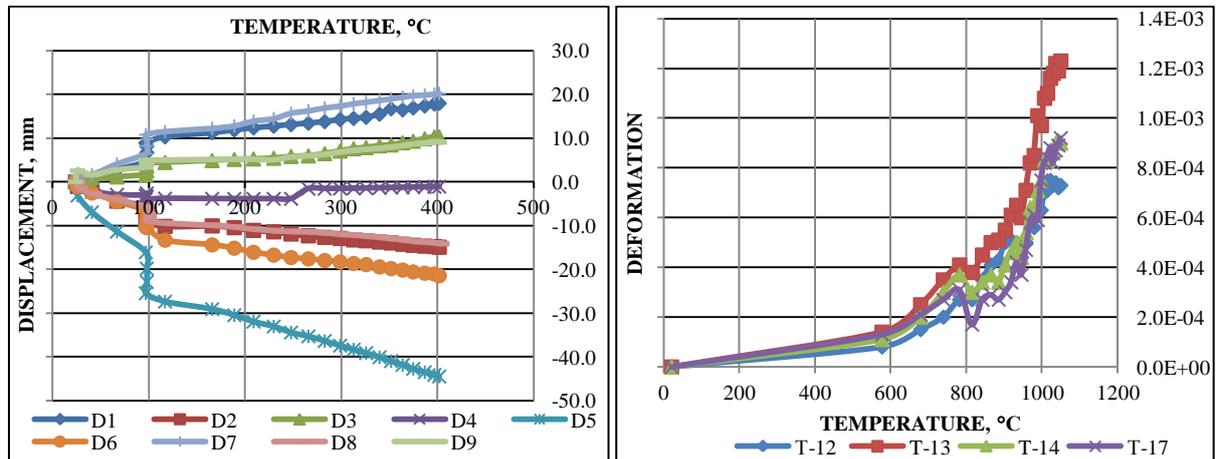
The wall panel flexed toward the fire exposure. While the middle of the panel moved aside exposure 44 mm and panel angles deviated away from the furnace about 20 mm. Diagrams of displacements and fiber strains are shown in Fig.7.

Figure 7. Diagrams of displacements of the wall panel and fiber strains of non-exposed surface

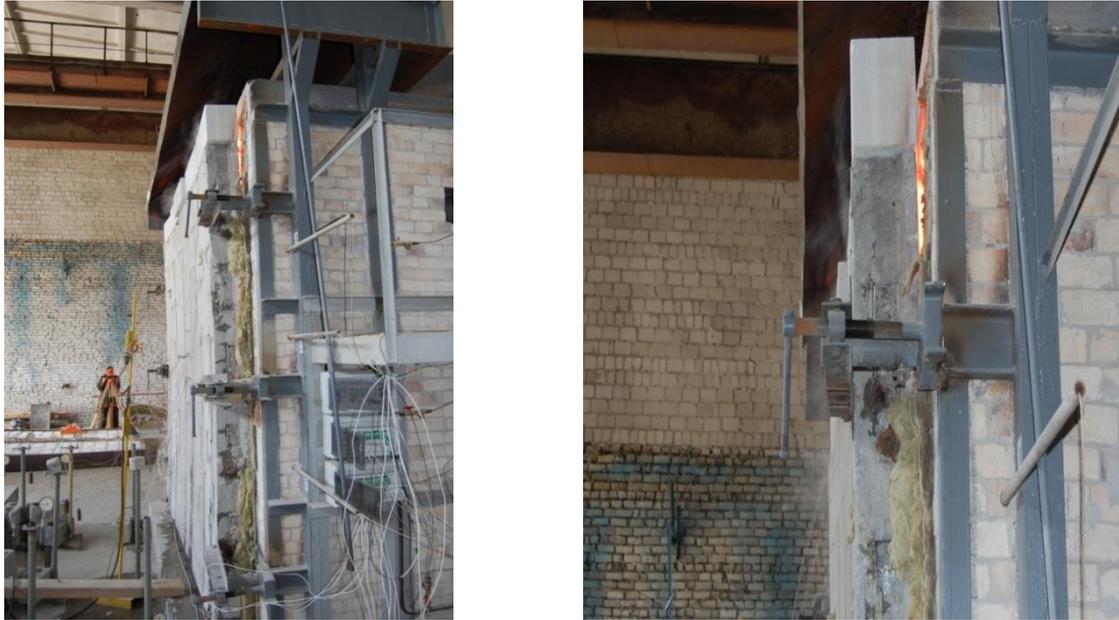
Such characteristic changes of the wall panel were noted by means of the visual, photo and video observation during the fire test (see Fig.8):

- at the non-exposed surface was seen exudation of moisture at first from the cracks along the anchor channel, then – in all holes and cracks after the 20th minute;
- angles and upper bound of the test specimen deviated away from the furnace, central area of the specimen bend aside fire exposure from the 40th minute until the end of the fire test;
- intensive non-exposed surface evaporation of moisture began after 75 minutes.

Cracks existent prior to the fire test were clearly visible on the surface of the test specimen after complete evaporation of moisture. The concrete layer of exposed surface became fragile. It was covered with a mesh of micro-cracks. Concrete cover to reinforcement of exposed surface wasn't damaged. Spalling of concrete cover to the reinforcement of exposed surface of the wall panel didn't occurred.

Figure 8. Wall panel BC-111 during the fire test

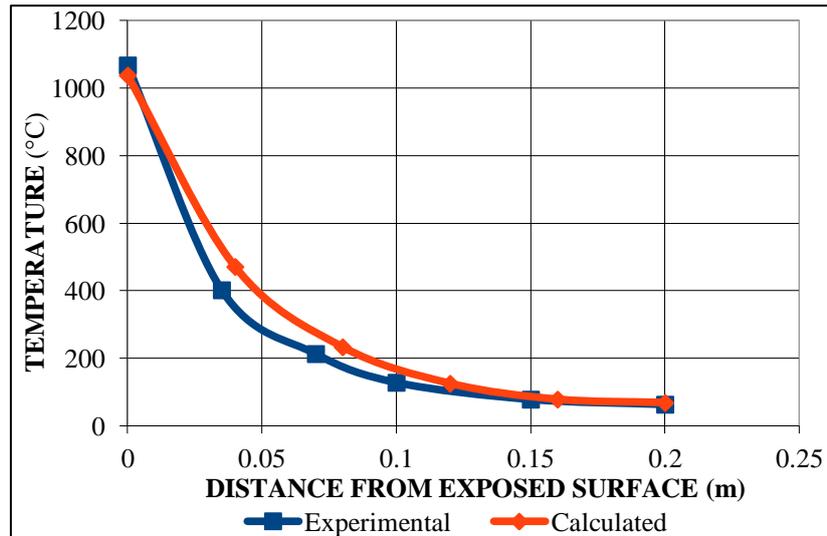
Calculated&experimental approach was applied for determining of load-bearing capacity (criterion R) for the fire exposure according to the standard temperature-time curve for a specified load combination and for a period of time duration of 122 minutes. This approach combined advanced calculation methods of stress-strain state of constructions and fire test results such as temperature over the non-exposed surface, temperature distribution through the wall panel cross-section (see Fig.9), reinforcement temperature near the exposed surface, etc.

Figure 9. Temperature distribution through the wall panel cross-section

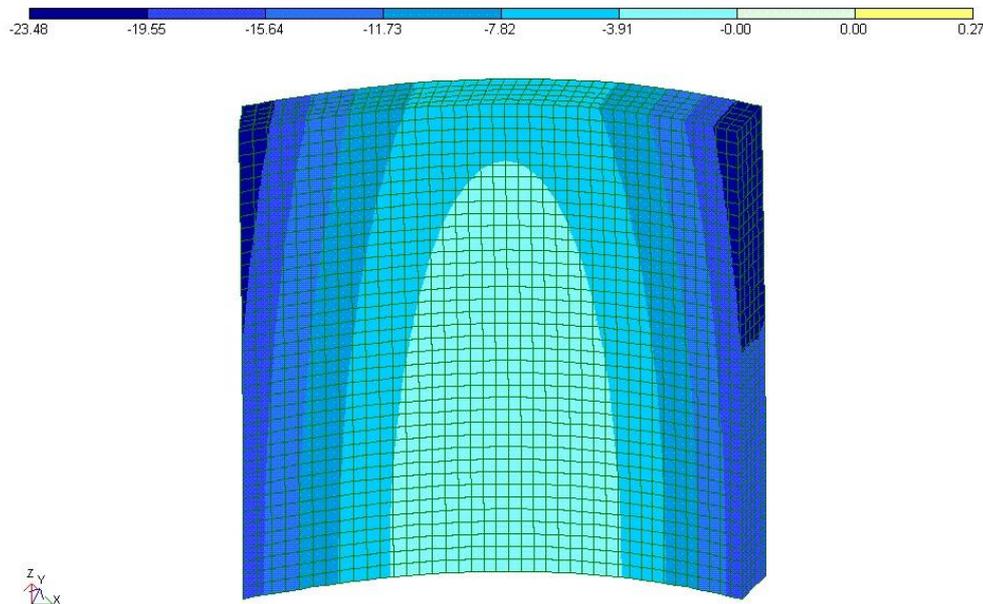
Stress-strain state of the wall panel BC-111 was determined by the results of calculation reproduced the behavior of construction during the fire test (see Fig.10). The wall panel flexed toward the fire exposure due to combined action of static load and fire exposure on the one side. Middle of the panel moved aside exposure and panel angles deviated away from the fire.

Figure 10. Deflected mode and displacements (mm) of the wall panel

As a result of analysis loss of load-bearing capacity (criterion R) of wall panel BC-111 didn't occurred for the uniformly distributed load and fire exposure according to the standard temperature-time curve duration of 122 minutes. Therefore, required fire resistance REI 120 satisfied for the wall panel with seismic damages.
