DAMAGE SURVEY AND OBSERVED DATA ANALYSIS OF LONG RC BUILDING WITH IRREGULAR PILE SUPPORTING STRATUM AFTER THE 2011 TOHOKU EARTHQUAKE

Kazuya MITSUJI¹, Susumu OHNO² and Masato MOTOSAKA³

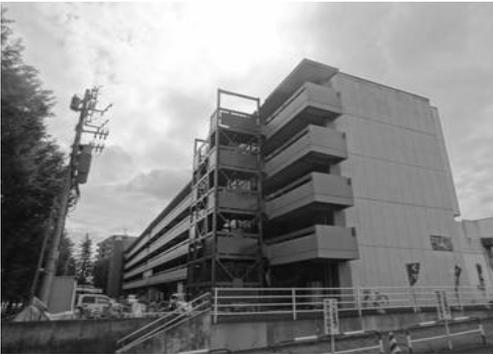
Photo 1. Panoramic view of building A

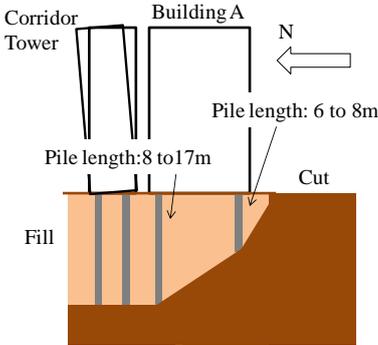
The building was constructed in those man-made residential area about 5km north-east from the centre of Sendai in 1971. Building site and neighbouring fill area distribution are shown in Figure 2. The building studied in this paper is called “building A” in Figure 2. Building A is five-storey RC frame structure and constructed in 1971 that was also suffered from the 1978 Miyagi earthquake. Plan of the building is long rectangular shape of 103m in longitudinal and 9m in transverse direction. Photo 1 shows the panoramic view of building A. Vicinity of the site is reclaimed area by banking, and the building exits at around the edge of fill area. Blue covered area in Figure 2 indicates fill area reclaimed by development of residential site (Fukken Gijutsu Consultant, 2008). According to the design documents, piles in north frames are longer than south frames. Difference of pile length between north and south is about 10m at most. Schematic figure of section of building A including pile foundations and ground is shown in Figure 3. Seismic behaviour of the building is considered to have been affected by subsurface layer of fill area with the irregularity of pile supporting stratum.

Figure 3. Schematic section of building A

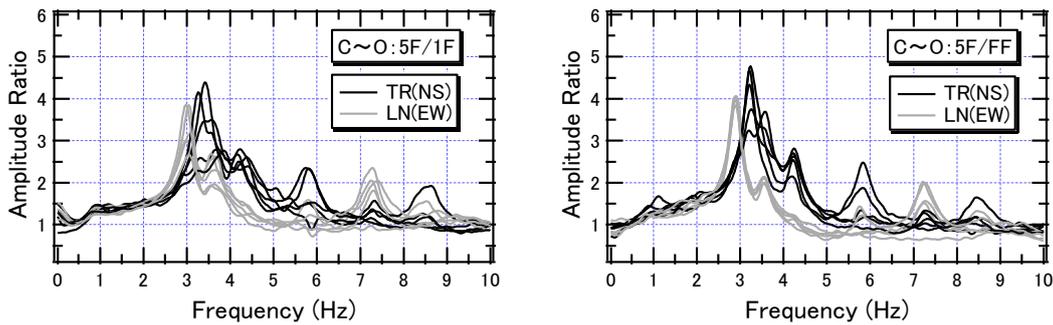
Estimated natural frequencies of structural frames from C to O and 3rd staircase tower based on microtremor measurements are summarized in Table 1. Transverse direction (TR) of the building is NS direction, and supposed to be strongly affected by the irregularity of pile supporting stratum. Amplitude ratios of superstructure of building A derived from transfer functions are shown in Figure 5. Natural frequencies are fluctuating dependent on the frames, but they can be estimated about 3.5Hz for fixed-base system (5F/1F) in TR (NS) direction. On the other hand, natural frequencies for dynamic soil-structure system (5F/FF) can be estimated about 3.2 to 3.3Hz in TR (NS) direction. The effect of soil-structure interaction is estimated about 10% in TR (NS) direction. Amplitude ratios of LN (EW) direction have peaks at around 3.0Hz for fixed-base system (5F/1F), and 2.9Hz for dynamic soil-structure system (5F/FF). Results of LN (EW) direction are more stable than TR (NS) direction.

While amplitude ratio curves of superstructure have multiple peaks indicating torsional motion and higher modes as shown in Figure 5, amplitude ratio curve of staircase tower has one distinctive peak indicating the bending type first mode. Natural frequency in TR (NS) direction is lower than LN (EW) direction. This is the effect of the rectangle plan with strong axis in NS and weak axis in EW direction. Small peak is observed indicating torsional motion in TR (NS) direction right after the first mode close to the natural frequency of LN (EW) direction. It is also interesting that UD direction has spectral peak at almost the same as TR (NS) direction. This is because the tower has been inclined by damage of the earthquake; therefore spectral peak of UD direction indicates coupling effect to TR (NS) direction by the leaning.

Figure 5. Amplitude ratios of frames (from C to O) based on microtremor measurements
(Left: fixed-base system (5F/1F), Right: dynamic soil-structure interaction system (5F/FF))

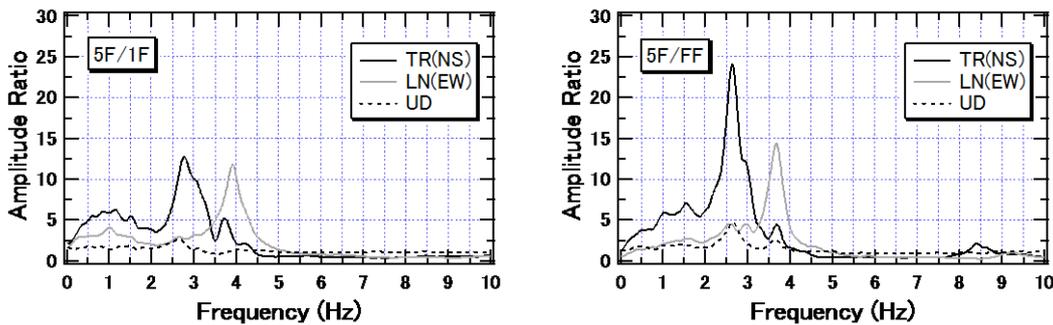
Amplitude ratios of the 3rd staircase tower are shown in Figure 6. Natural frequencies are estimated 2.8Hz in TR (NS), 3.9 in LN (EW) direction for fixed-base system (5F/1F), and 2.6Hz in TR (NS) and 3.7Hz in LN (EW) direction for dynamic soil-structure system (5F/FF).

Figure 6. Amplitude ratios of the 3rd staircase tower based on microtremor measurements
(Left: fixed-base system (5F/1F), Right: dynamic soil-structure interaction system (5F/FF))

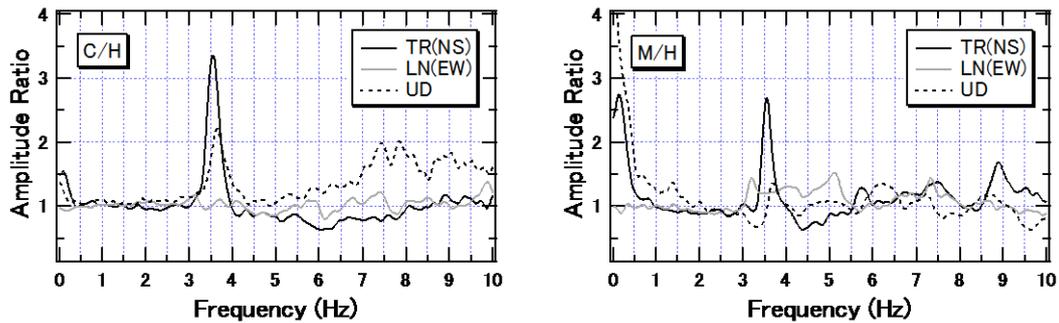
The effects of long structure and the irregularity of pile supporting stratum to dynamic characteristics of superstructure are discussed by comparison of amplitude ratios between foundations. Spectral amplitude ratios between foundations of frame C and H, and M and H are described in Figure 7. Position of each frame is described in Figure 4. Results between foundations of C and H are related to dynamic characteristics of west edge to centre of the building, and results between foundations of M and H are those of east edge to centre of the building. Spectral peaks at 3.5Hz can be found in TR (NS) and UD direction in the results of C and H, and M and H. This frequency is almost the same as natural frequency of superstructure (base-fixed system). Namely, motion of foundation is amplified in TR (NS) direction and coupled with motion in UD direction at around the first natural frequency of superstructure. The irregularity of pile supporting stratum and difference of pile length can be considered to give the significant effect to the coupling effect.

Figure 7. Amplitude ratios between foundations based on microtremor measurements

(Left: amplitude of west to centre, Right: amplitude of east to centre)

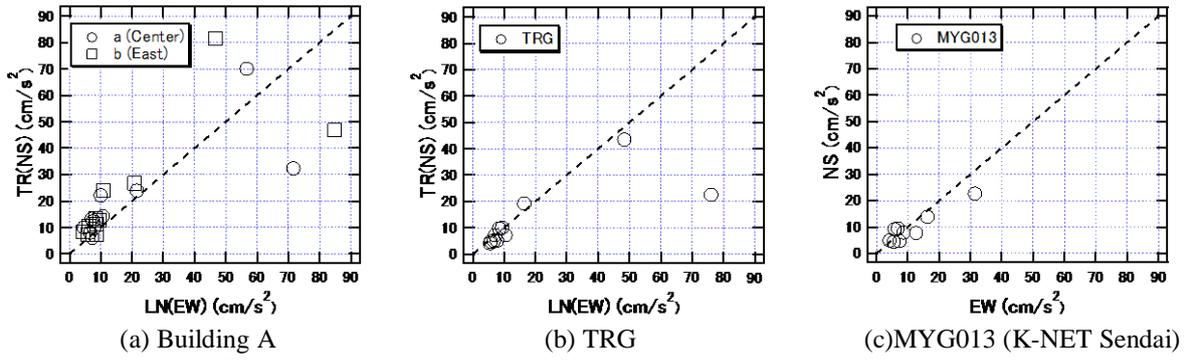
Maximum acceleration distributions in horizontal direction (NS-EW) are shown in Figure 9. Distributions are summarized for each observation site. Maximum accelerations of TRG and MYG013 don't indicate specific distributions dependent on the direction. Maximum accelerations of EW direction are larger than NS direction in case of large amplitude. On the other hand, maximum accelerations of building A indicate the trend that NS direction is larger than EW direction, although there are a few exceptions in large amplitude. This is considered the effect of the irregularity of pile supporting stratum. As shown in Figure 3, soil condition is rigid bedrock (cut area) on the south of the building, and pile supporting stratum is deeper in north due to reclaimed soft soil layer. The effect of the irregular ground appears on maximum acceleration distributions of building A. In the figure of (a) of Figure 9, maximum accelerations of centre (“a”) and east (“b”) of the building are compared. Maximum accelerations of east part (“b”) tend to be larger by about 10% than centre (“a”) of the building together with the information in Table 2.

Figure 9. Maximum acceleration distributions in horizontal directions

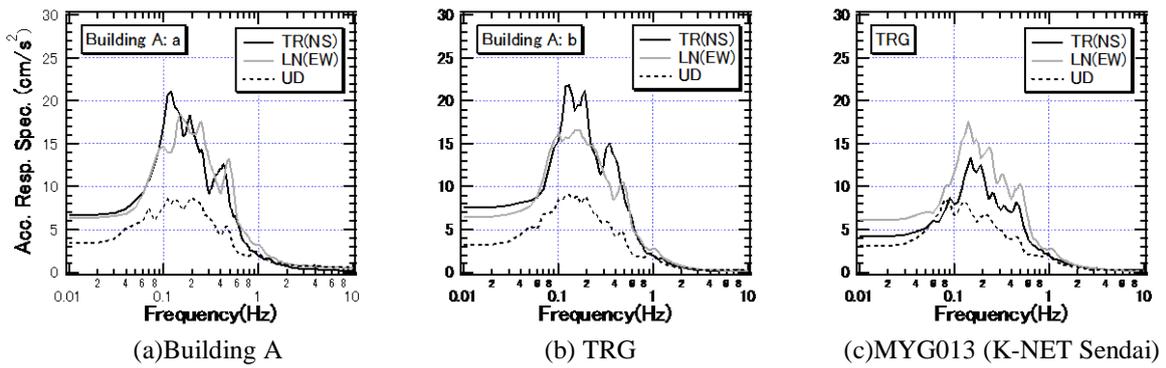
Average response spectra of observed earthquakes of “a” and “b” of building A, and TRG are shown in Figure 10. Results are expressed the average of response spectra for each earthquakes. Comparison of amplitude characteristics between building A and TRG are focused. Spectral peak in TR (NS) direction appear around 0.1 to 0.2 (s) for centre (“a”) and east (“b”) of the building. Peak of LN (EW) direction slightly shifts to longer range of period in the result of centre (“a”). Small peak can also be found at around 0.4 to 0.5 (s) in both horizontal directions. It is interesting that average response spectrum of TRG in LN (EW) direction is larger than TR (NS) direction. This result meets good agreements with the maximum acceleration distributions in Figure 9. This is because of the effect of the irregularity of pile supporting stratum. It should be also noted that amplitude of response spectra of building A are larger than those of TRG. The effects of reclaimed soft soil layer of the site of building A appear in the results.

Figure 10. Average response spectra of observed earthquakes

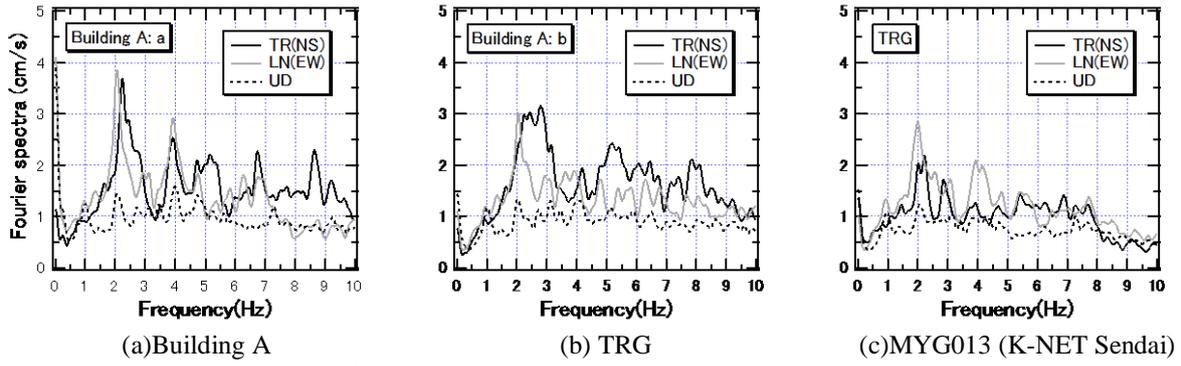
Average Fourier spectra are shown in Figure 11. First spectral peaks are observed around 2Hz in both centre (“a”) and east (“b”) of building A that are considered to be the characteristics of one-dimensional wave propagation in reclaimed soft soil layer. Some small peaks are also found at about 4Hz, 5Hz and higher frequencies that are the effect of the irregularity of pile supporting stratum. However, distinctive peak at about 2Hz is also observed in the average Fourier spectra of TRG that are supposed to rigid bedrock site. The reason will be studied furthermore in the near future.

Figure 11. Average Fourier spectra of observed earthquakes

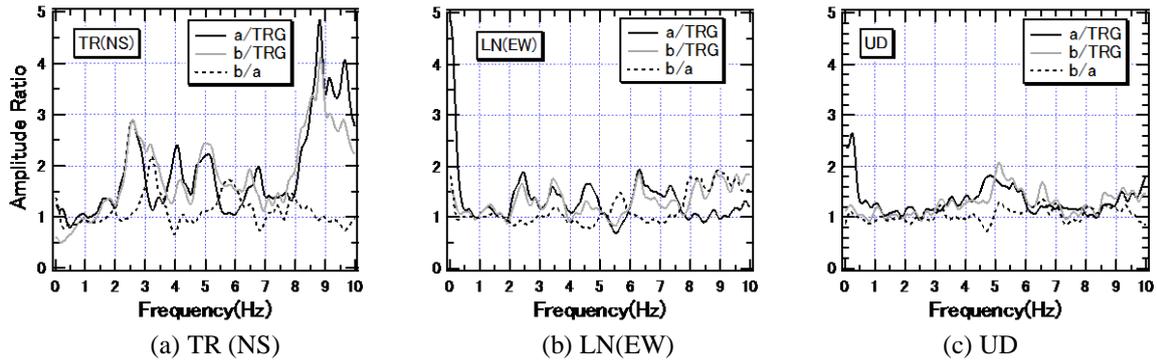
Relative relations between observation sites are discussed by the results of Figure 12 where average amplitude ratios between centre (“a”), east (“b”) of the building and TRG are compared in the three directions. Amplitude ratios of a/TRG and b/TRG indicate the clear peaks at about 2.5Hz in both TR (NS) and LN (EW) direction. Peaks of TR (NS) direction are more outstanding. This result leads to the assumption that one-dimensional dynamic characteristics of reclaimed soft soil layer of the site of building A can be considered 2.5Hz in horizontal directions. Some small peaks appear in 4Hz, 5Hz and higher frequencies that are considered the effect of the irregularity of pile supporting stratum. The effect is more remarkable in TR (NS) direction. Those results are in accordance with the results of average Fourier spectra of Figure 11. Specific spectral peak cannot be observed in UD direction while motion of foundation of UD direction is relevant to that of TR (NS) direction in the results of microtremor measurements as shown Figure 7. Seismometers (“a” and “b”) were installed in the almost centre of the plan in NS direction shown in Figure 4. On the other hand, sensors for microtremor measurements were placed at the north side of the building. Therefore, the effect of the coupling of TR (NS) and UD direction cannot be observed in the results of earthquake observation records, but only in the results of microtremor measurements. Difference of amplitude ratio between centre (“a”) and east (“b”) of the building can be found in TR (NS) direction. Spectral peak is located at 3.0 to 3.5Hz that is close to natural frequency of superstructure by microtremor measurements. This can also be considered the effect of the irregularity of pile supporting stratum.

Figure 12. Average amplitude ratios between observation sites

Based on the results from earthquake observation records analysis, attempts to estimate one-dimensional wave propagation characteristics of reclaimed soft soil layer are conducted. Predominant frequency of soft soil layer is assumed 2.5Hz from the results of Figure 12. According to design documents of building A, pile lengths of north frames are 8 to 17m. Two cases are prepared for the estimation where 15m (Case 1) and 20m (Case 2) of depth of subsurface layer are assumed. Using the information of predominant frequency and depth of subsurface layer, shear wave velocity of subsurface layer is estimated 180m/s for Case 1, and 240m/s for Case 2 by eq. (1). Shear wave velocity of damaged man-made reclaimed residential area of hill side of Sendai is approximately estimated 180m/s by surface wave method in the damage survey after the 2011 Tohoku earthquake (Sendai city, 2012). The results estimated from the earthquake observed records meet good agreements with the damage survey of man-made reclaimed residential area.
