SEISMIC ASSESSMENT AND STRENGTHENING OF AN EXISTING MULTI-STOREY MASONRY BUILDING IN SARAJEVO, BOSNIA AND HERZEGOVINA

Naida ADEMOVIĆ¹ and Mustafa HRASNICA²

ABSTRACT

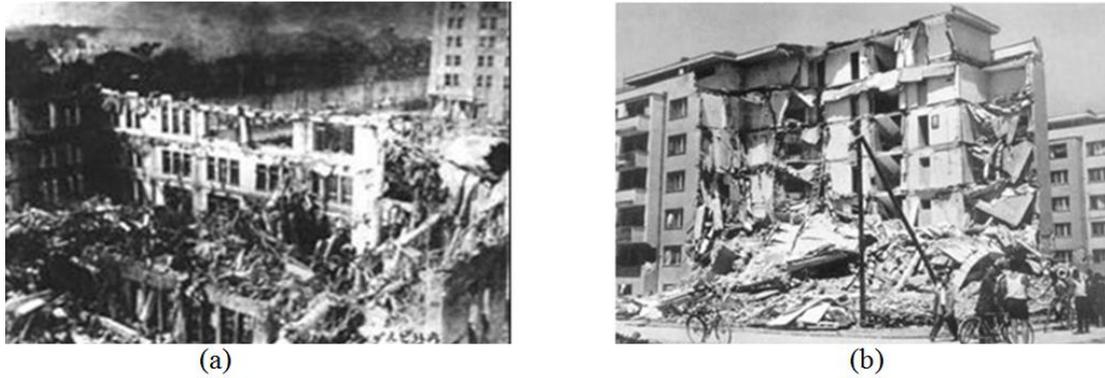
Effects of the devastating earthquakes that struck this region are illustrated in Fig.1(a) and Fig. 1 (b).

Figure 1. (a) Banja Luka 1969 earthquake and (b) Skopje earthquake (Petrovski, 2003)

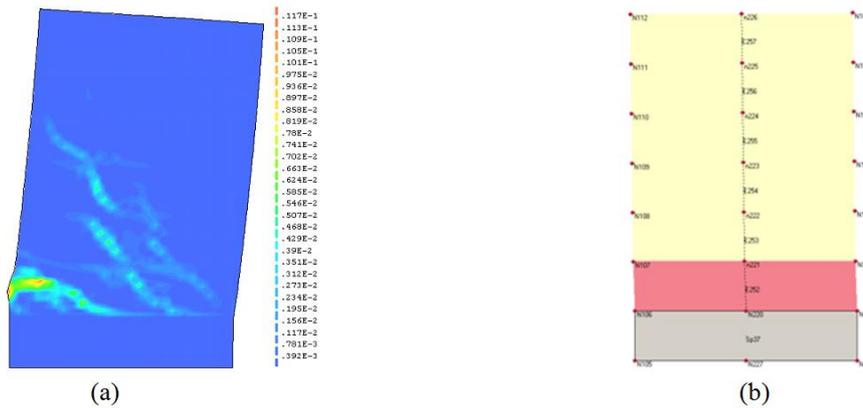
Figure 8. (a) Failure DIANA (wall Y-6); (b) Failure 3MURI (wall Y-6)

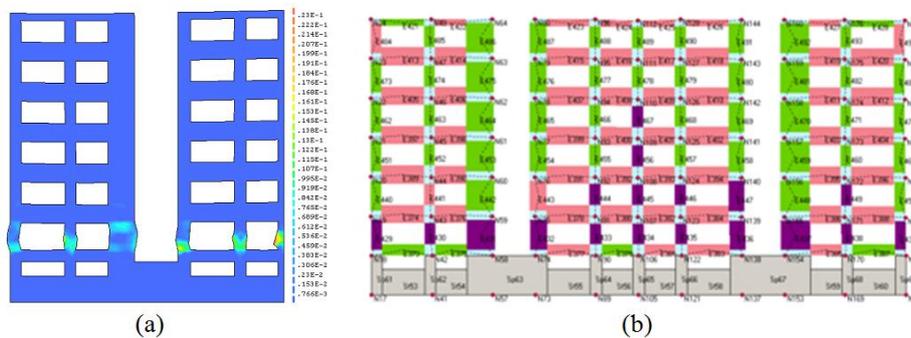
Figure 9. (a) Failure DIANA (wall X-1); (b) Failure 3MURI (wall X-1)

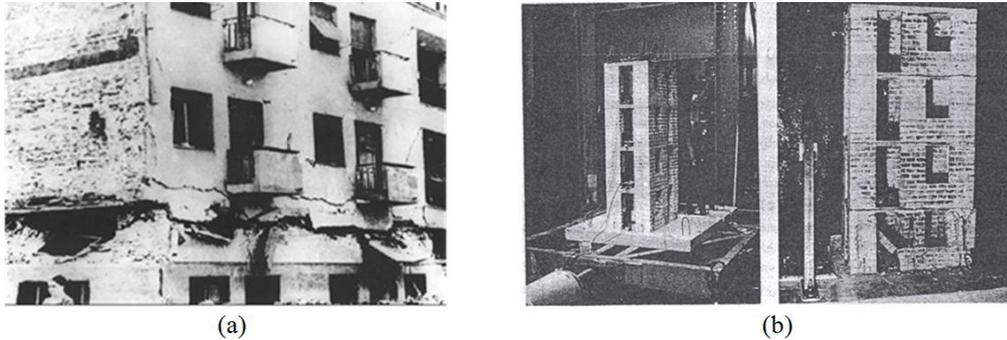
Similar behavior has been identified by the previous earthquakes on a similar structure in Skopje as stated in the World Housing Encyclopedia (2002), and illustrated in Fig.13(a), and well as in the experiments done in Slovenia as shown in Fig.13(b) (Tomažević et al., 1999). Good correlation of the modelled structure in FEM and structure exposed to Skopje earthquake is more than evident.

Basement in the analyzed structure can be regarded as the first floor in the experiment procedure due to a very high stiffness of the basement made out of reinforced concrete. The propagation of the damage in the experiment slowly expands to the upper floors.

Figure 13. (a) Damage after Skopje earthquake (WHE, 2002); (b) Experiments (Tomažević, et al., 1991)

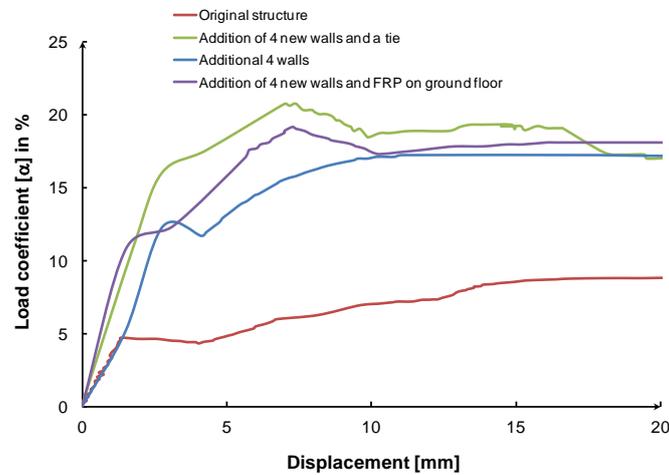
Figure 19. Pushover curve – different strengthening proposals

Comparing the capacity curves of the current structure and different proposed strengthening techniques it is observed that ties have a beneficial effect on the increase of the structure capacity. However, the problem of the shear failure and local crushing remained at the ground level. This was solved by strengthening the structure locally with the FRP on the ground floor level. Comparison of different strengthening methods and their implication on the capacity is shown in the Fig. 19.
