SEISMIC SAFETY EVALUATION AND STRENGTHENING OF SCHOOL BUILDINGS AFTER 2011 VAN EARTHQUAKES

ABSTRACT

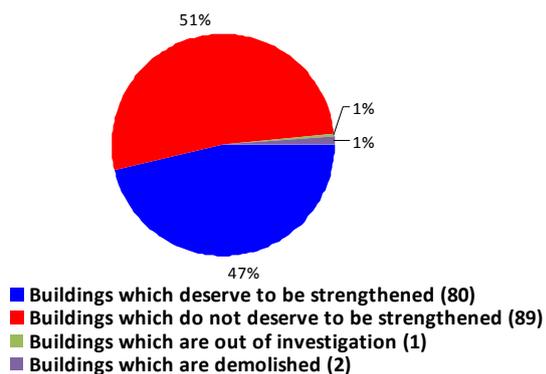
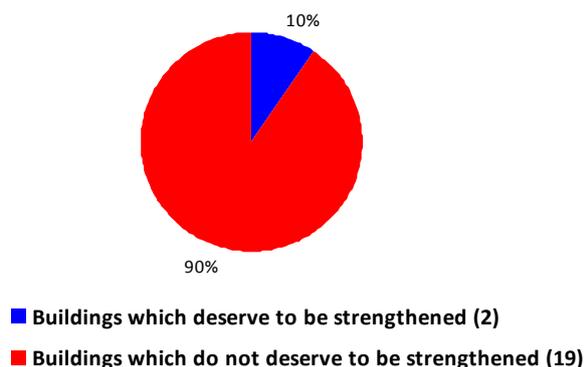
Figure 1. Total and masonry buildings investigated by TU Istanbul

Large numbers of information are gathered in all these inspection, strengthening and supervision activities. Figure 1 and Figure 2 show variation of buildings investigated by the team of TU Istanbul. As seen approximately the half of the school buildings investigated are found to deserve strengthening. These figures show another interesting fact that the most of the school buildings investigated have a reinforced concrete structural system, only one seventh of them are masonry. Similarly, approximately the half of the reinforced concrete buildings investigated is found to deserve strengthening. Figure 3 shows variation of concrete compressive strength in the school buildings. As seen, the average strength is in between 7MPa~9MPa. It is important to remember that most of them are constructed approximately in the last ten to fifteen years. Furthermore, they are expected to be constructed under supervision of several authorities. Figure 4 displays characteristic and average concrete compressive strength versus construction year of school buildings. Usually, one expects that the strength should improve along the time significantly due to developing technologies. However, as seen, almost no change can be detected. Comparison of these variations displays that the variation of the concrete strength in a building is large as well, which clearly shows the inadequate control in production and placing of concrete. Figure 5 illustrates variation of concrete strength depending on buildings having various numbers of stories. Generally, it is expected that concrete strength should increase, as number of stories of a building increases, since more attention is given to higher building. However, almost no such relation can be seen. All these figures show once more that the deficiencies in these buildings are not complex but very simple, in other words, earthquake resistant school buildings can be constructed easily provided that required structural attention is given, since most school buildings have regular structural layouts.
