## EXPERIMENTAL STUDY ON A SHAKING TABLE TEST OF A CONFINED MASONRY STRUCTURE

Tatsuo NARAFU<sup>1</sup>, Hiroshi IMAI<sup>2</sup>, Chikahiro MINOWA<sup>3</sup> and Toshikazu HANAZATO<sup>4</sup>

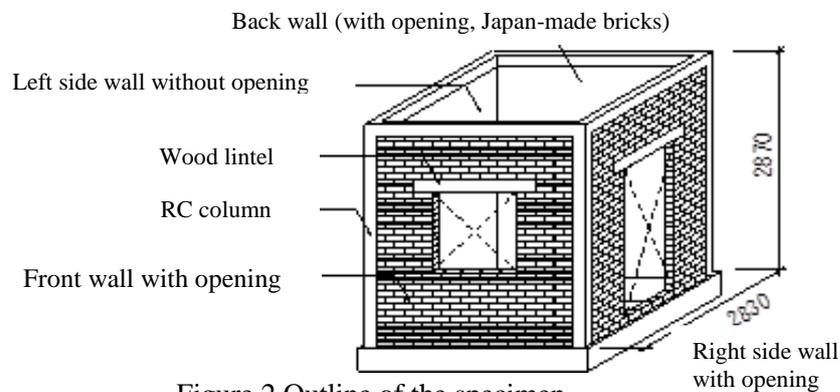
Figure 2 Outline of the specimen

The design of the specimen followed usual design in Indonesia applying stretcher bond (Figure 2). Section of reinforced concrete (RC) columns and beams is 120mm x 120mm so that surface of brick walls and RC members are in the same plane (Thickness of wall is 12cm). Bricks were imported from Pakistan. The specimen has square plan of 2830mm x 2830mm, and 2870mm in height. Total weight is estimated to be about 6,000kg. Design, materials and construction methods of each of parts are as follows,

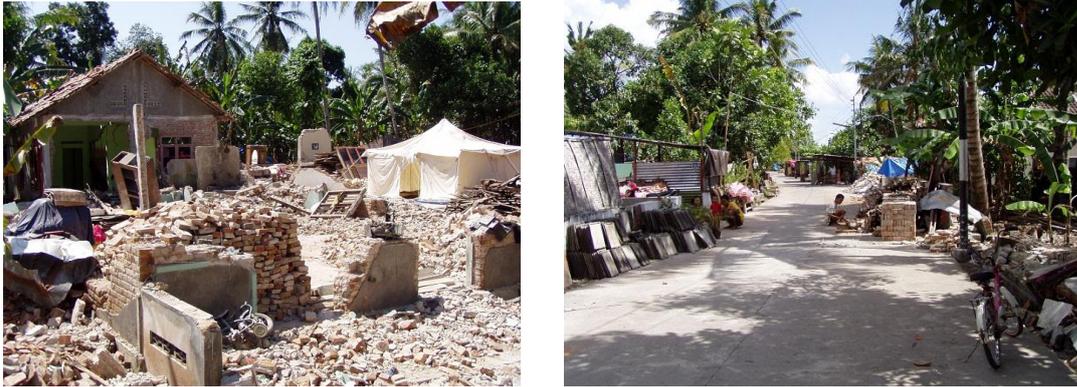
The left picture of Figure 10 shows debris of the specimen. Several bricks were still connected together by joint mortar. On the contrary debris of actual buildings damaged by earthquakes was usually separated into pieces like in the right picture of Figure 10. It is usually observed people start collecting reusable building materials like bricks, roof tiles from the debris in developing countries shown in Figure 11. Bricks could be reusable because joint mortar could be removed easily without breaking bricks. It implies bonding strength of mortar is not so strong. It is assumed weak bonding of mortar is one of the reasons of vulnerability of masonry walls in developing countries.

Figure 11 People immediately started to collect reusable material such as bricks, roof tiles from debris (left) and some were sold on road sides (right) in Bantul, Yogyakarta Special Province, Indonesia, soon after Central Java Earthquake 2006
