FRAGILITY CURVE OF THE BRIDGE MEMBER AT NATIONAL ROAD BASED ON THE DAMAGED DATA DUE TO THE 2011 OFF THE PACIFIC COAST OF TOHOKU EARTHQUAKE

Susumu NAKAMURA¹

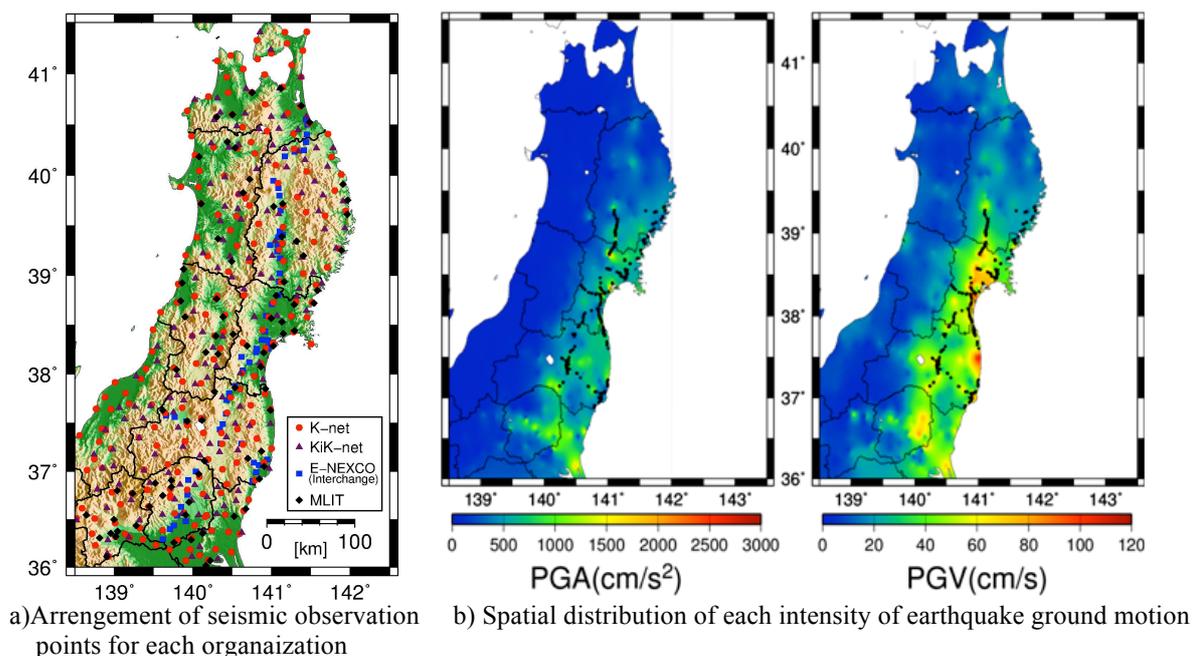
Figure 3. Spatial distribution of PGV and PGA which estimated in northeast 6 prefectures and the surrounding prefectures by space interpolation and the arrangement of the observation points

Infrastructure, Transport and Tourism were used. The spatial distribution of PGV and PGA which estimated in northeast 6 prefectures and the surrounding prefectures by space interpolation and the arrangement of the observation points are shown in Figure 3.

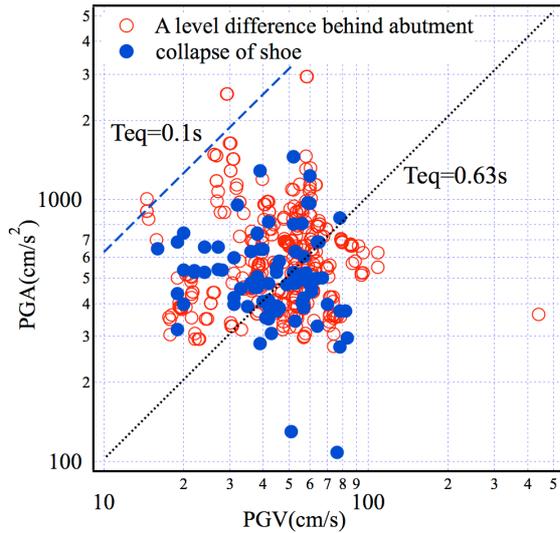
Figure 4. Relationship between PGA and PGV at damaged bridge

The relationship between PGA and PGV which estimated at the location of damaged bridge according to not only the level difference behind the abutment but also collapse of shoe including collapse of shoe support is shown in Figure 4. Both damages have caused from comparatively small PGA and PGV. It is found that the damages of the level difference behind the abutments have generated by the earthquake ground motion which has a frequency characteristic whose equivalent predominant period ($=2\pi \text{ PGV/PGA}$) is longer than about 0.1 second.

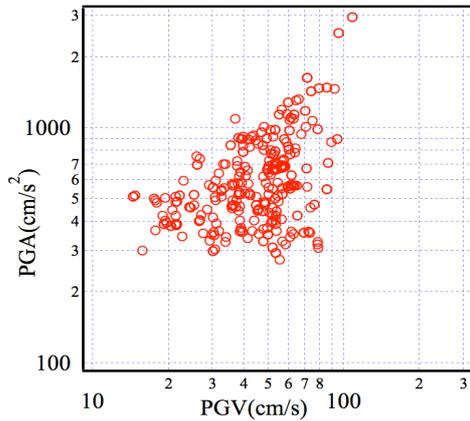
Figure 5. Relationship between PGA and PGV at the bridge with a level difference

Next, the relationship between the intensity PGA and PGV of earthquake ground motion at the bridge with a level difference behind abutments and the structural characteristics are shown in Figure 5. It is found that damage has appeared in the remarkable small earthquake ground motion, and that the damage number has increased with the increase in PGV. The relation between PGV and the damage number according to the kind of bridge is shown in Figure 6. The damage about the bridge of PC and RC is slightly large compared with the damage about a steel bridge, and the clear relation with the kind of bridge is not found. Moreover, many damages were caused against PGV in the wide range from 30 cm/s to 70 cm/s.

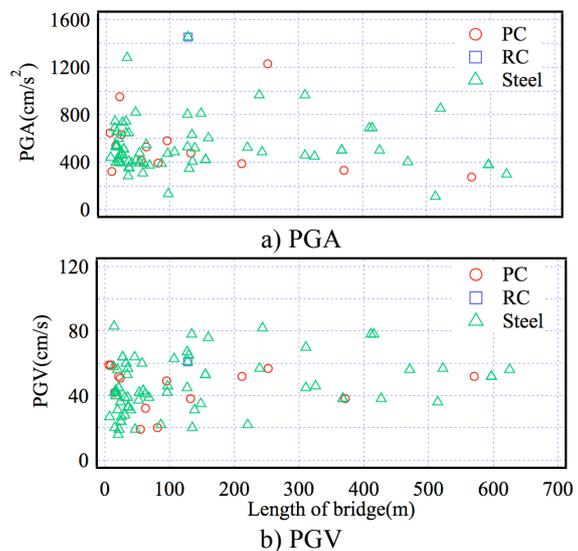
Figure 7. Relationship between PGA, PGV at the bridge with damaged shoe and the structural characteristics, such as the kind of bridge and bridge length

Next, the relationship between the intensity of earthquake ground motion at the bridge with damaged shoe and the structural characteristics, such as the kind of bridge and bridge length, is shown in Figure 7. It is found that many damages of shoe have occurred in the steel bridge. The tendency about the kind of damaged bridge is different from that according to the level difference behind abutments. It is considered that a steel bridge with lightweight had been used because many wide rivers such as Abukuma river, the Kitakami river, etc. exist in Tohoku region. Moreover, for the bridge with length longer than 100 m, the damage number of shoe has the tendency to increase against small PGA as bridge length becomes long. It is estimated to be caused because the inertia force which acts to a shoe increases as bridge length becomes long.

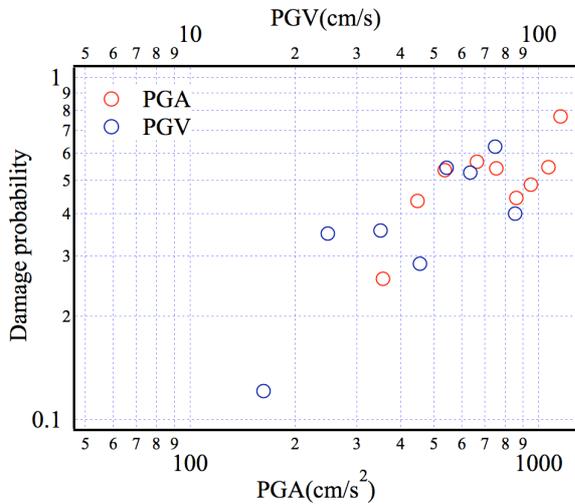
Figure 8. Relationship between damage probability about the level difference behind abutments, and the intensity PGA and PGV

First, the relation between damage probability about the level difference behind abutments, and the intensity of earthquake ground motions such as PGA and PGV is shown in Figure 8. The damage probability in certain intensity interval of earthquake ground motion was defined as the ratio between the number of the damaged bridges and the sum of the number of the damaged bridges and the number of non-damaged bridges. Furthermore, the intensity was taken as the average value of the intensities at these bridge locations in the intensity interval. The average intensity of earthquake ground motion in every intensity interval, the number of damaged bridges, and the number of non-damaged bridges are shown in Table 3. As for PGA, damage probability increases from 300Gal to 600Gal as PGA increases, but damage probability becomes constant value to PGA beyond 600Gal. On the other hand, as for PGV, although sufficient correlation for the increase in damage probability and PGV is not accepted, damage probability increases in the wide PGV range of 20 cm/s to 70 cm/s. Based on not only the relation in the wide PGV range but also the damage which was caused by subsidence of the ground behind abutments, it will be thought that the level difference damage behind abutments has correlativity with the component of velocity of an earthquake ground motion.

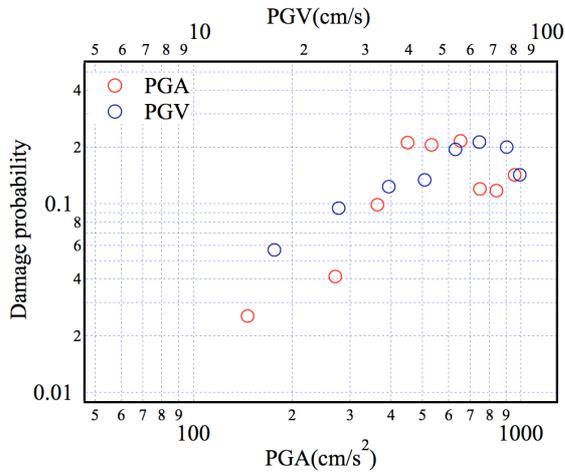
Figure 9. Relationship between damage probability about collapse of shoe, and the intensity PGA and PGV

Next, the relation between damage probability about shoe, and the intensity of earthquake ground motions such as PGA and PGV is shown in Figure 9. Here, the definition of damage probability and the average intensity in the intensity intervals is the same as the level difference damage behind abutments. The average intensity of earthquake ground motion in every intensity interval, the number of damaged bridges, and the number of non-damage bridges are shown in Table 4. The damage probability decreases at PGA for more than 700 Gal and PGV for more than 70 cm/s. As for intensity smaller than those values, a damage probability increases as PGA increases from 300 Gal to 500 Gal. As for PGV, as PGV increases, a damage probability increases in the wide PGV range between 20 cm/s and 70 cm/s. It is found that the damage of shoe has the high correlation with the component of velocity of an earthquake ground motion, but that it also has relationship with acceleration. It is thought that this is related to a relation with the type of shoe.
