## LESSONS LEARNED FROM THE 28 NOVEMBER 2013 BORAZJAN, SOUTH OF IRAN EARTHQUAKE

### ABSTRACT

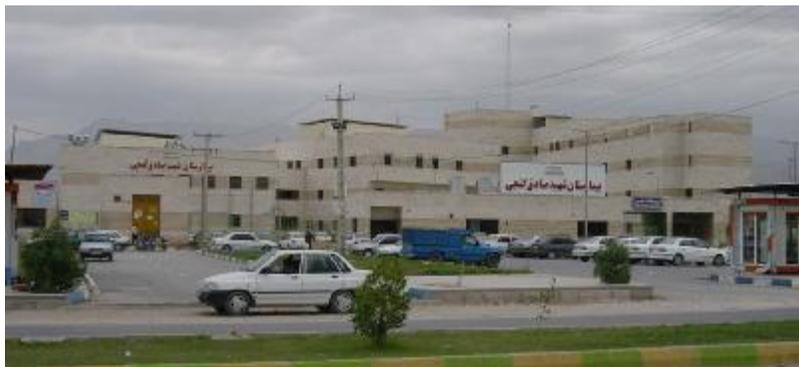
The Shahid Ganji newly built hospital building of Borazjan city which is located about 20 Km to the epicenter is one of the most important buildings in the recent earthquake stricken area (Figure 10). This building which has different floors up to 4 story sustained several non-structural damages due to the earthquake which caused relocation of the hospitalized people to other hospitals (e.g., the old Borazjan hospital which had not sustained any damage and the hospitals in Bushehr city, the capital of the Bushehr Province).

In addition to above damages, what seemed to be more impressive was the ground settlement in parts of the ground floor of the new hospital building. These settlements were observed with different degrees, from a small vertical displacement at the floor of the corridor to large settlements in some of the rooms on the ground floor. According to the hospital authorities, signs of settlements had been seen in those rooms before the earthquake. The earthquake occurrence caused large settlements in those rooms to a degree that it was necessary to fill the floors and bring them to the normal level. For this reason, during the visit, the floors of those rooms had been reinforced by steel bars to rebuild the floors (Figures 13a and b). The hospital site location on satellite images shows that the site is located on a fluvial basin (Figure 14). Therefore, if the ground is soft sediment, it can magnify the earthquake acceleration in the site. In this case, a comprehensive geotechnical study must be carried out and if necessary, special measures (e.g., soil consolidation and inclusion of the acceleration magnification factor in the structural design) have to be taken into consideration so that these problems are avoided in normal conditions and during the earthquakes. An important point in this regard is the study on the site selection of important and vital structures which as much as possible should be selected in places that are far enough from geological hazards such as faulting, landslide, liquefaction, settlement, etc.

Figure 10. A view of the Shahid Ganji new hospital in Borazjan city.

It did not seem that a minimum separation joint was adapted in the Borazjan new hospital building. Noting that this building has 4 stories and its minimum height should be at least 12 m, the minimum joint between the two blocks should be at least 12 cm. This amount of joint did not seem to have been implemented, at least from what could be seen from inside of the building (Figures 12a and b). Anyhow, taking into consideration that the vibration in this building blocks has been intensified during the earthquake, the two adjacent blocks have strongly pounded each other and have caused significant local damages.
