## SEISMIC ISOLATION AS A REHABILITATION TECHNOLOGY FOR IMPROVING SEISMIC PERFORMANCE OF RC BUILDING IN ARMENIA

Nazeli GALSTYAN<sup>1</sup>, Shunsuke SUGANO<sup>2</sup>, Toshihide KASHIMA<sup>3</sup>,  
Matsutaro SEKI<sup>4</sup>

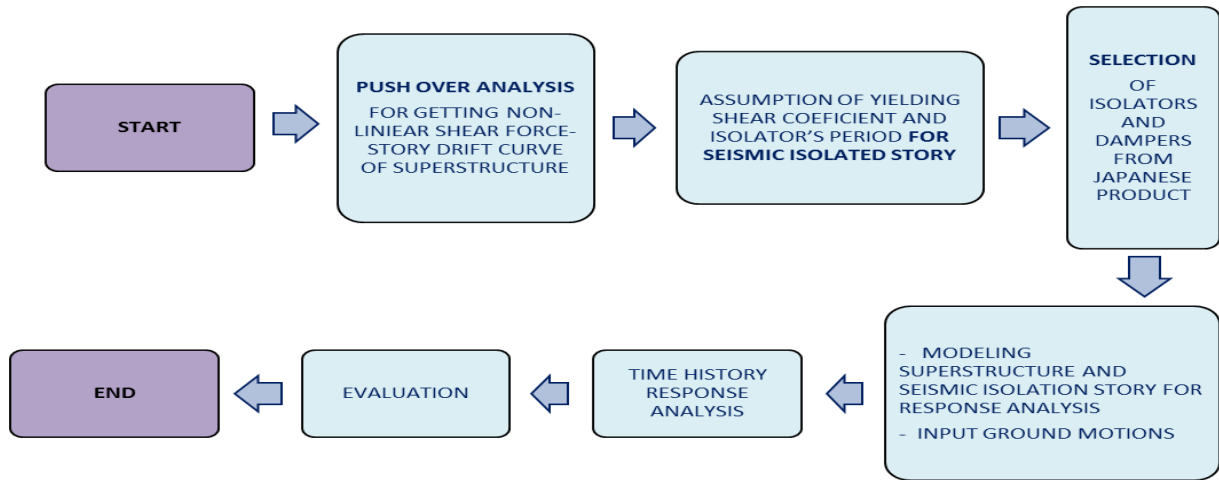
Figure 1. Structural design.

Structural design method has started with push over analysis, then the assumption of yielding shear coefficient have been done, after what the selection of seismic devices. The modeling of building with and without seismic isolation have been made based on noted steps and then time history analysis have been done for both models. The evaluation has concluded the procedure (Fig. 1).

- Structural design has been made based on the non-linear time history response analyses, and based on the non-linear model for structural members, which has been made by using Dr. T.Saito's Stera 3D software.
- The maximum input acceleration ground motion is considered  $400\text{cm/s}^2$  in accordance with defined maximum design value in Armenia.
- The seismic devices: isolators and dampers are chosen from Japanese products as shown in Table1.
- Performing the parametric study
  - Ground motions: Spitak, Elecentro, Hachinohe and Taft .
  - Seismic isolation story

- ✓ Yielding shear force coefficient:  $\alpha_y = \begin{cases} 0.02 \\ 0.04 \end{cases}$
- ✓ Isolation period:  $T_v = \begin{cases} 2 \text{ seconds} \\ 3 \text{ seconds} \\ 4 \text{ seconds} \end{cases}$

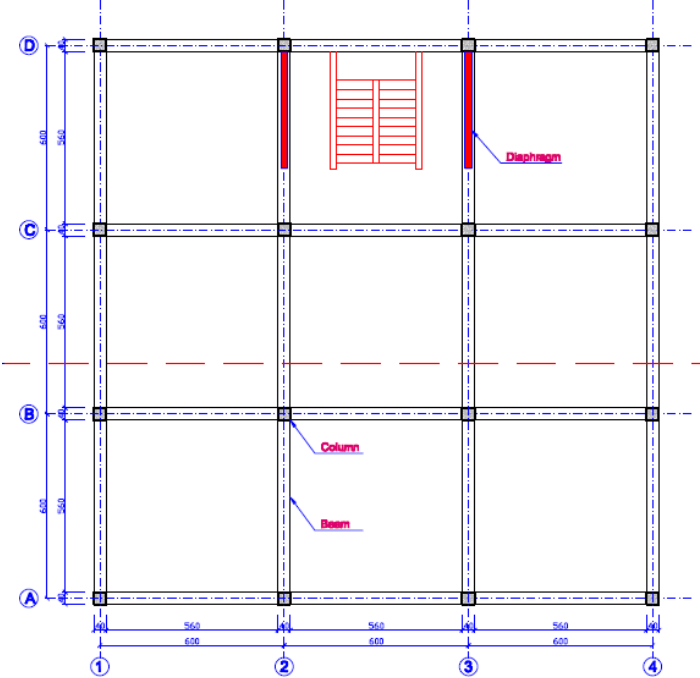
Figure 2. Plan of FB building.

The plan of the analysed building is shown in Figure 2 and a building view of similar structure type is shown in Photo. 1.

The structure is RC frame for one direction and the other is RC panel. Natural periods of the

building for the first three mods for frame direction are 1.196 sec., 0.673 sec. and 0.394 sec. correspondingly.

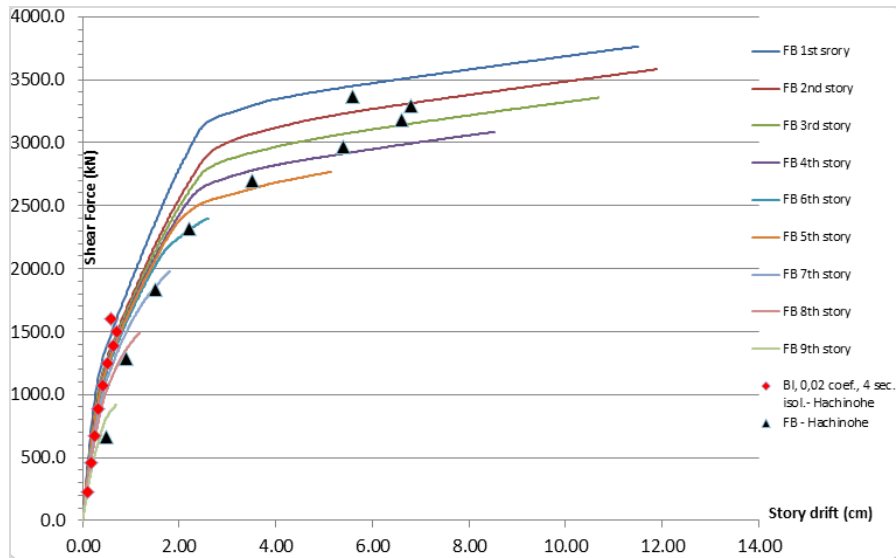
Figure 3. Relative drift of superstructure.

Relationship between the story drift and share force based on push-over analysis is introduced in Figure 3.

An example of reduction of the shear force and relative drift of the superstructure is introduced in Figure 4, for the isolators with different periods. In Figure 3, the comparison of maximum response for superstructure between fixed base and seismic isolation to Hachinohe earthquake is shown.

Compared with story drift of superstructure without seismic isolation, story drift with seismic isolation reduced by 30~15 % in the most effective case.
