**GLOBAL SEISMIC RISK REDUCTION PROGRAMS:
INTERNATIONAL PERSPECTIVE ON THE SUCCESSFUL
APPLICATION IN ISTANBUL**

ABSTRACT

INTRODUCTION TO ISMEP

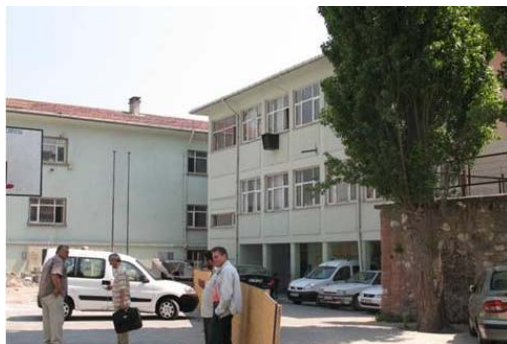
Figure 1 depicts a vulnerable building in Istanbul taken during a recent site visit and condition-assessment survey. For this building, the walls terminate above the first floor to allow for parking. This introduces a soft-story mechanism at this level and can lead to collapse in a future earthquake. Once such dangerous buildings are identified, it is important that steps be taken to address the vulnerabilities. Many thousands of school, hospital, and government buildings in Istanbul use reinforced concrete moment frames. There are over a dozen sub-groups within the same design group. The main differences between the various subgroups are the layout of the frames, geometry of the structures, and presence of URM walls. The most common type (see Figure 2) is a three or four story, regularly configured building, with a basement, and an emergency staircase attached to the short sides of the structure.

Figure 1. A vulnerable structure

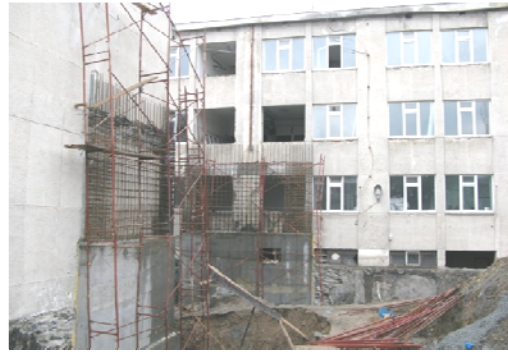
The addition of shear walls (schematics shown in Figure 4 and construction photograph for a school building is shown in Figure 5) is the most widespread retrofitting method for the Istanbul strengthening work. This technique is attractive because of its effectiveness, relative simplicity of construction, and cost effectiveness. The key reason for effectiveness is that the additional shear walls are designed to resist a large portion of the lateral seismic loads, which significantly reduces the demand on the existing frame members. This technique has been widely used to retrofit a significant number of public schools and hospitals in Istanbul, as well as in California, Japan, New Zealand, etc.

Figure 5. Construction of exterior concrete walls for a school retrofit

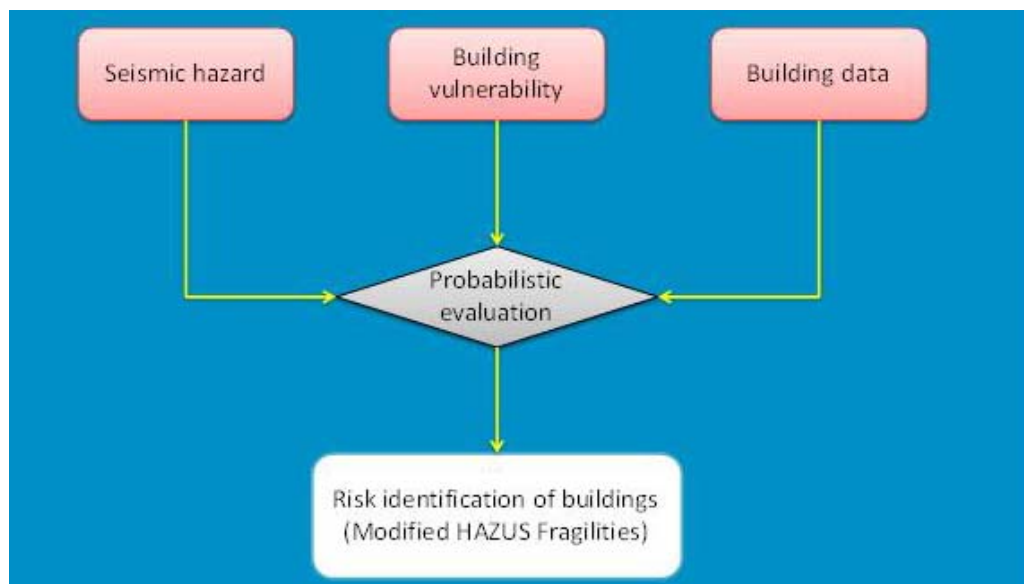
Cost-benefit analysis (CBA) was performed and applied to the database of buildings to prioritize the buildings based on the expected number of fatalities. In addition, an estimate of cost associated with seismic upgrade of vulnerable buildings was prepared. Given that the focus of this study is on public schools and hospitals in Metro Manila, main goal is to identify whether the buildings studied need to be retrofitted and, if so, what the costs and benefits are. The status quo (no retrofit) is used as the baseline, and the benefits derived from a seismic upgrade program and the costs associated with such an approach are quantified. The cost algorithm is based on fatalities and uses hazard, exposure, and building vulnerability as input; see Figure 6.

Figure 6. Prioritization process

- Seismic hazard. The seismic hazard map were input as a layered map for analysis. Data is based on the provisions of the National Code
- Exposure. A database that lists the number of occupants for the facilities under consideration. Field surveys have been conducted by the project team and data from these surveys were used to augment and modify the databases.

- Building Vulnerability. The risk analysis platform provides fragility information for various building types. In this project, the fragility were based on the recommended values of FEMA HAZUS (FEMA 2003) and modified for Metro Manila.

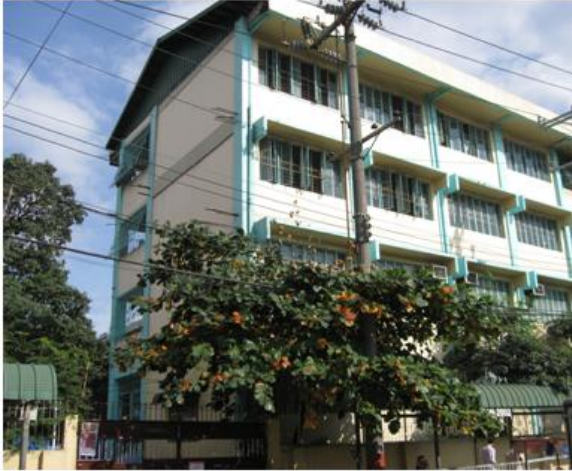
Typical school and hospital buildings are comprised of reinforced concrete–frame construction with infill walls. For some public buildings reinforced concrete shear walls are used. Figure 8 presents a typical school building.

Figure 8. Typical school building
